Retrofitting For Rollover Crashworthiness Occupant Protection

Raphael Grzebieta¹, Don Friedman^{2,3}, Susie Bozzini³, Cindy Shipp³ and Hussein Jama¹

¹NSW Injury Risk Management Research Centre, University of New South Wales.

Abstract

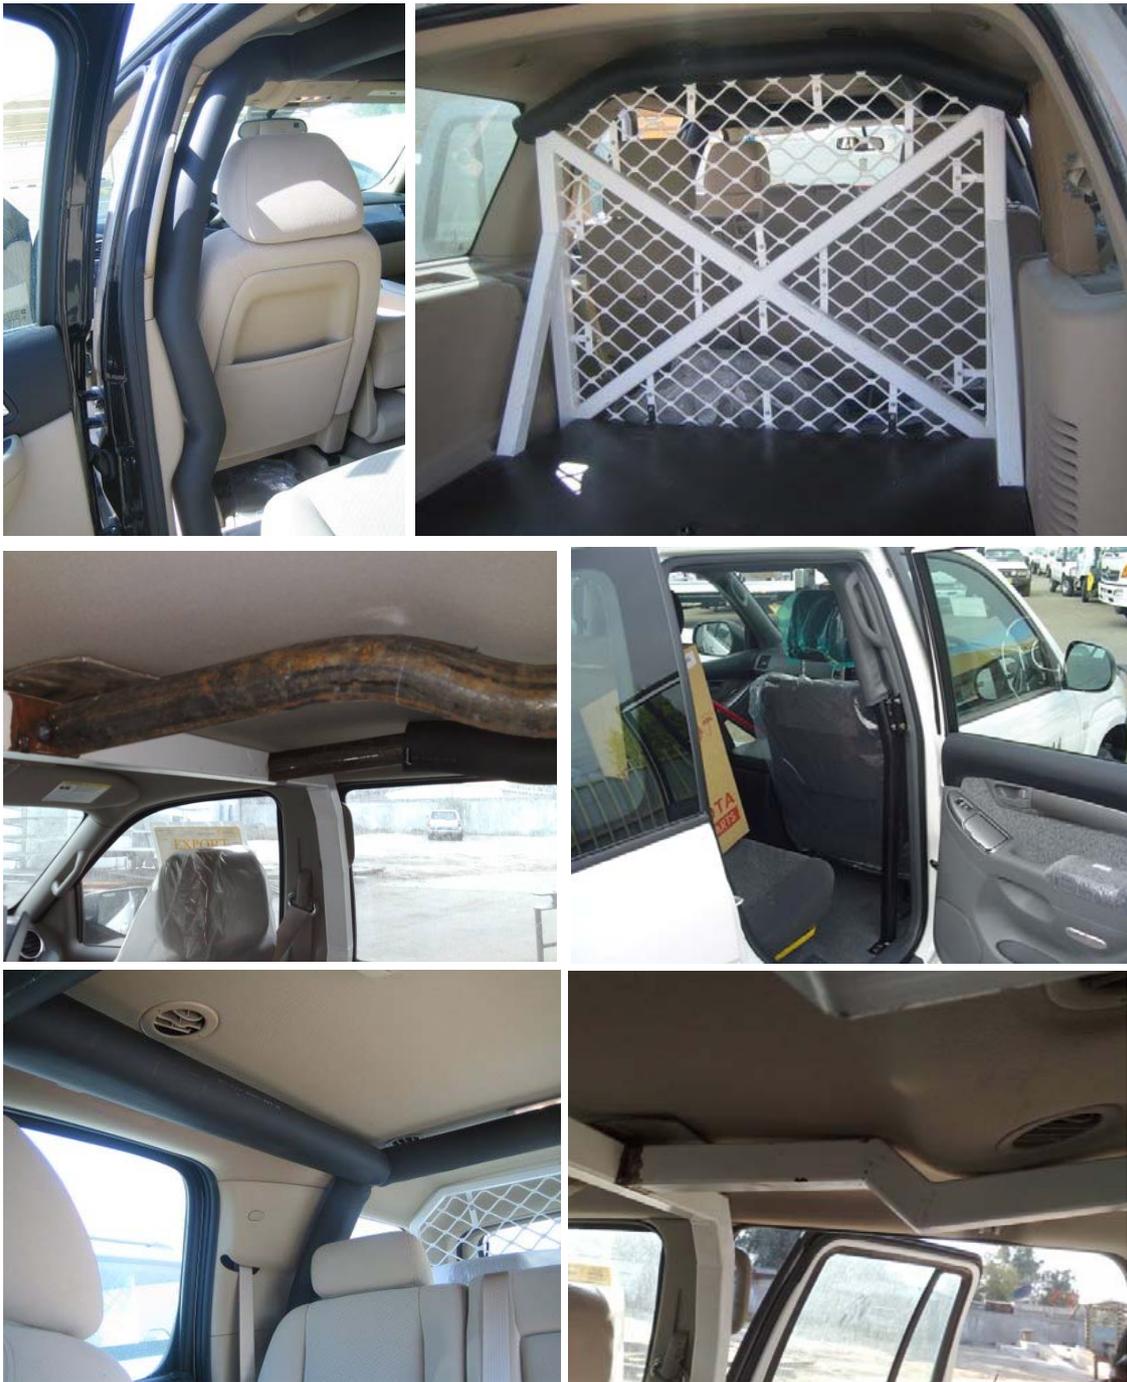
Figure 1: Examples of roof strengthening using internal rollover bars.

To mitigate the injuries observed in rollover crashes, a number of mining and petroleum companies have attempted to install rollover protection bars such as the examples shown in Figure 1 and Figure 2. Although such roof strengthening may at first appear to provide a survivable interior space to protect occupants against roof crush, these quick fix methods demonstrate a lack of understanding of how vehicles deform and occupants are injured in rollover crashes.

Firstly, interior roll bars reduce survivability space. They can significantly exacerbate and/or cause other injuries resulting from body strikes to hard surfaces in other crash modes such as side and frontal impact. Secondly, such interior reinforcement may also impede the firing of critical passive devices such as side air curtains and seat belt pretensioners that help reduce occupant impact forces. Thirdly, Figure 2 shows how despite the installation of an internal roll bar the roof has collapsed at the front header rail on the front passenger side of the vehicle. Not only does such deformation reduce the survivability space for the seat belted front passenger, it can substantially increase head roof contact loading and head impact velocity which lead to severe and fatal injuries. Fourthly, Figure 2 and Figure 3 show how when the vehicle pitches forward during the rollover because of the engine mass, the A-pillar deforms approximately to the yellow line. This usually occurs when the A-pillar is weak, and rollover contact support and roof crush resistance is mainly provided by the front fender and the stronger B and C pillars.

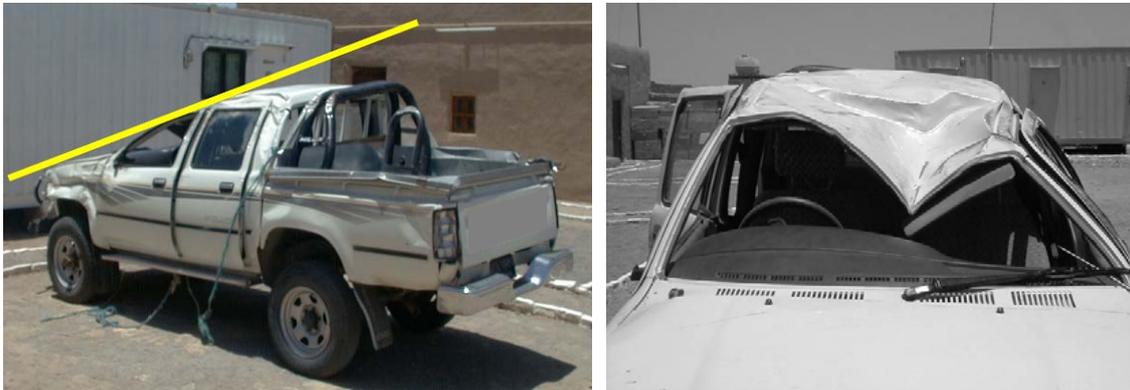
Figure 2: Vehicle reinforced with internal roll bar at B-pillar and external roll bar behind C-pillar. Note buckle of front windshield header rail intruding into occupant compartment.

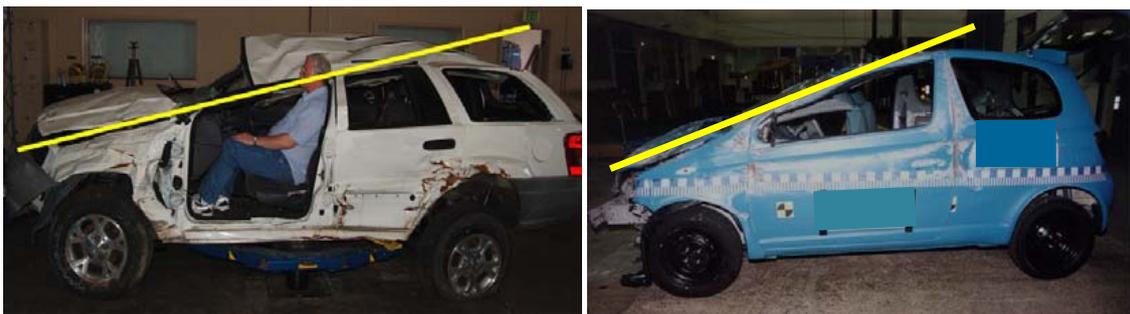
Figure 3: Note deformation line of A-pillar approximately matches yellow line shown. The line indicates how the vehicle has pitched forward during rollover as a result of the engine mass.

As a result of these observations and how vehicles deform during real world rollovers as shown in Figure 2, Figure 3 and Figure 5, the JRS rollover crash test rig (Figure 6) was developed together with a rollover crash testing protocol. Detailed descriptions of how the test rig functions are described elsewhere [13], [14], [15].

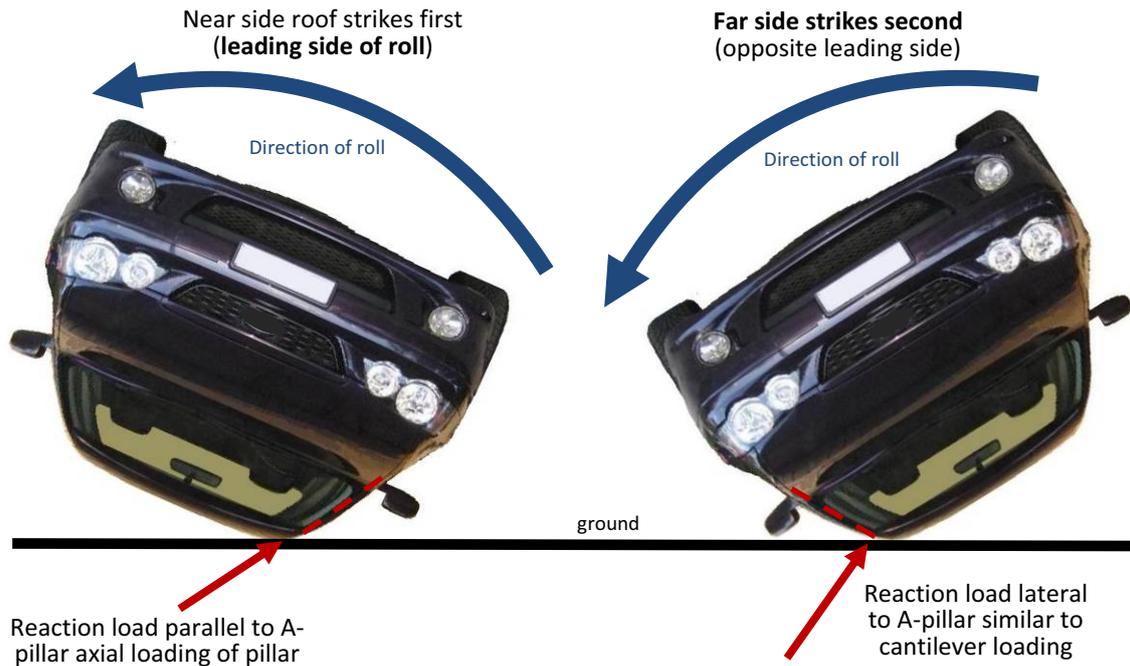
Figure 4: Loads applied to vehicle's roof during rollover.

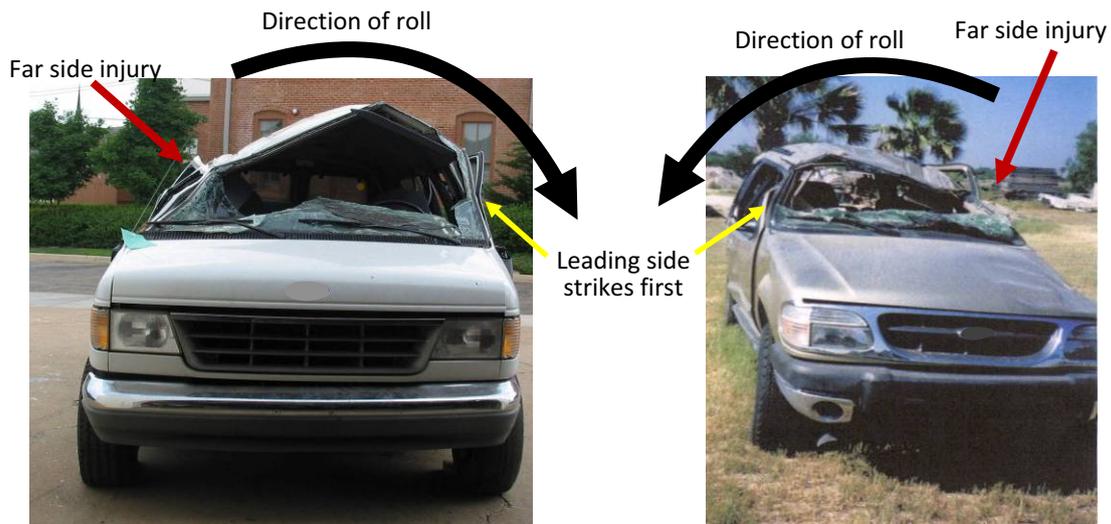
Figure 5: Injuries are usually to occupants seated on far side of rollover where roof crush occurs.

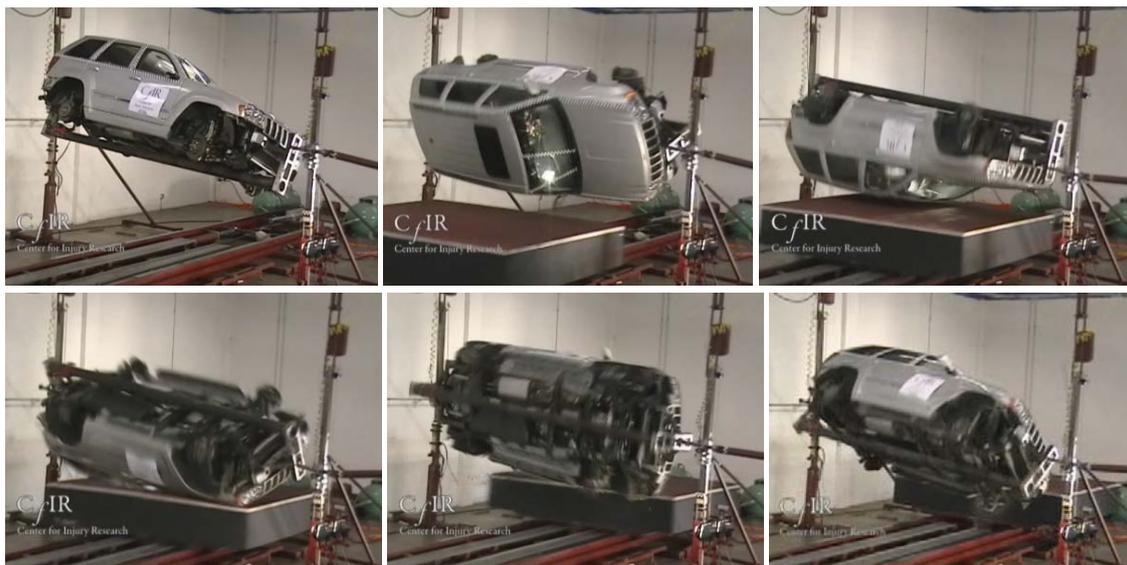
Figure 6: Still frames of a production SUV with SWR of 2.2 subjected to a JRS test (Roll 1). Note: frame 3 near side strikes floor; Frame 4 far side strikes floor.

The ends of the vehicle are mounted on towers on an axis of rotation through its Center-of-Gravity (CG). The vehicle is simultaneously rotated and released as a roadbed moves under it. The test starts from an almost vertical orientation to the road bed position similar to that shown in the first frame in Figure 6. During the simultaneous rotation and fall, the vehicle strikes the moving roadbed below on the leading side of roll (near side – frame 3) at the side roof rail at the prescribed roadbed speed, vehicle angular rate, drop height and impact pitch angle. After striking the near side, the vehicle continues to roll and strikes the side opposite to the leading side (far side – frame 4). The vehicle is then captured. The motions of the vehicle and roadway are coordinated so that the touchdown conditions can be controlled and thus repeated within a narrow range.

This paper focuses on the rollover crash tests carried out on a sample production vehicle with a low roof strength to weight ratio (SWR)² of 2.2, a strong roof vehicle with a SWR of 4.6 and a similar make low roof strength vehicle with a HALO™ prototype attached. Figure 6 shows the low strength vehicle being tested in the JRS. Figure 7 shows exterior and interior views of the roof structure with and without the ATD after two rollover tests. It is clear from Figure 7 there is significant roof crush. The neck loading was significant at around 9.7 kN with a 60% probability of an AIS 3-4 neck injury. ATD neck injury measures are also provided in another paper elsewhere [16].

The test shown in Figure 6 and Figure 7 are of a 2007 production vehicle. To reduce testing costs, an earlier model 1993 vehicle from the same manufacturer was used to fit the HALO™ and compare results to a JRS test of the 1993 production model (Figure 8). Details and discussion concerning this comparison is presented in an earlier paper [17]. The SWR for the 1993 model is 2.3 albeit the roof deformation appeared a little larger than the 2007 model and the neck load was close to 10 kN. This paper focuses on the roof ground contact interaction and how the HALO™ reduces the loads to the roof and the occupant.

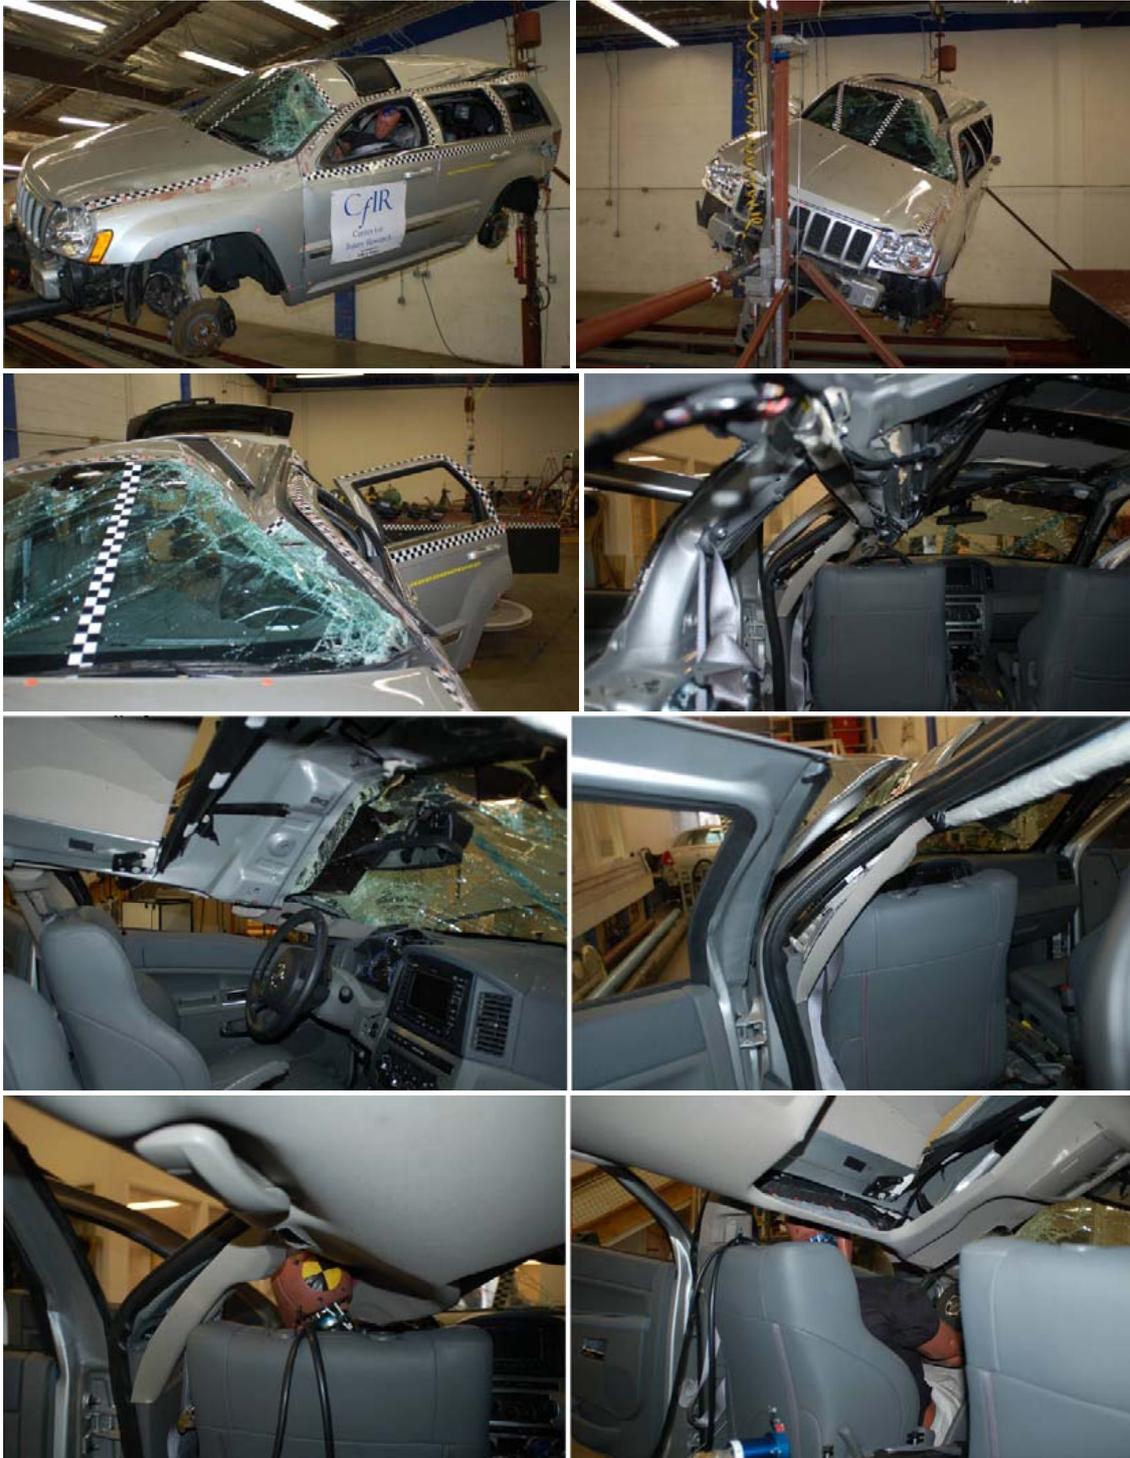
Figure 7: Deformed roof structure of low roof strength (SWR = 2.2) vehicle after roll 2 JRS test.

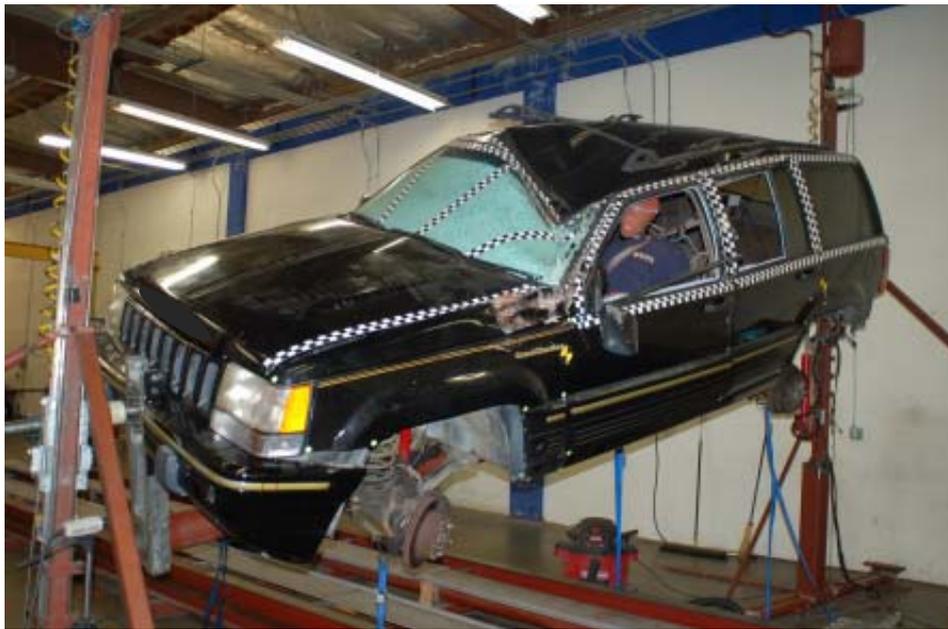
Figure 8: Older 1993 model of vehicle (SWR 2.3) shown in Figure 7.

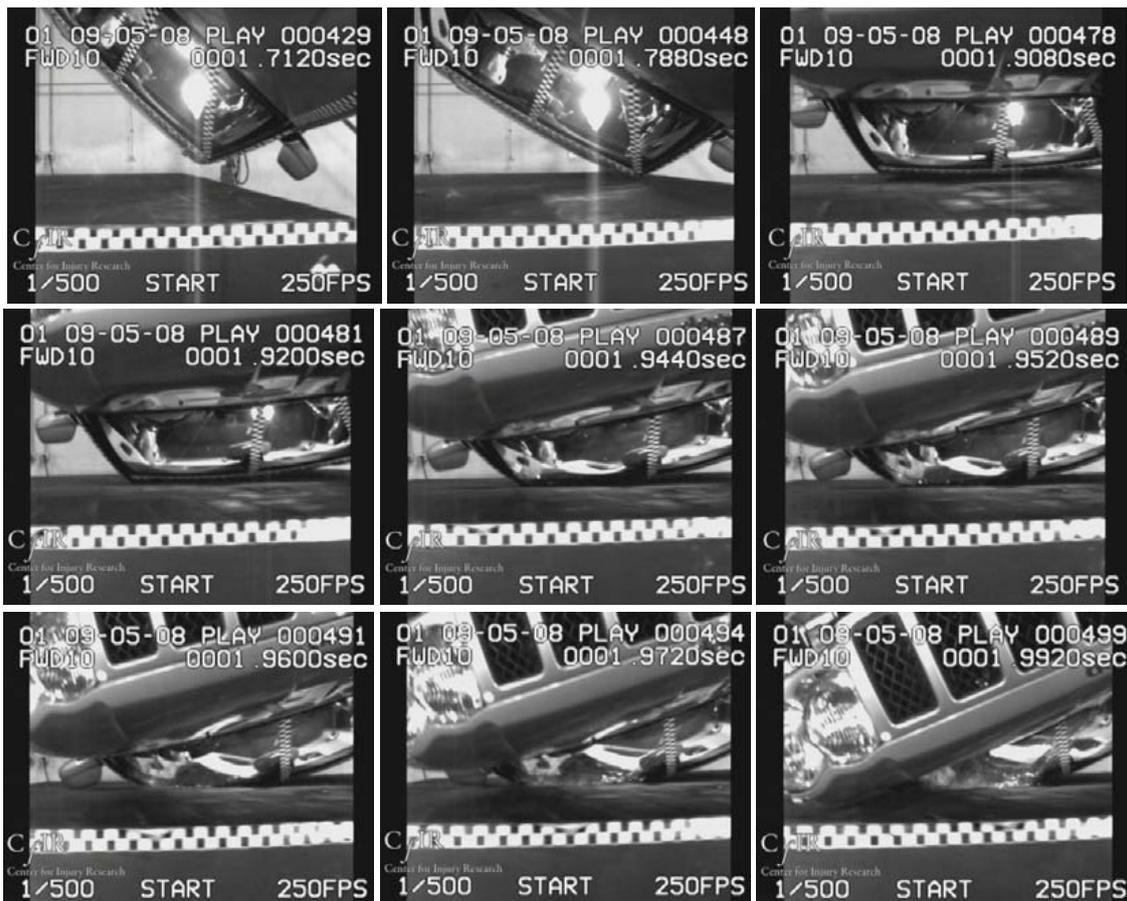
Figure 9: ATD interaction with low roof strength vehicle's (SWR 2.2) roof and floor during near side and far side touch down.

Figure 9 shows a view from the high speed video from the floor inertial reference point. Frame 1 ($t=1.712$ sec) shows the vehicle during vertical release. Frame 2 ($t=1.788$) shows near side touch-down. Frame 3 (1.908 sec) shows that the middle of the roof touches down. This touchdown of the middle of the roof is important. It indicates that the vehicle's centre of gravity (CG) about which it rotates continues to move vertically downwards. The radius of rotation about the CG from the moment shown in frame 2 to the moment shown in frame 3 has now reduced by around 10 cm. In frame 4 ($t=1.920$ sec) the far side of the roof comes into contact. It is at this point in the roll the vehicle must raise the CG (increase its radius of rotation) to continue to rotate. In other words, the roof must be strong enough to lift the vehicle back up. Because the roof is weak, it collapses as shown in frames 5 to 9 ($t=1.944$ sec to 1.992 sec). The ATD's head being adjacent to the ground contact gets caught in the buckling roof and remains momentarily stationary (frames 4 to 7 – $t=1.920$ sec to $t=1.960$ sec). The ATD's torso continues to move forward and thus loads the ATD's neck. In frames 7 to 9 ($t=1.960$ sec to 1.992 sec) the roof buckles so much that the ATD's head is thrust upwards relative to the ground. The peak roof intrusion speed relative to the interior of the vehicle was around 12.6 km/hr (3.5 m/sec) [17].

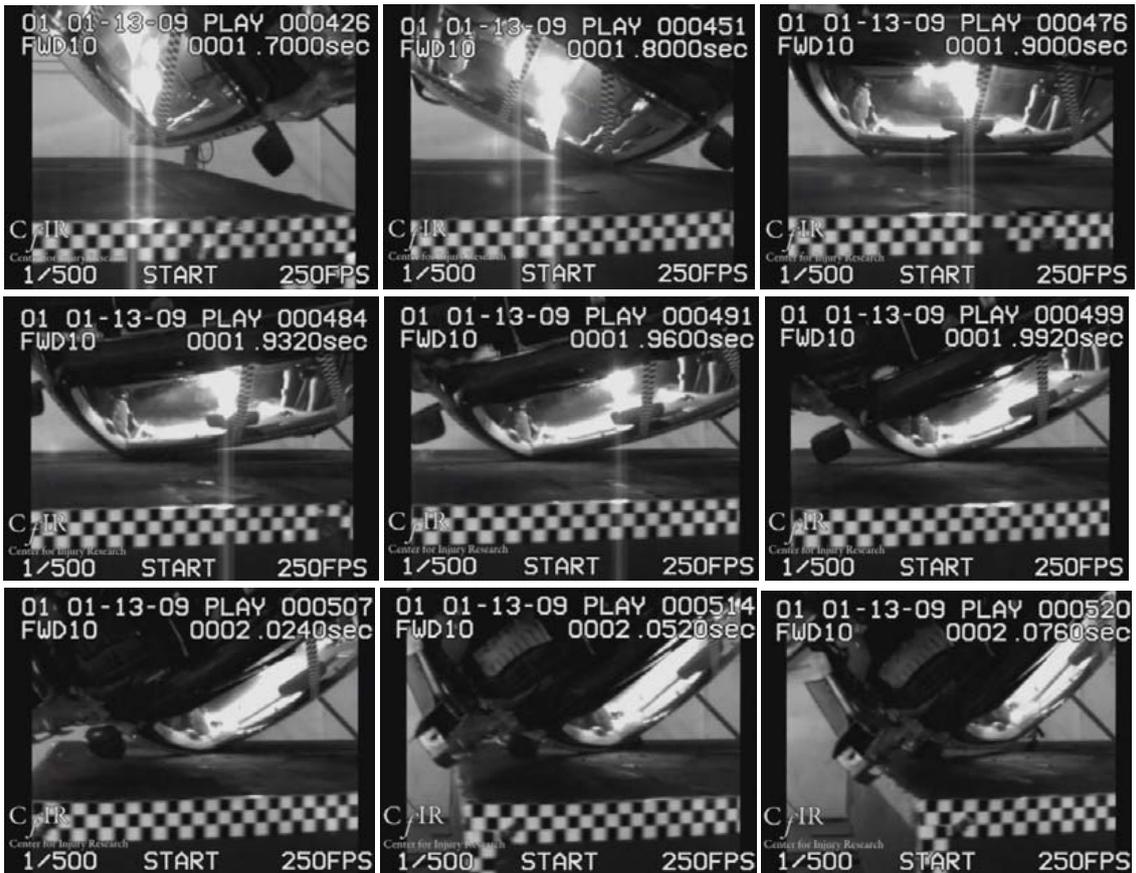
Figure 10: ATD interaction with high roof strength vehicle's (SWR 4.6) roof and floor during near side and far side touch down.

In the case of a strong roof vehicle, the mechanism loading the ATD's neck is significantly different. Figure 10 shows the individual frames of the roof structure as it contacts the moving floor. What is interesting to note is that the ATD's head does not move relative to the front header rail line during the roll process. Frame 3 ($t=1.900$ sec) also shows the vehicle is airborne at that moment of the roll event. That is, the roof at the midpoint is not in contact with the floor. Hence when the far side of the vehicle comes into contact with the floor in Frames 4 ($t=1.932$ sec) and 5 ($t=1.960$ sec), the amount of lift of the vehicle's CG is not as great as in the case of the weak roof vehicle (Figure 9, Frame 4, $t=1.920$ sec). It

should be noted that the axial neck load measured by the ATD was 3.6 KN in the second roll and the maximum roof intrusion velocity relative to the vehicle interior was 5.1 km/hr (1.41 m/sec).

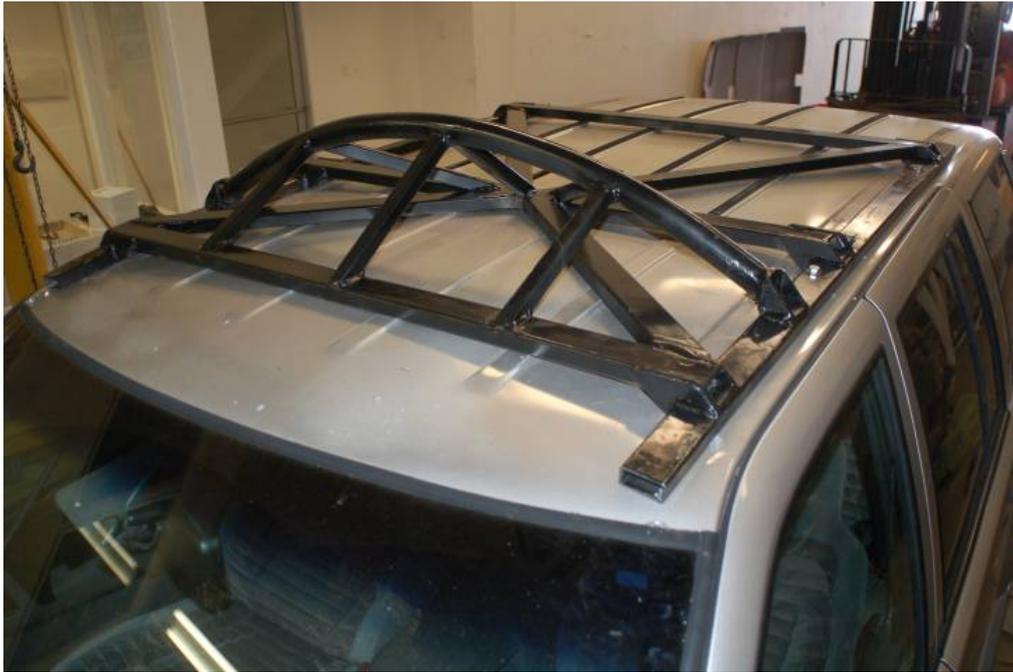
Figure 11: Prototype HALO™ fitted to roof of low strength (1993) vehicle.

It was this observation that led to the concept of fitting a hoop bar (Figure 11) to the outside of the vehicle's roof that helped maintain the vehicle's roll radius. Obviously if the roundness of the roof about the vehicle's CG is maintained, the roll action will be smooth, somewhat similar to that of a round tyre. Figure 12 shows the individual frames of the (1993) low strength roof structure fitted with a HALO™, as it contacts the moving floor. The HALO™ also strengthened the roof. Internal flat plating was attached to the B-pillars to strengthen them as well. The ATD's head is visible in the frames. Note how the vehicle is supported by the round bar when the vehicle is rotated at 180° (T=1.652 sec). The frames show the ATD's head does not move towards the vehicles CG relative to the inside windshield header rail. Transition from the near side to the far side is smooth.

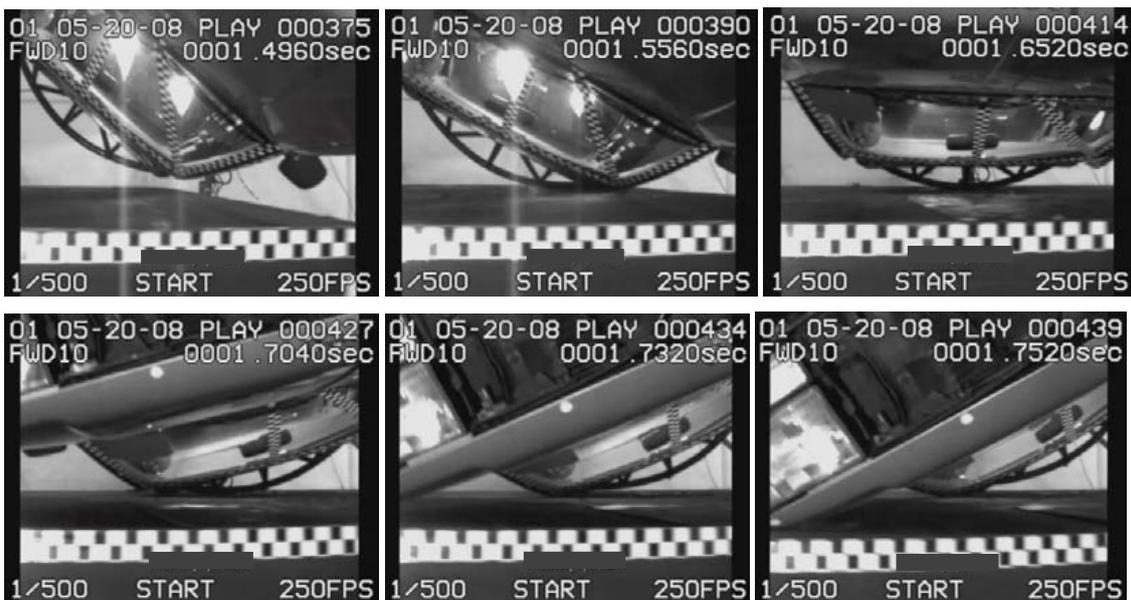
Figure 12: ATD interaction with (1993) low roof strength vehicle's (SWR 2.3) roof and floor during near side and far side touch down. ATD's head is circled.

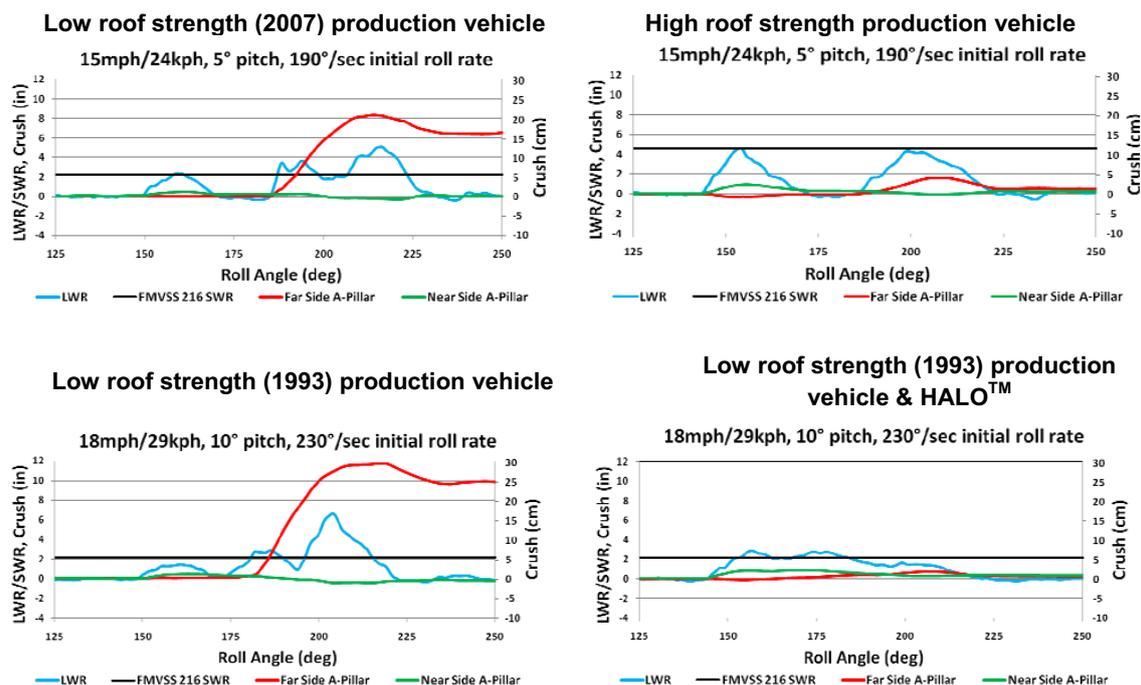
Figure 13: Loads measured in moving floor for: low roof strength (1993 & 2007) production vehicles; high roof strength vehicle; and low roof strength (1993) vehicle with HALO™.

Figure 13 shows the loads measured by the moving floor and roof crush versus roll angle. The dark black line in the plot indicates the vehicle's SWR capacity. The load to weight ratio (LWR – blue line) is a non-dimensional value of the load measured by the floor divided by the vehicle's total weight. The red and green lines indicate roof crush at the far and near side A pillar roof rail connection.

Figure 13 shows that for both (1993 & 2007) low roof strength production vehicles the load demand exceeds the vehicle's A-pillar capacity to sustain the load. The high load peak loads at 205° for the 2007 vehicle and 215° are likely interactions of the vehicle's dash board and side door as a result of complete roof collapse. The load demand for the high roof strength vehicle on the other hand is within the vehicle's pillar load capacity. Moreover, the load peaks for the high roof strength vehicle are uniform, indicating two evenly distributed peaks. On the other hand, the low strength roof vehicle displays uneven

peaks when comparing the near side load interaction with the far side load interaction. The far side load interaction is also very large relative to the vehicles SWR. Of particular note is the plot of the road loads for the (1993) low strength roof vehicle with the HALO™ fitted. It is clear that the roof load is distributed relatively evenly over the whole roll. Moreover, the magnitude of the load has been significantly reduced from a LWR of around 6 to around 2.5.

Figure 13 also shows that for both (1993 & 2007) low roof strength production vehicles, the maximum and residual roof crush is very large in comparison to the high strength vehicle and the vehicle with the HALO™. Indeed the maximum roof crush is an order of magnitude less than the low strength vehicle's maximum roof crush and the residual roof crush for the high strength vehicle is barely discernable.

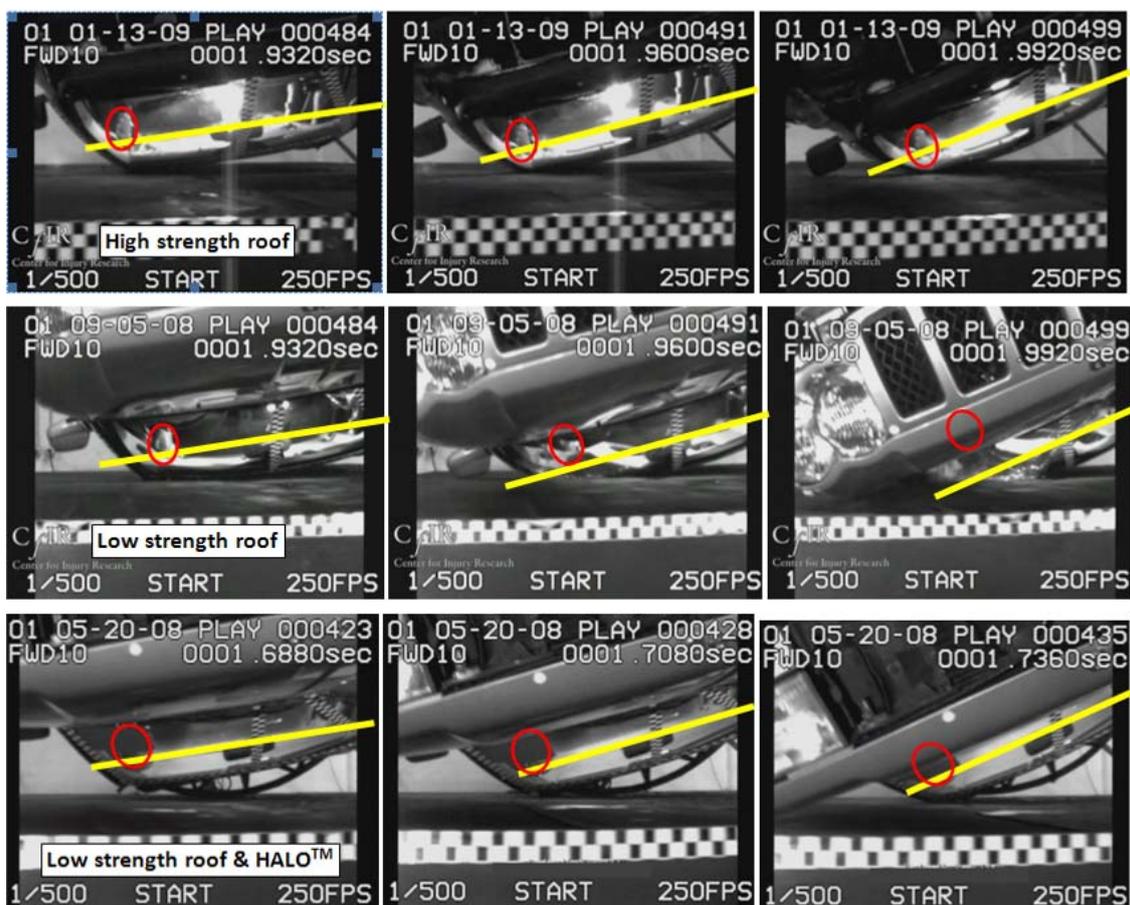
Figure 14: Top row - high strength roof; Middle row: low strength roof;
Bottom row – low strength roof with HALO™

Figure 14 shows three frames in each row from the high speed video taken respectively for the high strength roof vehicle, the low strength (2007) roof vehicle, and the (1993) low strength roof vehicle with the HALO™. The rotation angles were matched (vertically) in the Figure. The yellow line is a reference line drawn relative to the vehicle's rear view mirror. The red circle shows the location of the ATD's head in each frame. The yellow line shows how the vehicle rotates about its CG and how the ATD's head moves relative to the line as well as relative to the moving floor. Figure 14 clearly shows that for the low strength roof vehicle (middle three frames) that the ATD's head moves towards the vehicle's seat base despite the rotation of the vehicle. This is the result of the vehicle's roof buckling and forcing the head inward towards the vehicle's seat base. Figure 14 also shows that the ATD's head is moving away from the floor for the low strength roof whereas in the case of the high strength roof, as well as for the HALO™ reinforced roof vehicle, the ATD's head moves closer to the floor and continues in a circular motion without any violent reverse direction motion.

In the case of the (1993) low strength roof vehicle fitted with the HALO™, the ATD's axial neck load was 1 kN and the peak intrusion velocity was 1.6 km/hr (0.44 m/sec). Clearly when the roof of a vehicle is strengthened, the load imparted onto the occupant as a result of roof crush is significantly reduced. Moreover, the results presented in this paper also demonstrate that loads imparted to an occupant's head and neck when they are seated in the vicinity of where the roof crushes, is causally linked to roof crush.
