SPE 127231

ROLLOVER PROTECTION – a Meaningful & Effective Solution

Susie Bozzini, Safety Engineering International, Josh A. Jimenez, Safety Engineering International, Raphael Grzebieta Ph.D., Safety Engineering International, Donald Friedman, Safety Engineering International

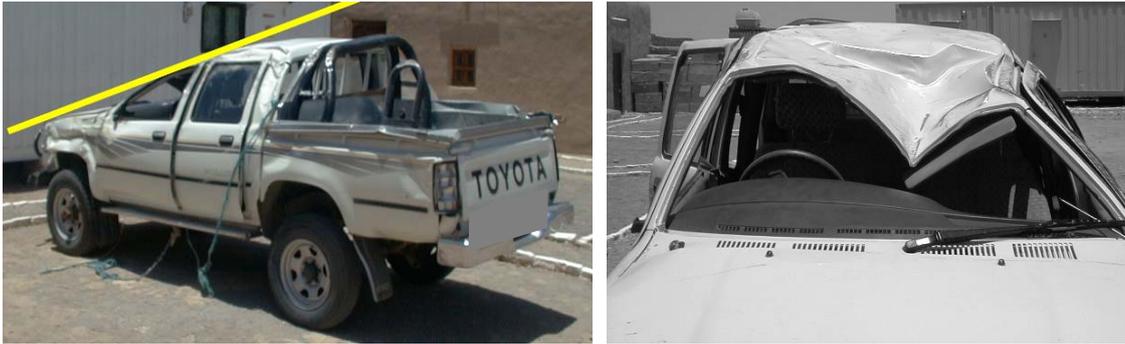
Figure 2. Vehicle reinforced with internal roll bar at B-pillar and external roll bar behind C-pillar. Note buckle of front windshield header rail intruding into occupant compartment.

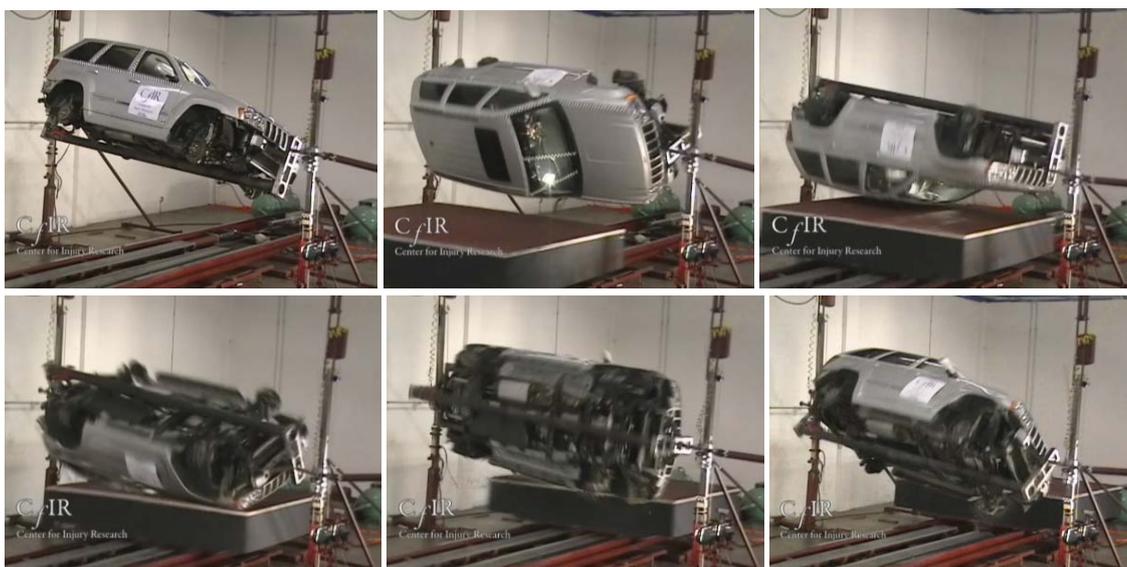
Figure 10. Still frames of a JRS test. Note: frame 3 near side strikes floor; Frame 4 far side strikes floor.

The test starts from an almost vertical orientation to the road bed position similar to that shown in the first frame in Figure 10. During the simultaneous rotation and fall, the vehicle strikes the moving roadbed below on the leading side of roll (near side – frame 3) at the side roof rail at the prescribed roadbed speed, vehicle angular rate, drop height and impact pitch angle. After striking the near side, the vehicle continues to roll and strikes the side opposite to the leading side (far side – frame 4). The motions of the vehicle and roadway are coordinated so that the touchdown conditions can be controlled and thus repeated within a narrow range.

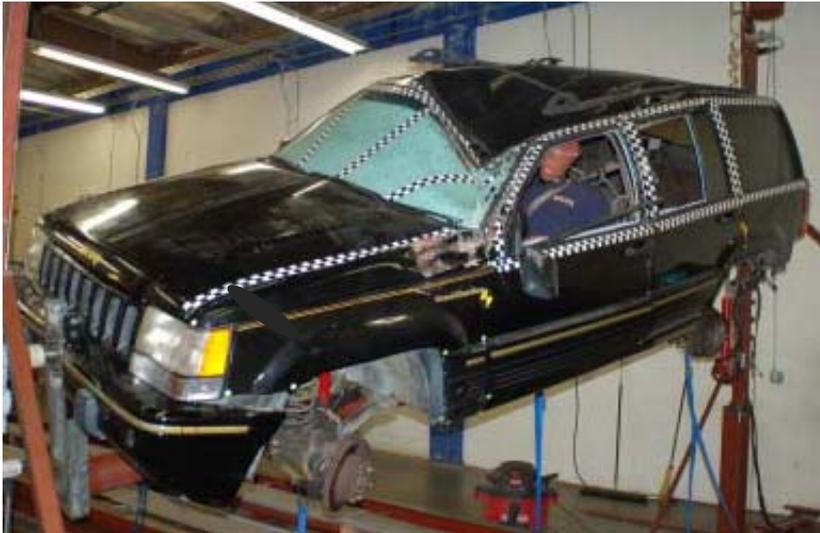
Figure 12. 1993 model of vehicle (SWR 2.3) shown in Figure 11.

The test shown in Figure 10 and Figure 11 are of a 2007 production vehicle. For research purposes, an earlier model 1993 vehicle from the same manufacturer was used to fit an external load attenuation device and compare results to a JRS test of the 1993 production model (Figure 12). Details and discussion concerning this comparison is presented in an earlier paper (Grzebieta, R., 2009). The SWR for the 1993 model is 2.3 albeit the roof deformation appeared a little larger than the 2007 model and the neck load was close to 10 kN. An examination of the roof ground contact interaction and how an external load attenuation device can reduce the loads to the roof and the occupant are discussed next.

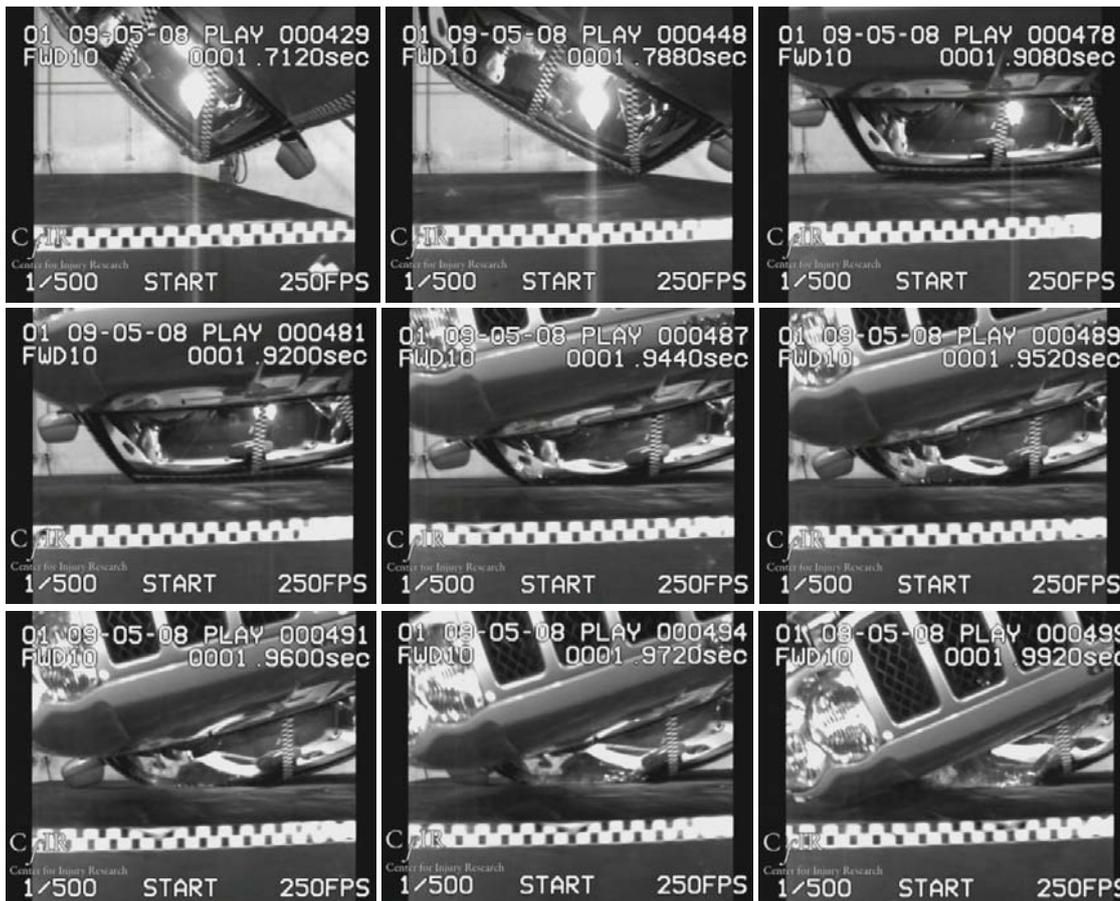
Figure 13. ATD interaction with low roof strength vehicle's (SWR 2.2) roof and floor during near side and far side touches down.

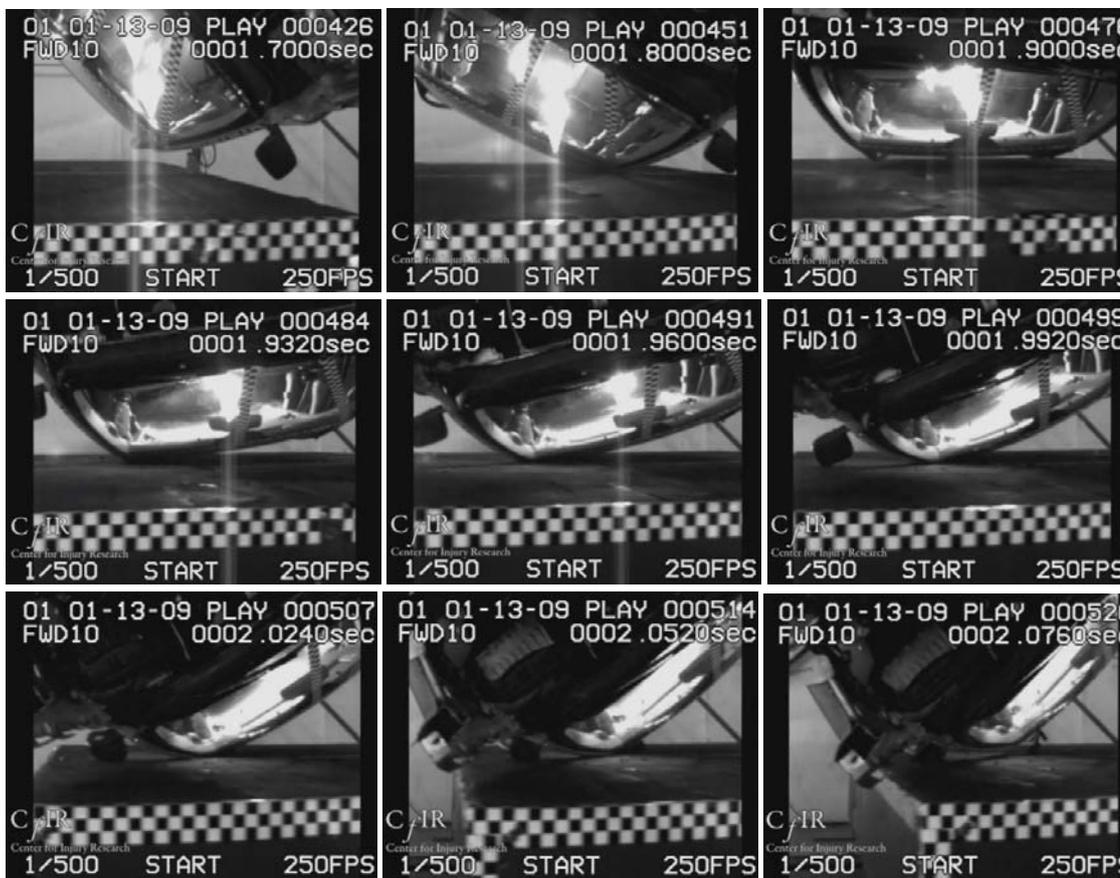
Figure 14. ATD interaction with high roof strength vehicle's (SWR 4.6) roof and floor during near side and far side touchdown.

In the case of a strong roof vehicle, the mechanism loading the ATD's neck is significantly different. Figure 14 shows the individual frames of the roof structure as it contacts the moving floor. What is interesting to note is that the ATD's head does not move relative to the front header rail line during the roll process. Frame 3 ($t=1.900$ sec) also shows the vehicle is airborne at that moment of the roll event. That is, the roof at the midpoint is not in contact with the floor. Hence when the far side of the vehicle comes into contact with the floor in Frames 4 ($t=1.932$ sec) and 5 ($t=1.960$ sec), the amount of lift of the vehicle's CG is not as great as in the case of the weak roof vehicle (Figure 13, Frame 4, $t=1.920$ sec). It should be noted that the axial neck load measured by the ATD was 3.6 KN in the second roll and the maximum roof intrusion velocity relative to the vehicle interior was 5.1 km/hr (1.41 m/sec).

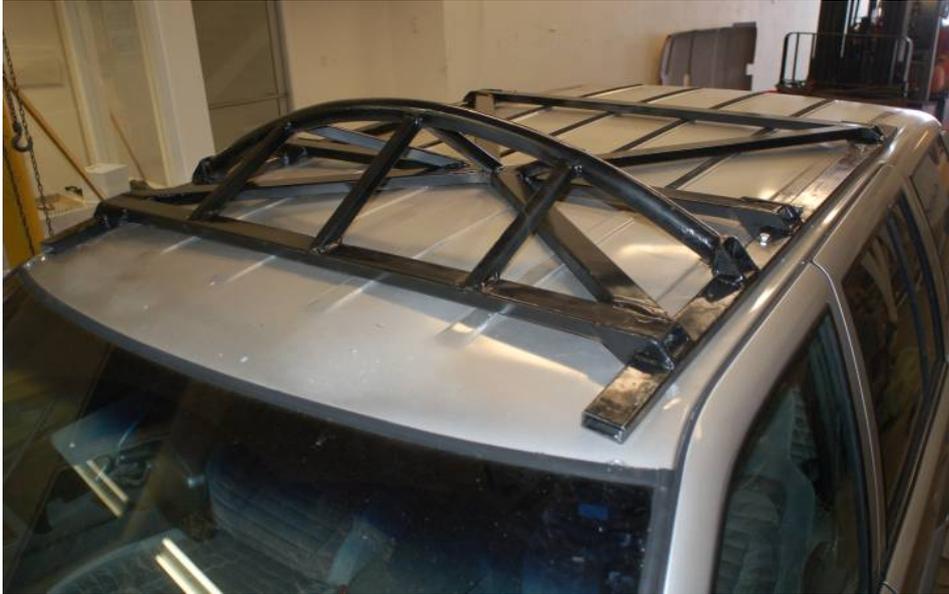
Figure 15. Prototype RDMD fitted to roof of low strength (1993) vehicle.

It was this observation that led to the concept of fitting a hoop bar to the outside of the vehicle's roof that helped maintain the vehicle's roll radius. A proof of concept is shown in Figure 15. Obviously if the roundness of the roof about the vehicle's CG is maintained, the roll action will be smooth. Figure 16 shows the individual frames of the (1993) low strength roof structure fitted with an external load attenuation device, as it contacts the moving floor. The total assembly of the external load attenuation device also strengthened the roof. Internal flat plating was attached to the B-pillars to strengthen them as well. The ATD's head is visible in the frames. Note how the vehicle is supported by the round bar when the vehicle is rotated at 180° (T=1.652 sec). The frames show the ATD's head does not move towards the vehicles CG relative to the inside windshield header rail. Therefore, transition from the near side to the far side is smooth.

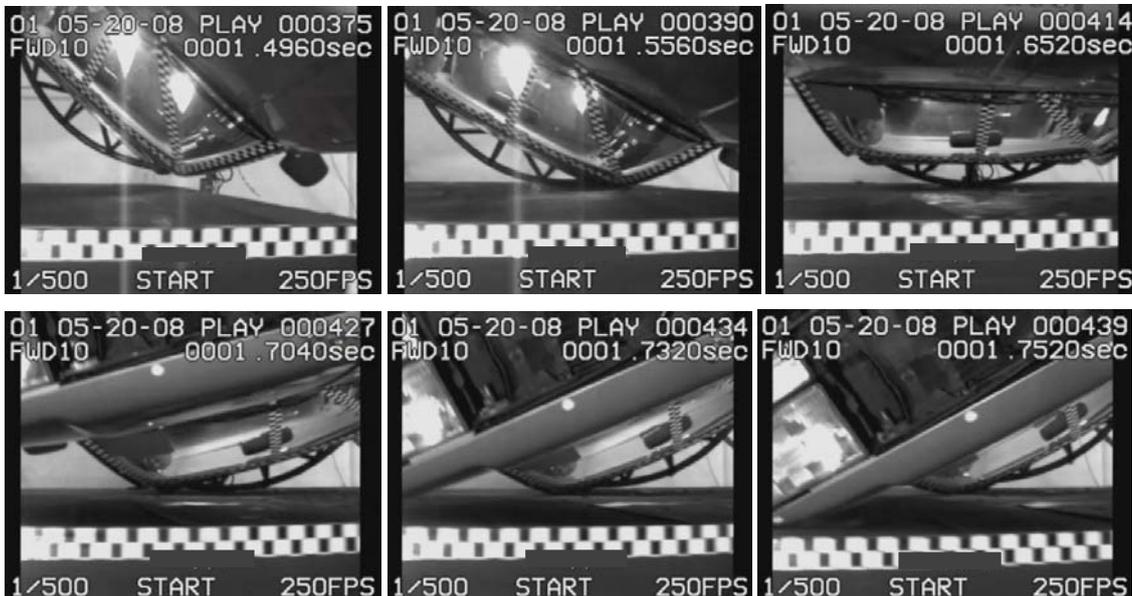
Figure 16. ATD interaction with (1993) low roof strength vehicle's (SWR 2.3) roof and floor during near side and far side touchdown. ATD's head is circled.

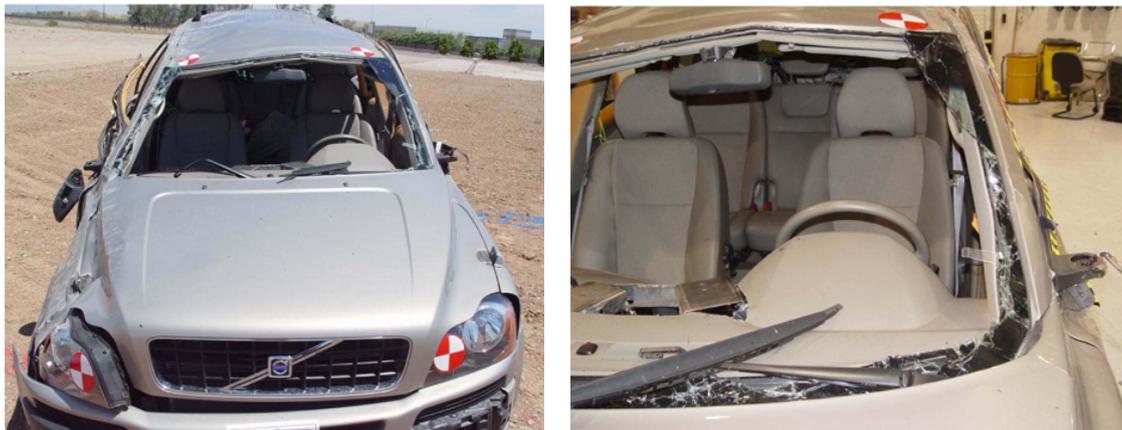
Figure 20. 2004 Volvo XC90 post test photos – 70 km/h (44 mph) Dolly Rollover Test

JRS dynamic testing also shows that SWR can incorrectly predict rollover performance, as was the case of the Honda CR-V (The CR-V is owned and trademarked by Honda Motor Co), which has a 2.6 SWR but performed almost as well as the Volvo XC90(The Volvo XC-90 is owned and trademarked by Ford Motor Co.) with a 4.6 SWR. The Volvo XC90 is considered the “gold standard” for rollover performance and was dolly rollover tested at a 70 km/h (44 mph) speed by Exponent with good results. The post test XC90 photos are shown in Figure 20.

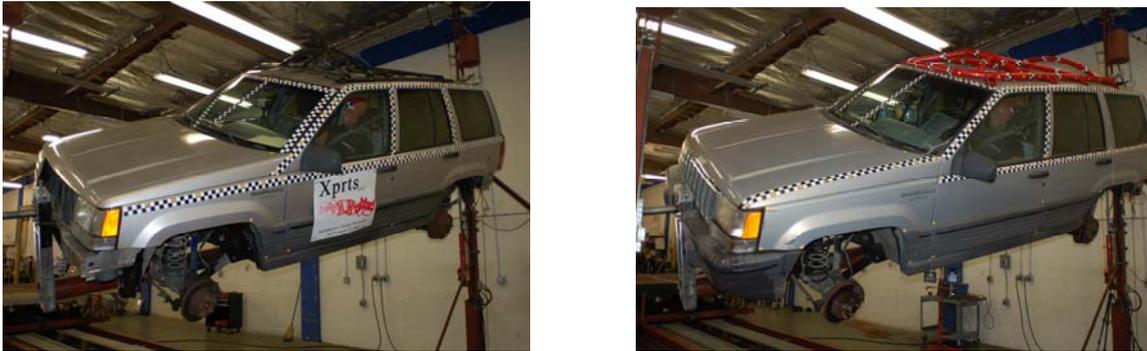
Figure 23. RDMD Prototype 1 & 2

prototype was made and attached to another 1993 Jeep Grand Cherokee and was again tested on the JRS. The redesign of the front section reduced the loads on the near-side touchdown by allowing the underlying vehicle structure to take some of the load. Prototype 1 and 2 are shown in Figure 23.

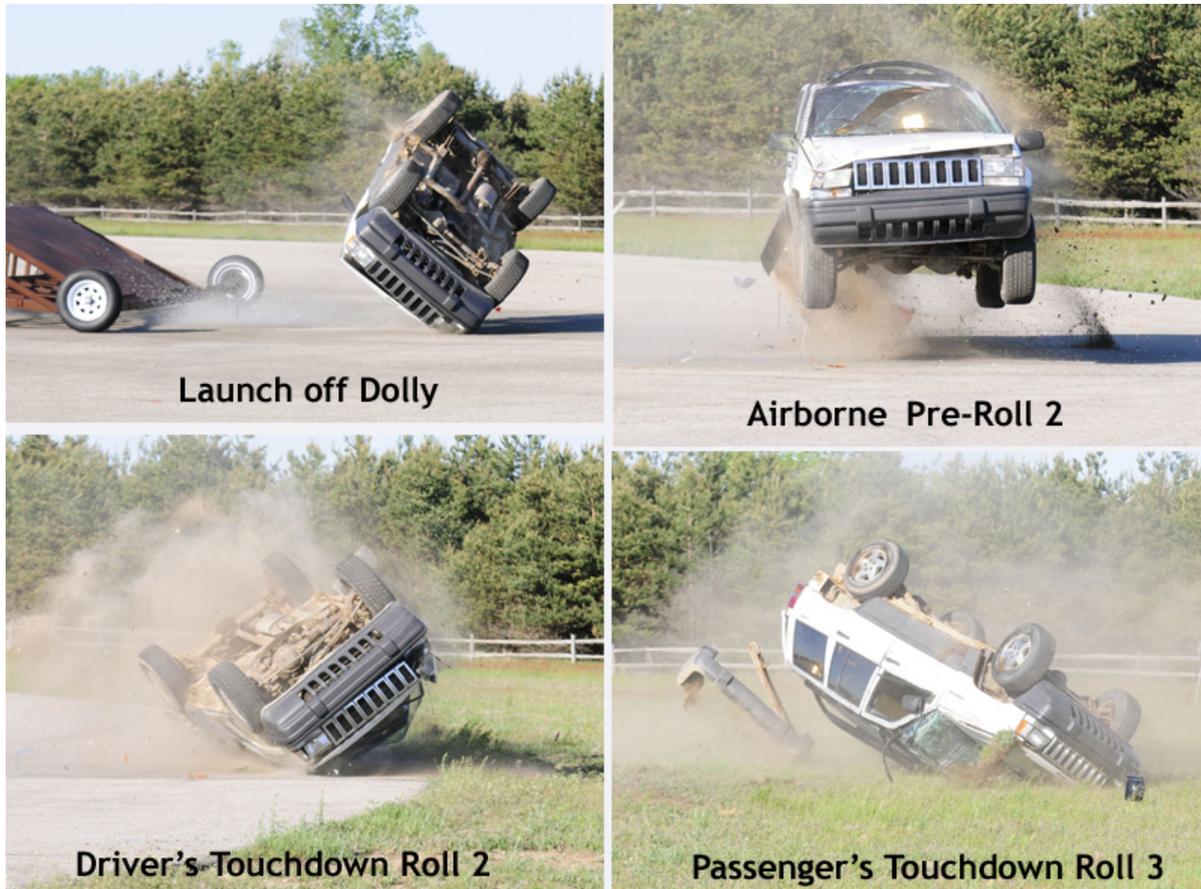
Figure 25. Sequence of photo's from 42 mph Dolly Rollover test of 1993 Jeep Grand Cherokee with RDMD HALO.

Following this test, another RDMD was designed and built for another 1993 Jeep Grand Cherokee. For this prototype, the internal high strength steel b-pillar reinforcements were included but were only extended three quarters of the way up the pillar. A 15 year old, high mileage, somewhat rusted, used vehicle was retrofitted in accordance with installation and attachment instruction procedures. There was no occupant, fuel or ballast payload, so that a worst case pitch angle from the engine forward weight bias would result during the test. The vehicle was mounted on a dolly at a 23 degree inclination. The dolly was propelled to 67 k/ph (42 mph) and launched onto a macadam pad for the first roll and then into dirt as shown in the Figure 25.

The vehicle was instrumented with a high speed interior camera facing forward and with the ends of string potentiometers at the driver and passenger A and B pillars, between which is the typical mid seat position of the occupant's head. The origin (the reels) of the string potentiometers were near the CG of the vehicle such that the original measurements taken were radial displacements. The location of the ends and origin of the string potentiometers were documented photographically so as to be able to resolve the motion into vertical and horizontal coordinates. There was a high speed and several real time cameras recording the exterior vehicle kinematics. The timing between the string potentiometers and the external cameras was established by photoanalysis.

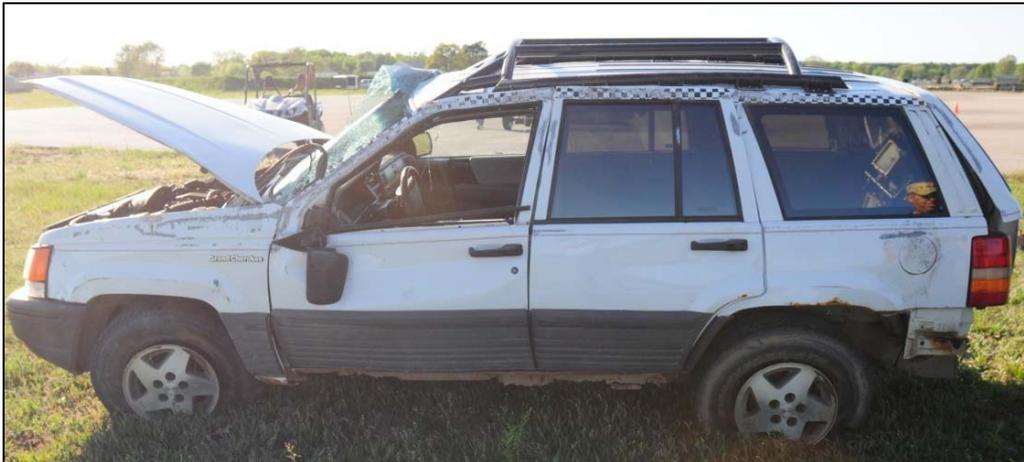
Figure 26. 1993 Jeep Grand Cherokee after 3 roll Dolly Rollover Test with RDMD attached.

taken immediately after the vehicle came to rest show a flat roof interior somewhat lower on the driver’s side and higher on the passenger side in Figure 26.

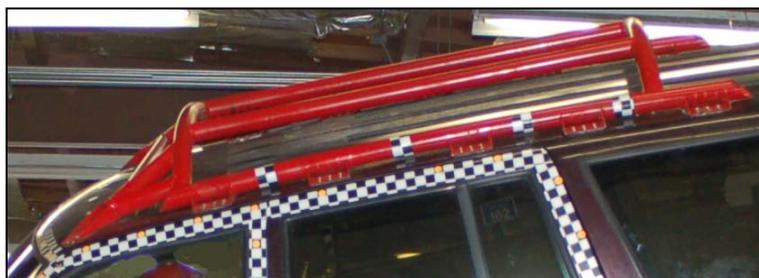
Figure 31. RDMD HALO retrofit on a Jeep Grand Cherokee

The best example of the performance of a retrofit system is shown with the Jeep Grand Cherokee whose production performance is on the right end of the chart above, while its performance with the HALO retrofit (Figure 31) is the second from the left. The production Jeep Grand Cherokee roof crush in the first roll was so great that the dummy was trapped and made a second roll meaningless, hence there is no red bar. The Land Cruiser with the retrofit did not have a b-pillar retrofit.

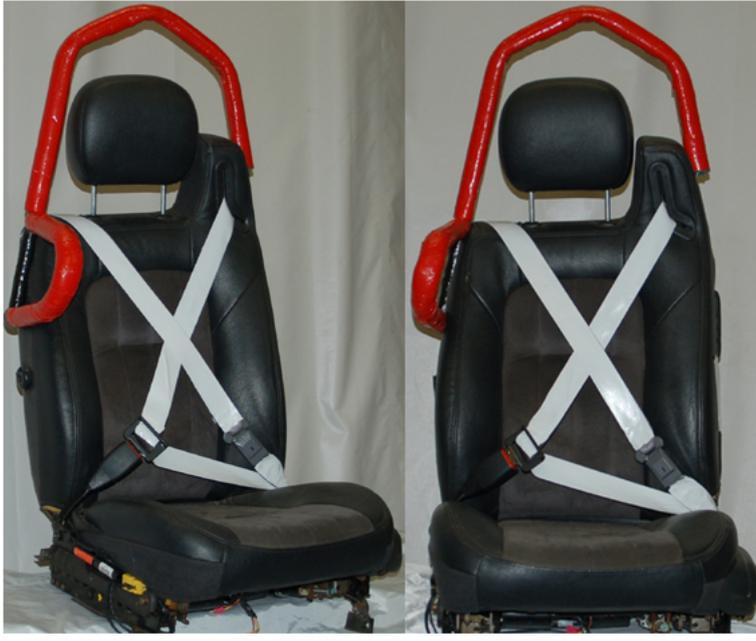
Figure 33. Prototype All-Belts-to-Seats Occupant Protection System.

Prototype: All-belts-to-Seats, 4 Point Harness, Automatic Pretensioner, Roll Bar, Shoulder Restraint

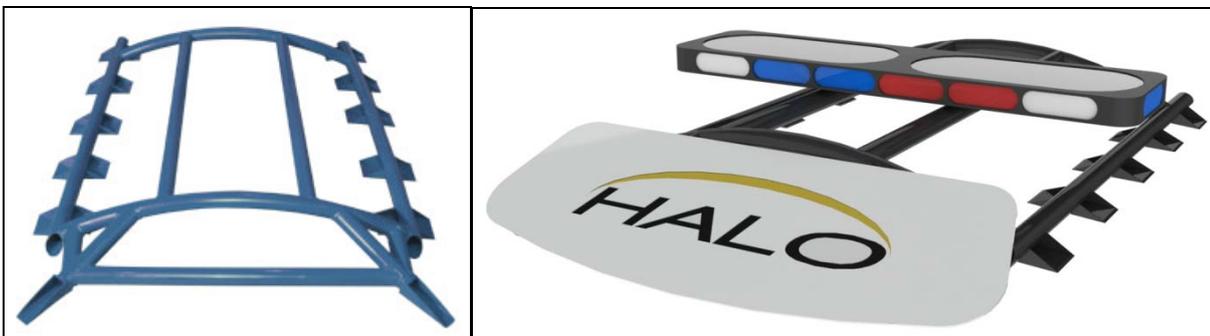
Figure 34. Final RDMD HALO™ System base unit and with wind faring and lighting attached.

The production RDMD named “HALO” has been designed to meet the latest NHTSA objective rollover injury criteria derived, validated by JRS tests and authenticated from the National Accident Sampling System (NASS) data base for post crash negative headroom for vehicle rollovers on level ground. It has also been designed and tested to minimize objective criteria for roof crush intrusion and roof crush intrusion speed in rollovers. Injury occurs in a rollover as the result of excessive crush and crush speed in any particular roll in the sequence of rolls in the vehicle’s trajectory to rest. Injury is not due to a sequence of non-injurious impacts.
