Jordan Rollover System

Jordan Rollover System (JRS)

The Jordan Rollover System

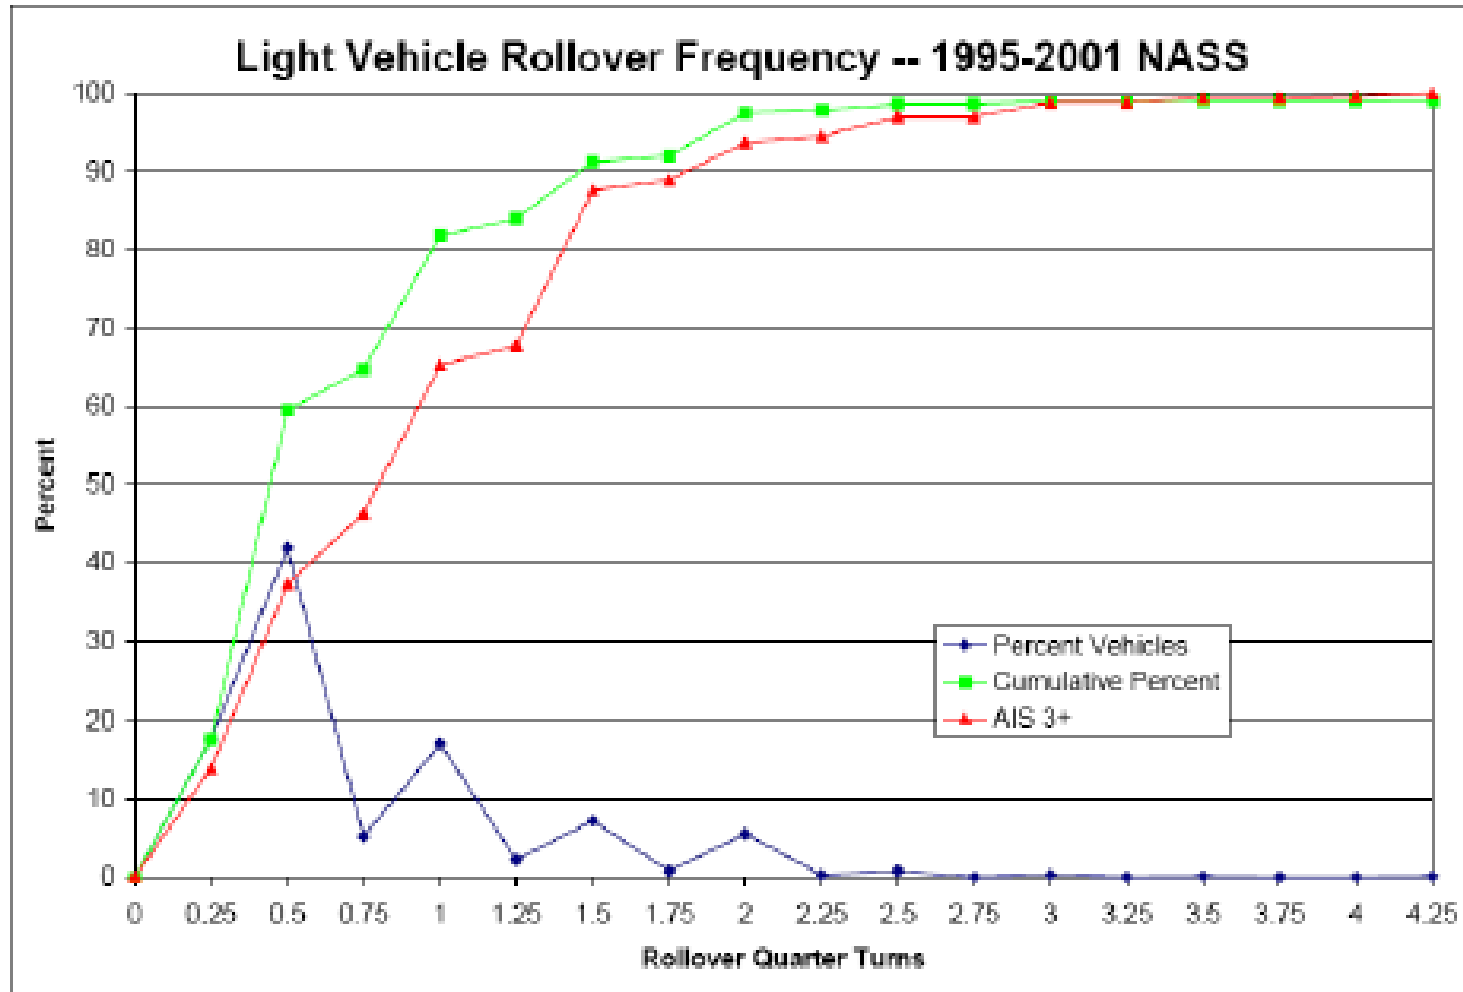
Rollover frequency and AIS 3+ Injury

As much as 40% of these injuries occur in pre roll crash events, limiting the likelihood that ESC will be as effective as predicted, emphasizing occupant out of position concerns when the rollover commences.

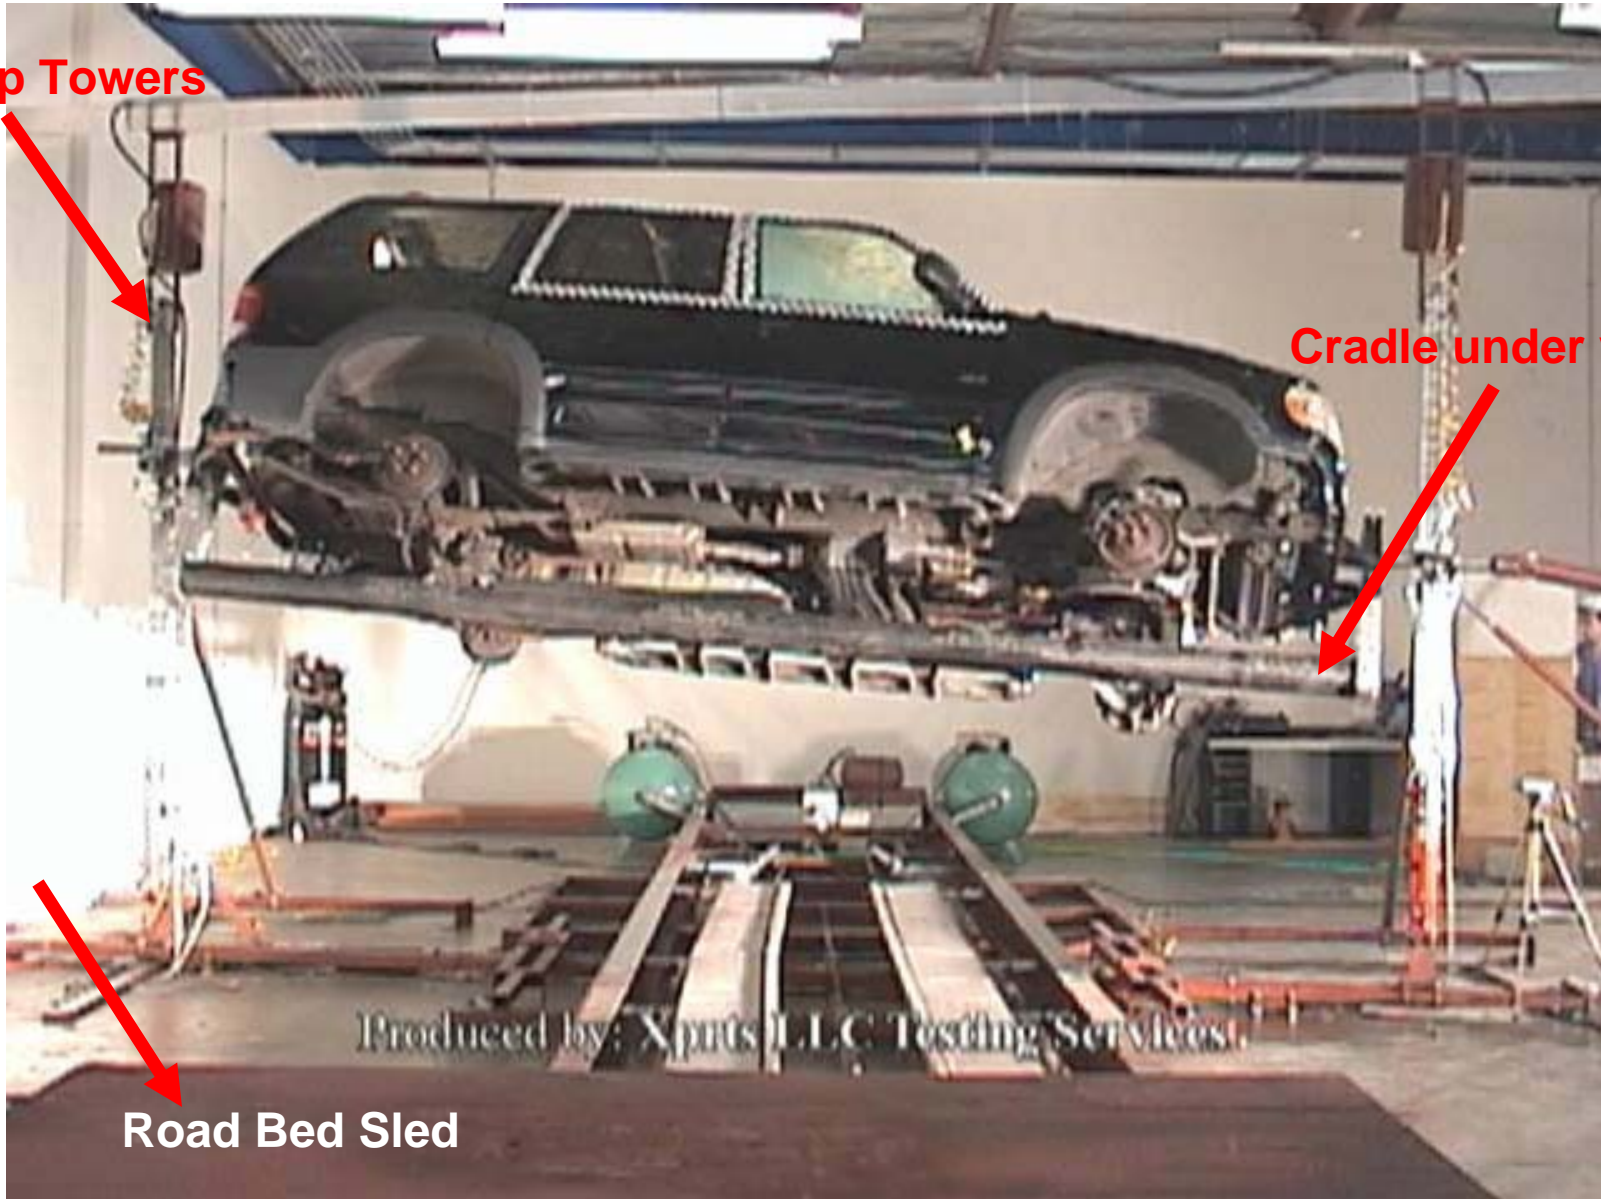
Jordan Rollover System Fixture

- A standard pneumatic sled to be used as a road bed for the vehicle to drop on to.
- A spit - drop test rig to hold and rotate the vehicle
- Instrumentation to measure the loads on the inside of the vehicle and in the road bed.
- A control module to set testing parameters such as roll angle, roll rate and road bed speed.

Drop Towers

Cradle under vehicle

Road Bed Sled

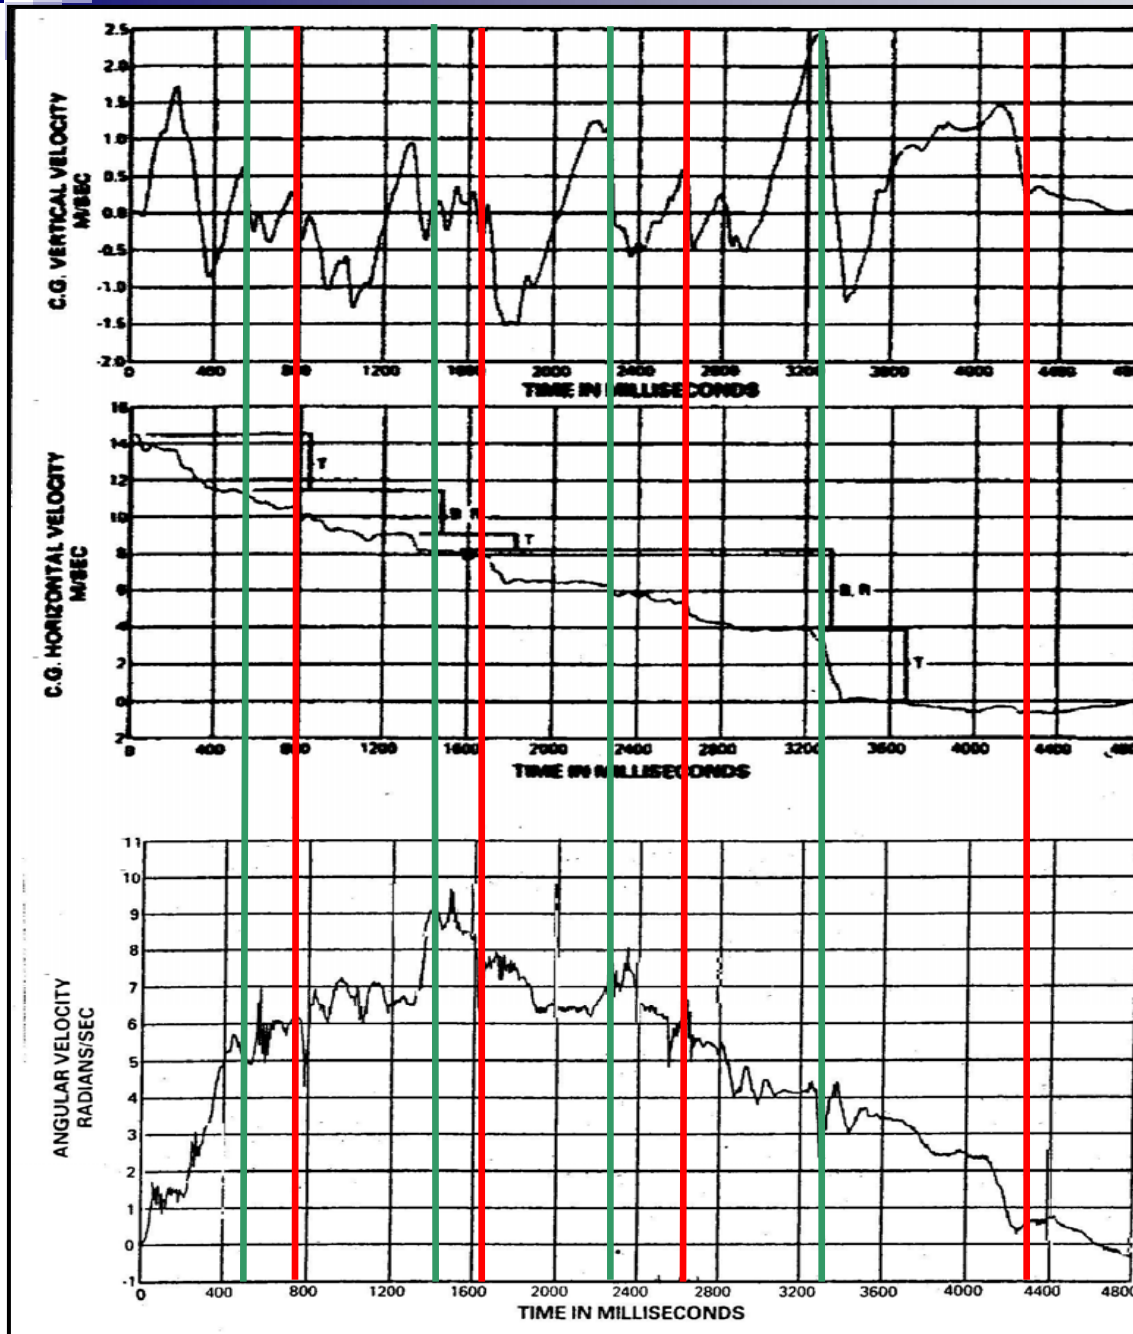
GM Malibu I Test 5

Near Side Contacts:
(Green Lines)

550 ms = 0.6 mph

1500 ms = 0.3 mph

2350 ms = 1.2 mph

3350 ms = 1.2 mph

Far Side Contacts:
(Red Lines)

790 ms = 0.6 mph

1677 ms = 0.4 mph

2662 ms = 1.2 mph

4330 ms = 0.7 mph

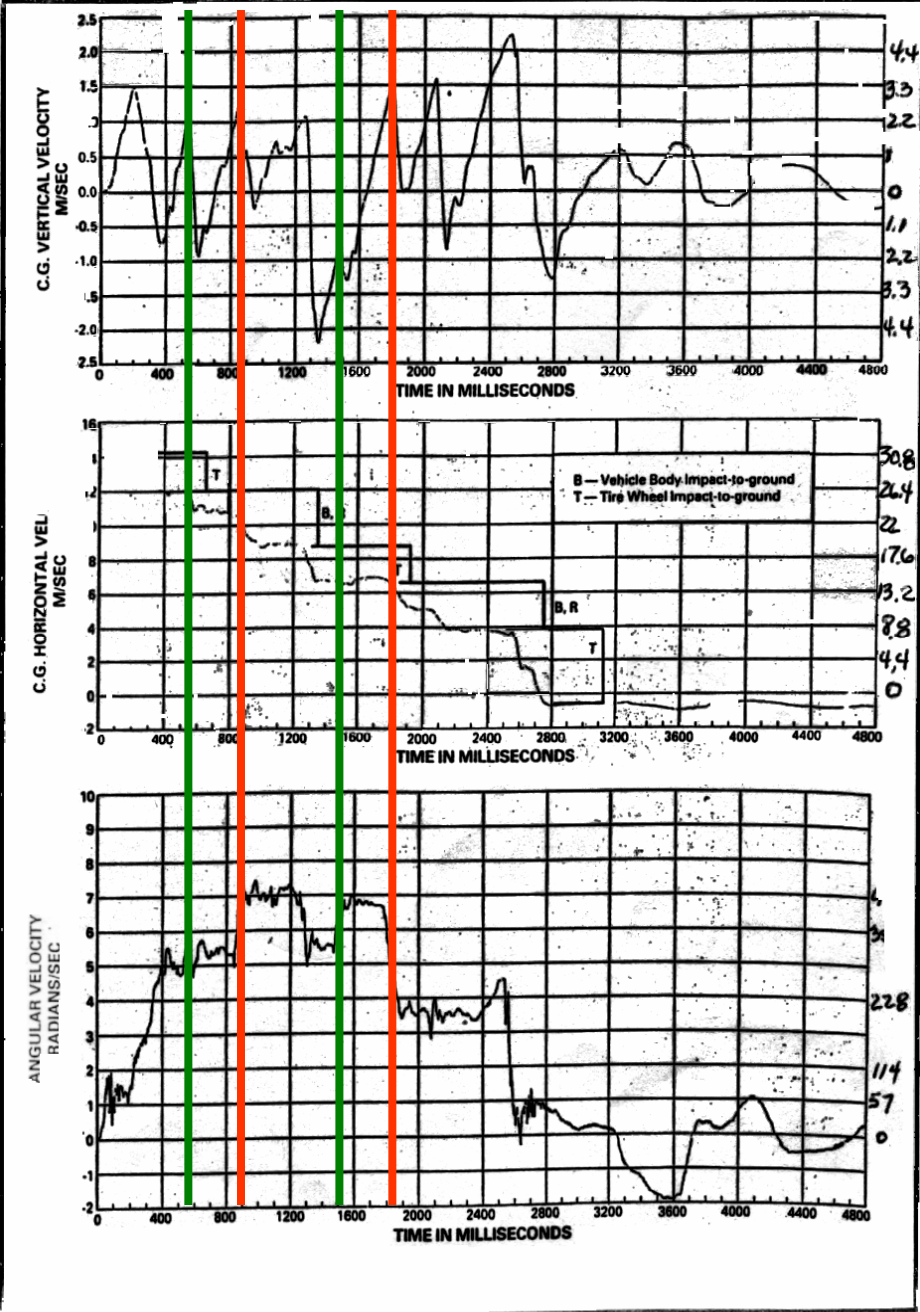
The C. G. Velocity Responses of Test 6 – A Roll caged Vehicle

GM Malibu I Test 6

Near Side Contacts:
(Green Lines)

575 ms = 2.2 mph

1500 ms = 2.5 mph

Far Side Contacts:
(Red Lines)

836 ms = 2.7 mph

1802 ms = 3.1 mph

Note: Similar data between vehicle types. The main difference is the rollcaged vehicle does not crush.

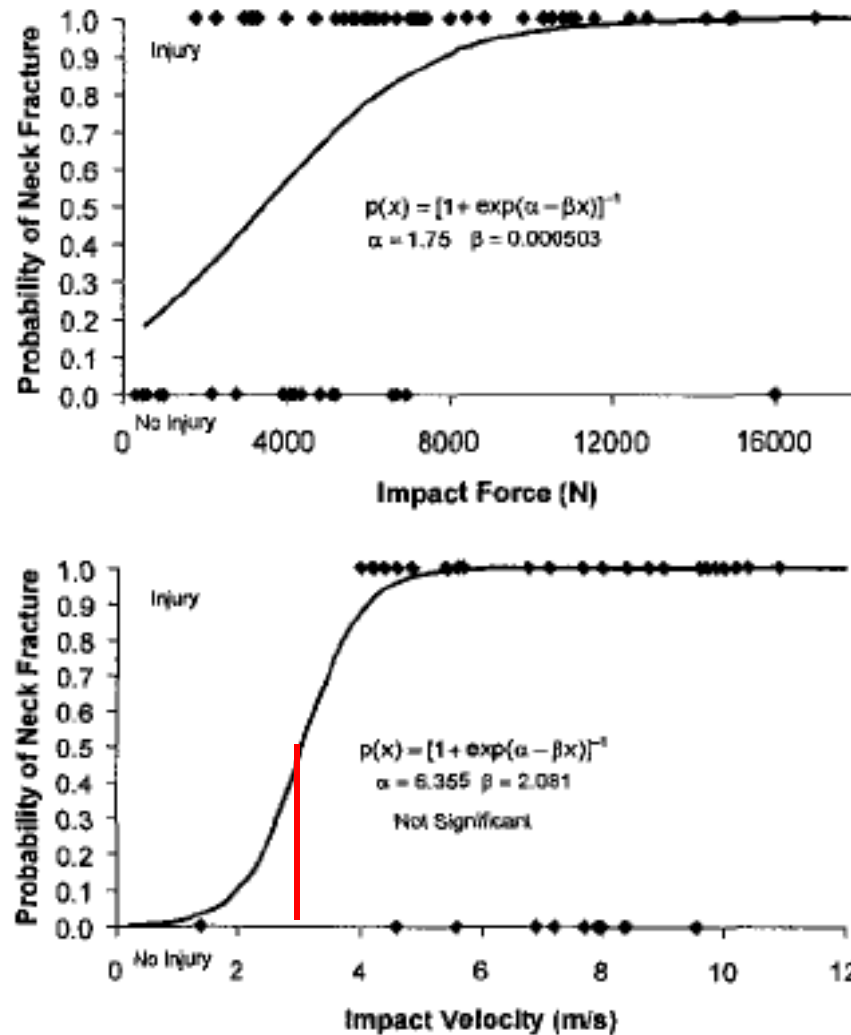
Statistical Probability Analysis of Serious Injury suggests 7 mph Criteria

Figure 13: PMHS data on neck fracture versus impact force and impact velocity.

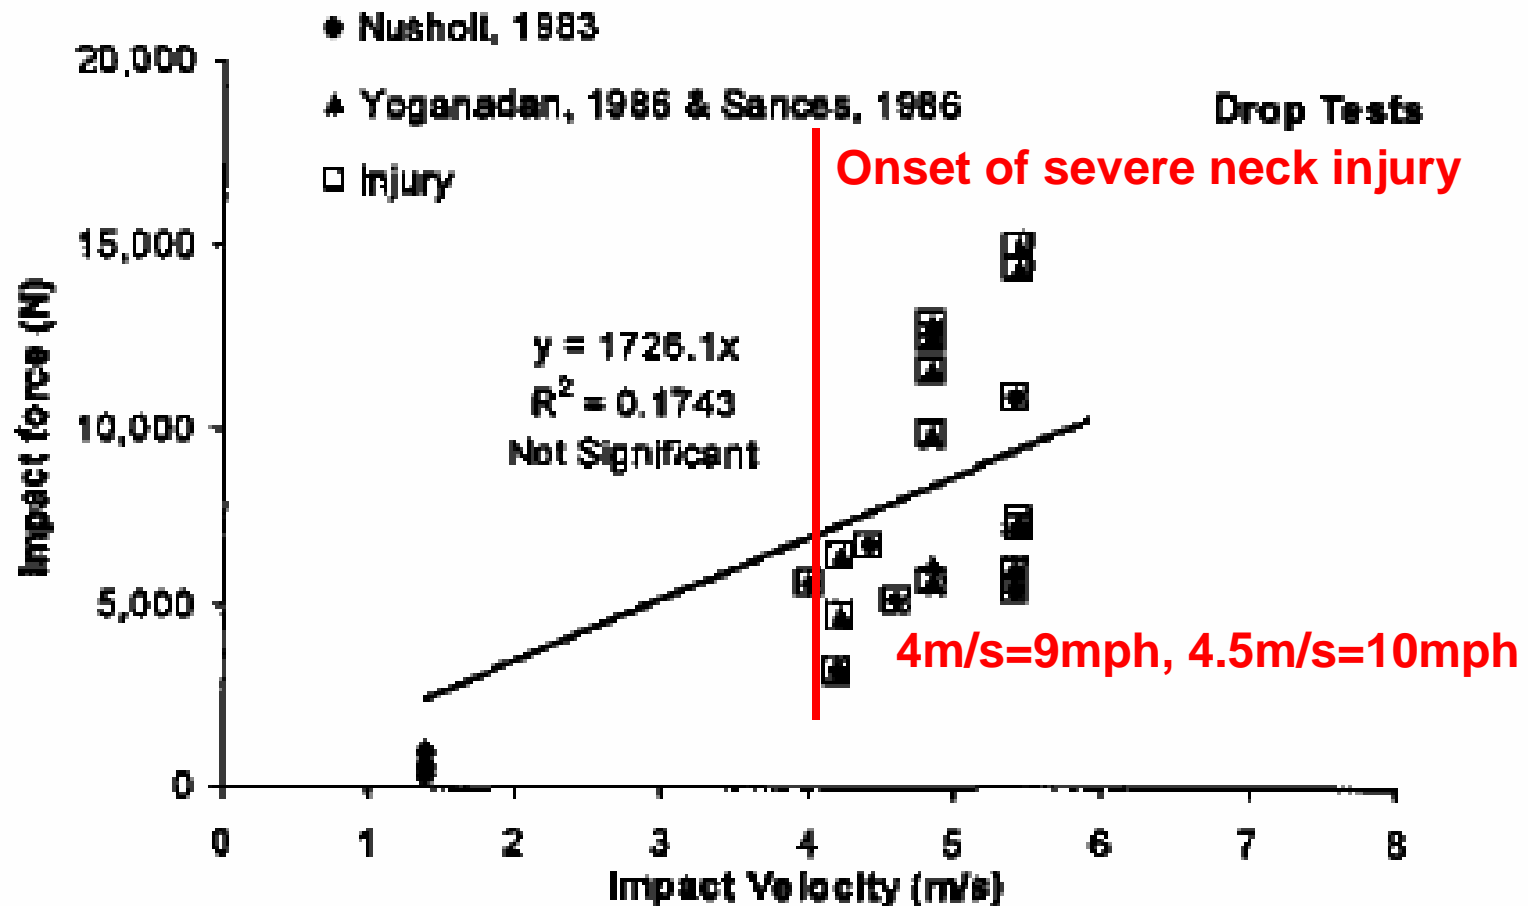
Rollover related Drop tests suggest 10 mph Head impact speed for Severe to Fatal injury

Figure 5: Impact Force as a Function of Impact Velocity for PMHS Drop Tests.

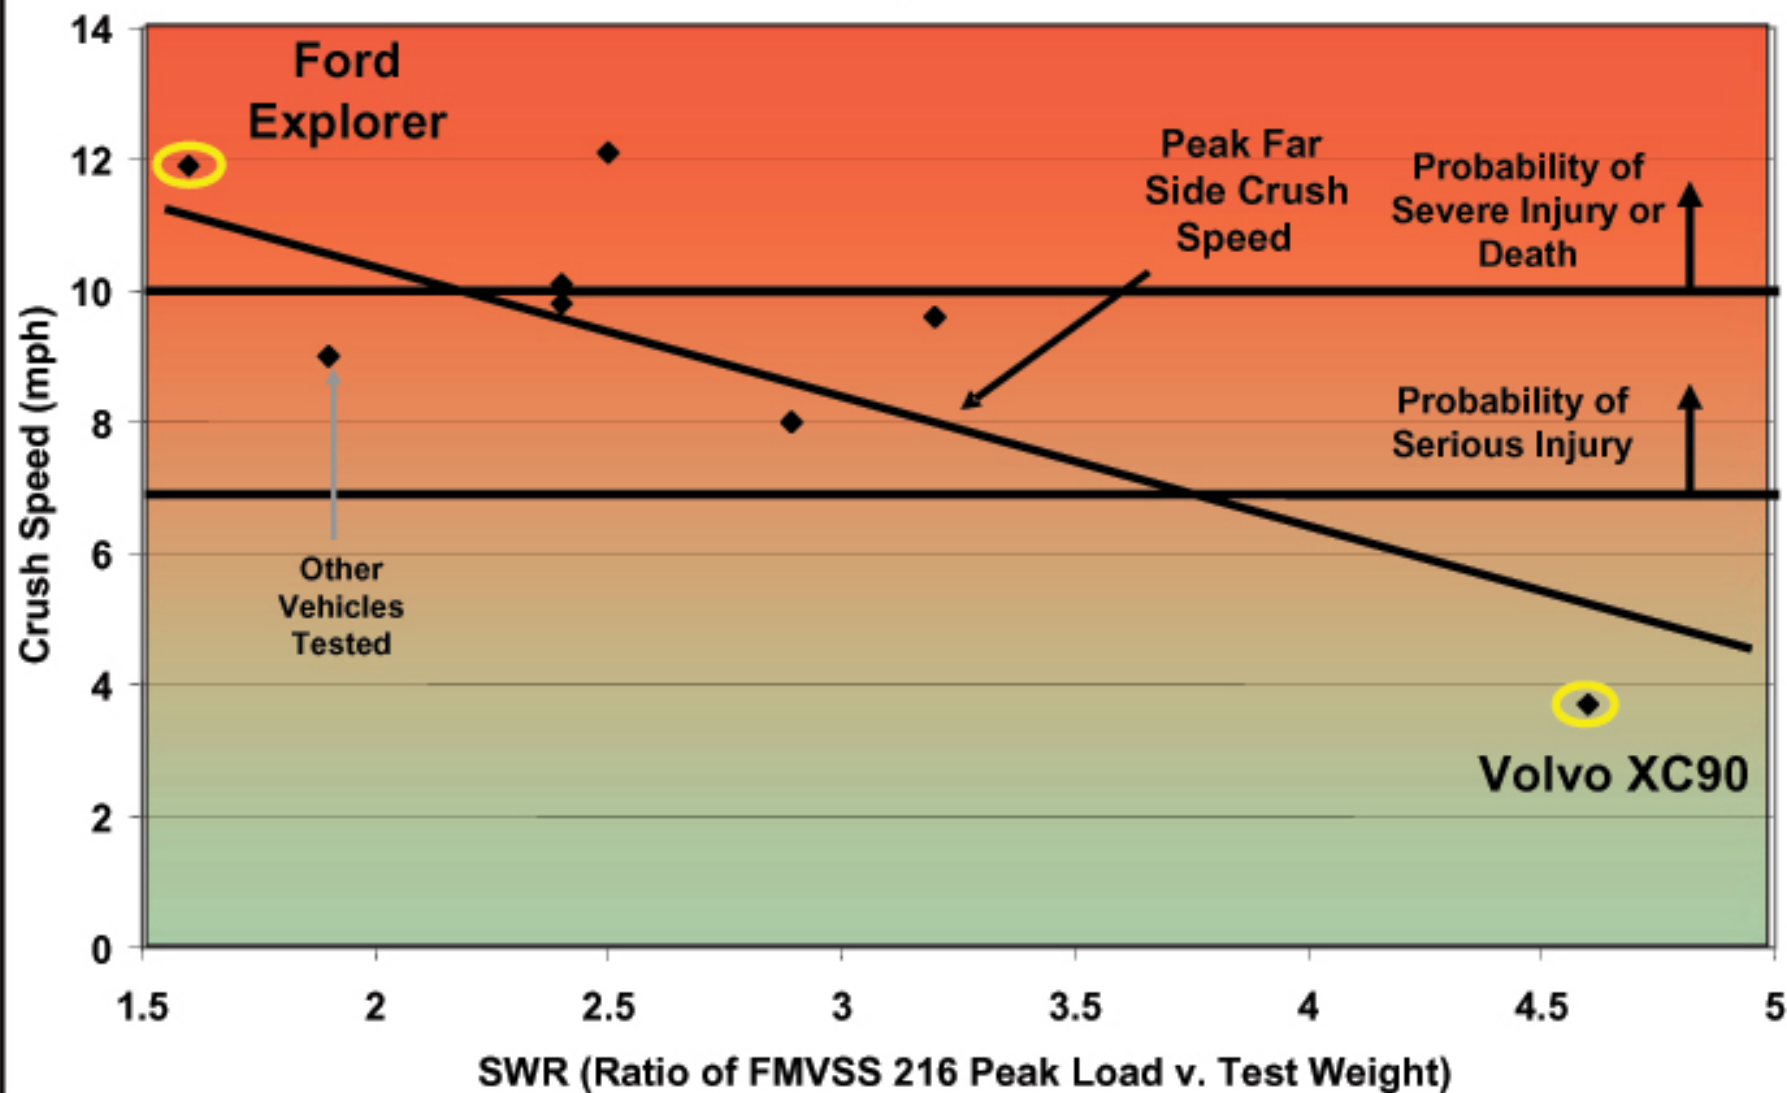
15 mph Equal Severity JRS Rollover Test Results: Injury Potential on Far Side Roof Crush Speed vs. FMVSS 216 SWR

Model Years	Make/Models	216 SWR	Max Crush (Inches)	Maximum Speed (MPH)	Injury Probability
2002-2006	Volvo XC90 SUV	4.6	3.2	3.7	Best
1999-2005	Hyundai Sonata Sedan	2.8	6.4	8.0	Fair
2003-2006	Kia Sorento SUV	1.9	6.9	9.0	Poor
1995-1999	Nissan Sentra Sedan	3.2	9.1	9.6	Poor
1995-2001	GMC Jimmy SUV	2.4	6.7	9.8	Poor
1995-2005	Chevy Blazer SUV	2.4	9.6	10.1	Not Acceptabl
1999-2001	Isuzu VehiCross SUV	NA	6.8	11.1	Not Acceptabl
2001-2006	C2500 HD Reg Cab Pickup	2.2	9.9	11.2	Not Acceptabl
1995-2001	Ford Explorer SUV	1.6	11.5	12.1	Not Acceptabl
1994-1999	Mitsubishi Eclipse	2.5	7.6	12.1	Not Acceptabl

(Criteria: Best = < 6mph and no ejection portals; Good = < 6 mph; Fair = < 8 mph; Poor = < 10 mph; Not Acceptable = > 10mph)

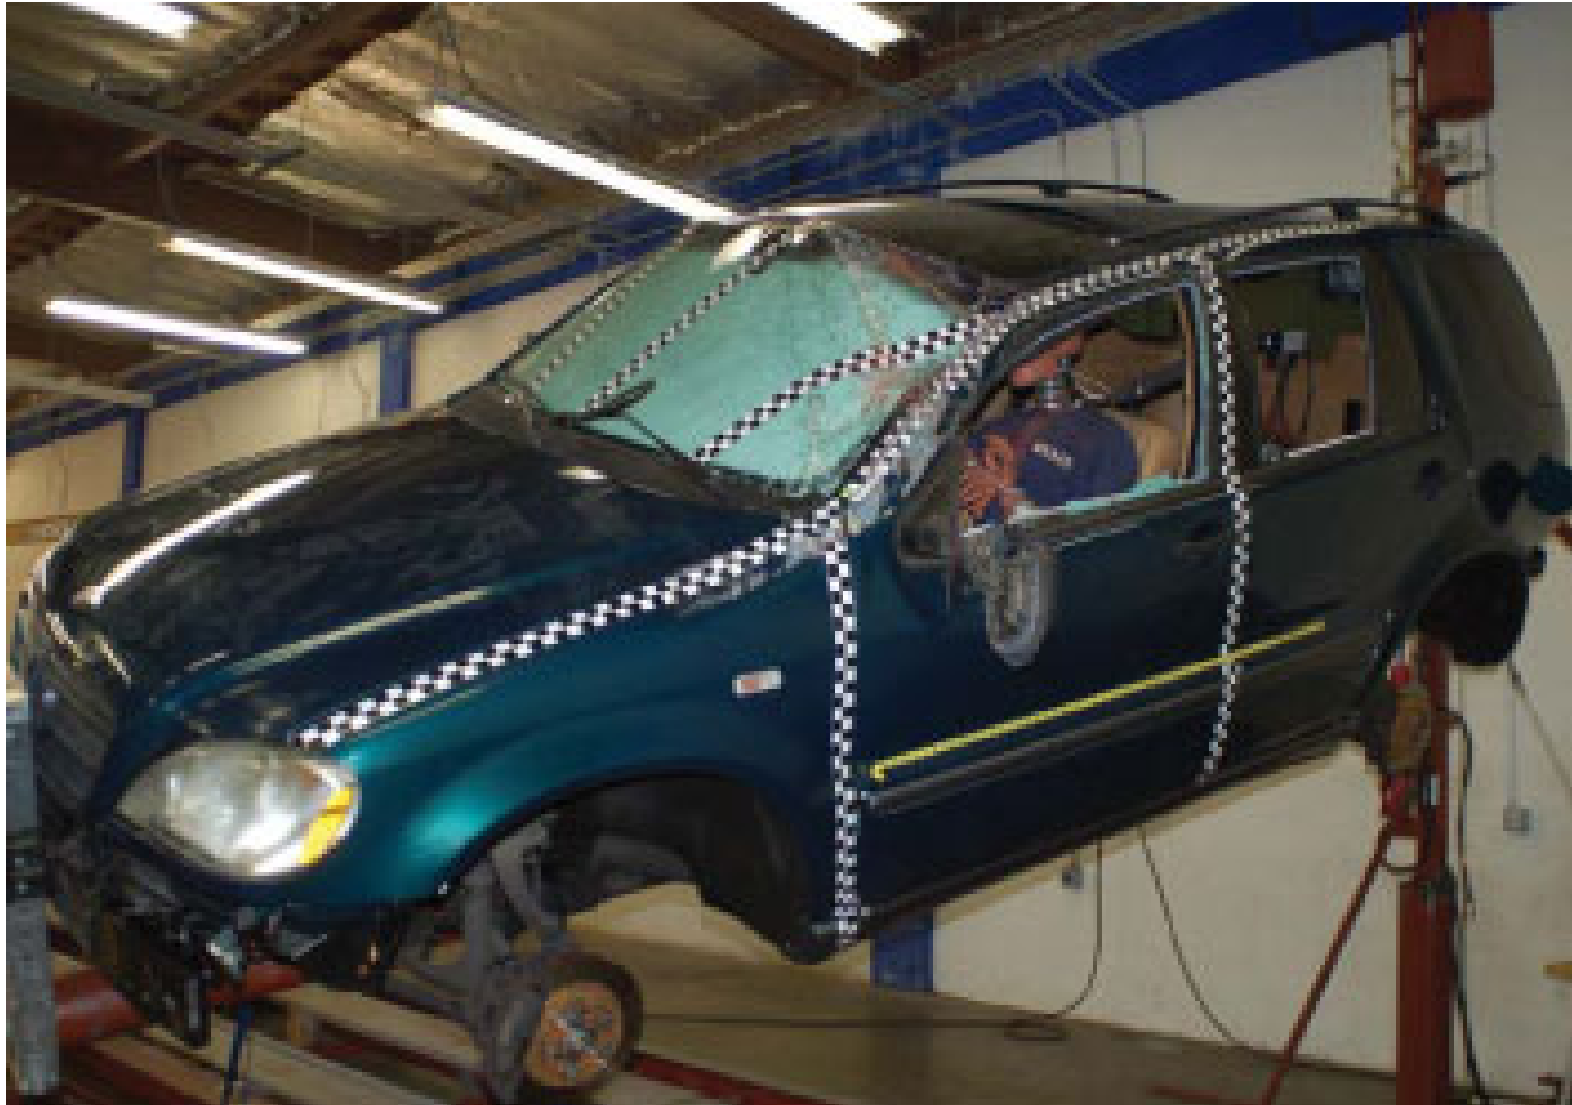
JRS 18 mph, 10° Pitch, 1998 ML320 Test

1998 Mercedes ML Location	Intrusion (in)		Peak Intrusion Velocity	
	Peak	End of Test	(ft/sec)	(mph)
A-Pillar	-7.7	-5.3	-11.2	-7.6
B-Pillar	-5.4	-2.8	-7.9	-5.4
Roof Header	-7.6	-5.4	-11.5	-7.8
Near Side A-Pillar	-0.9	0.6	-3.0	-2.0

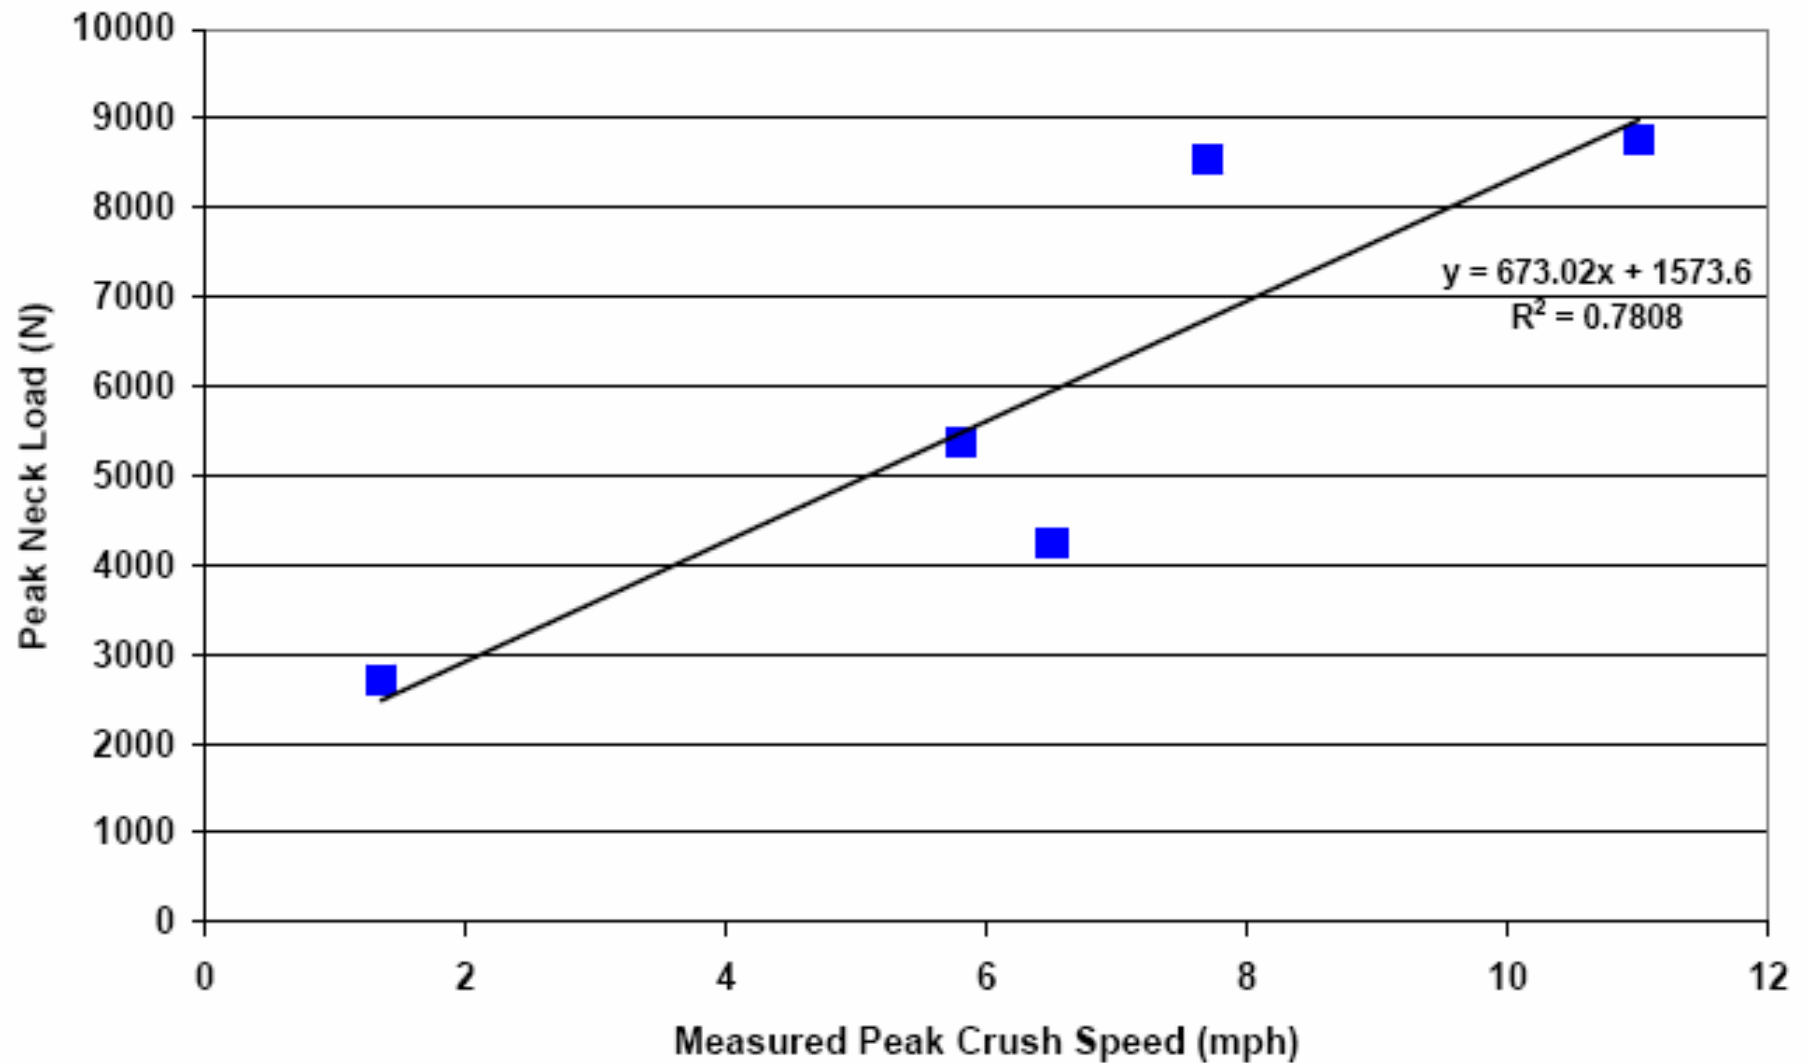
Peak Neck Load v. Peak Crush Speed

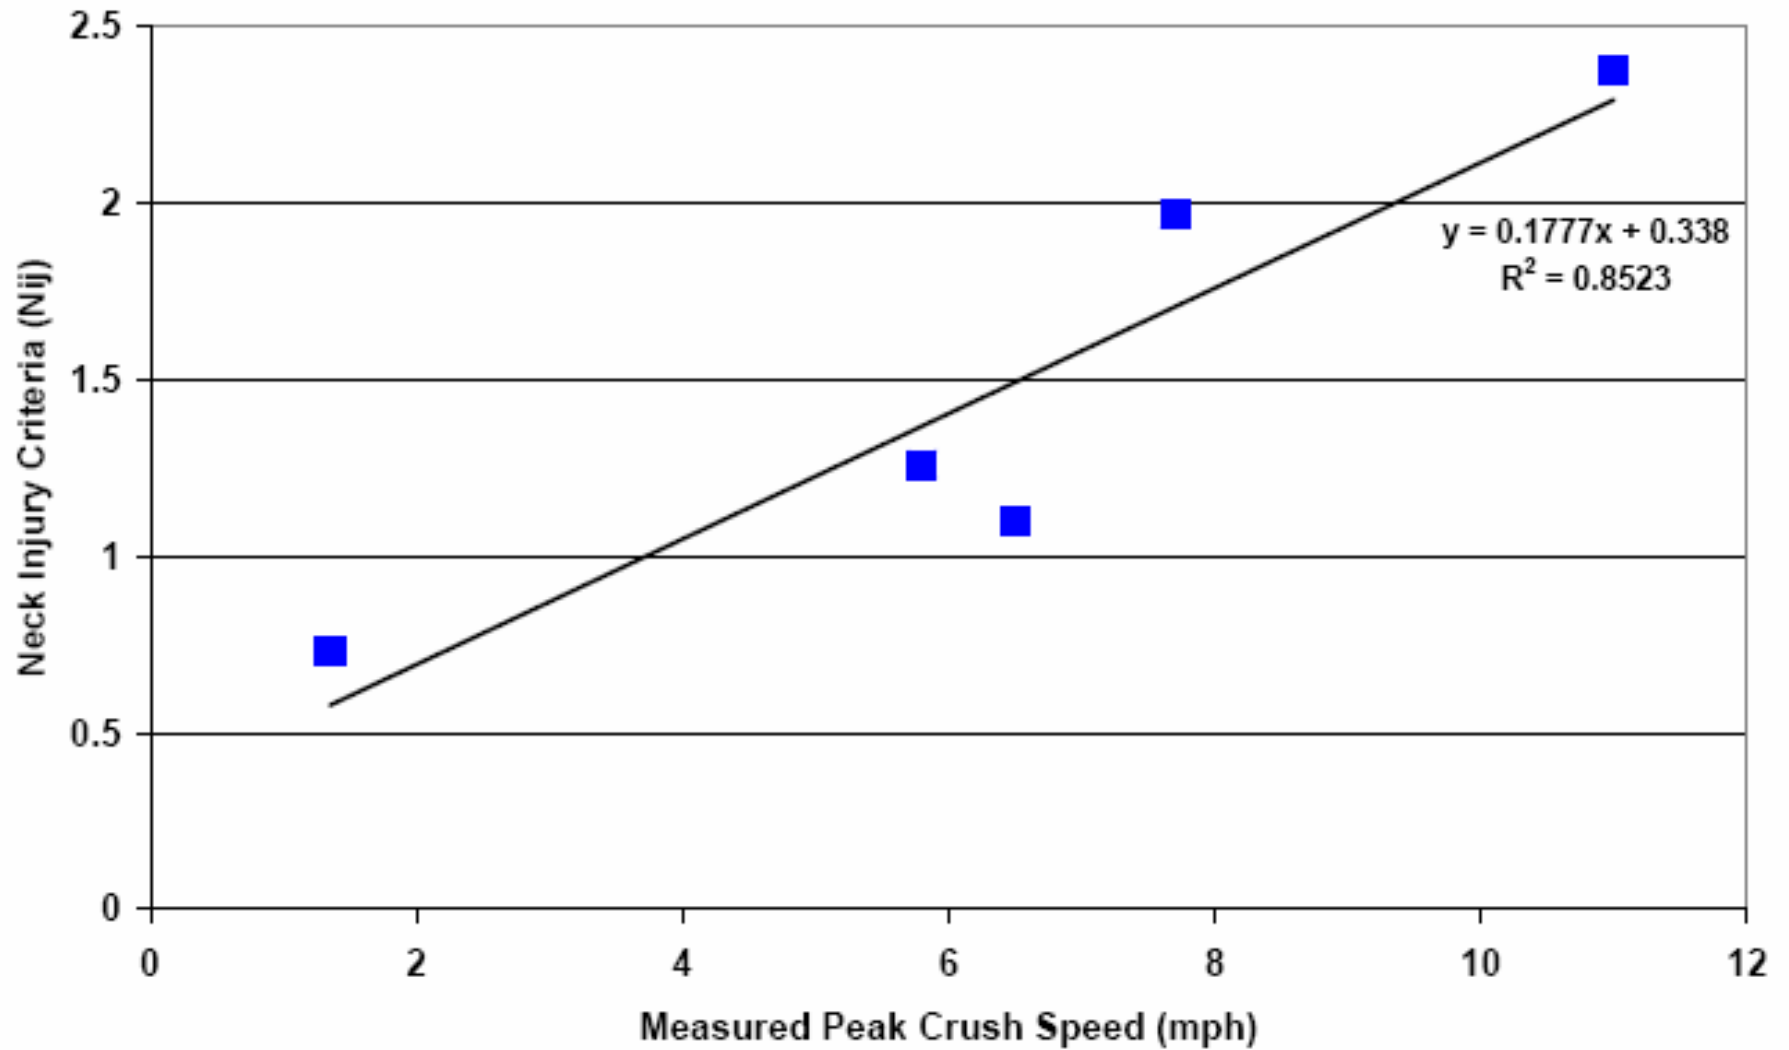
Neck Injury Criteria (Nij) v. Peak Crush Speed

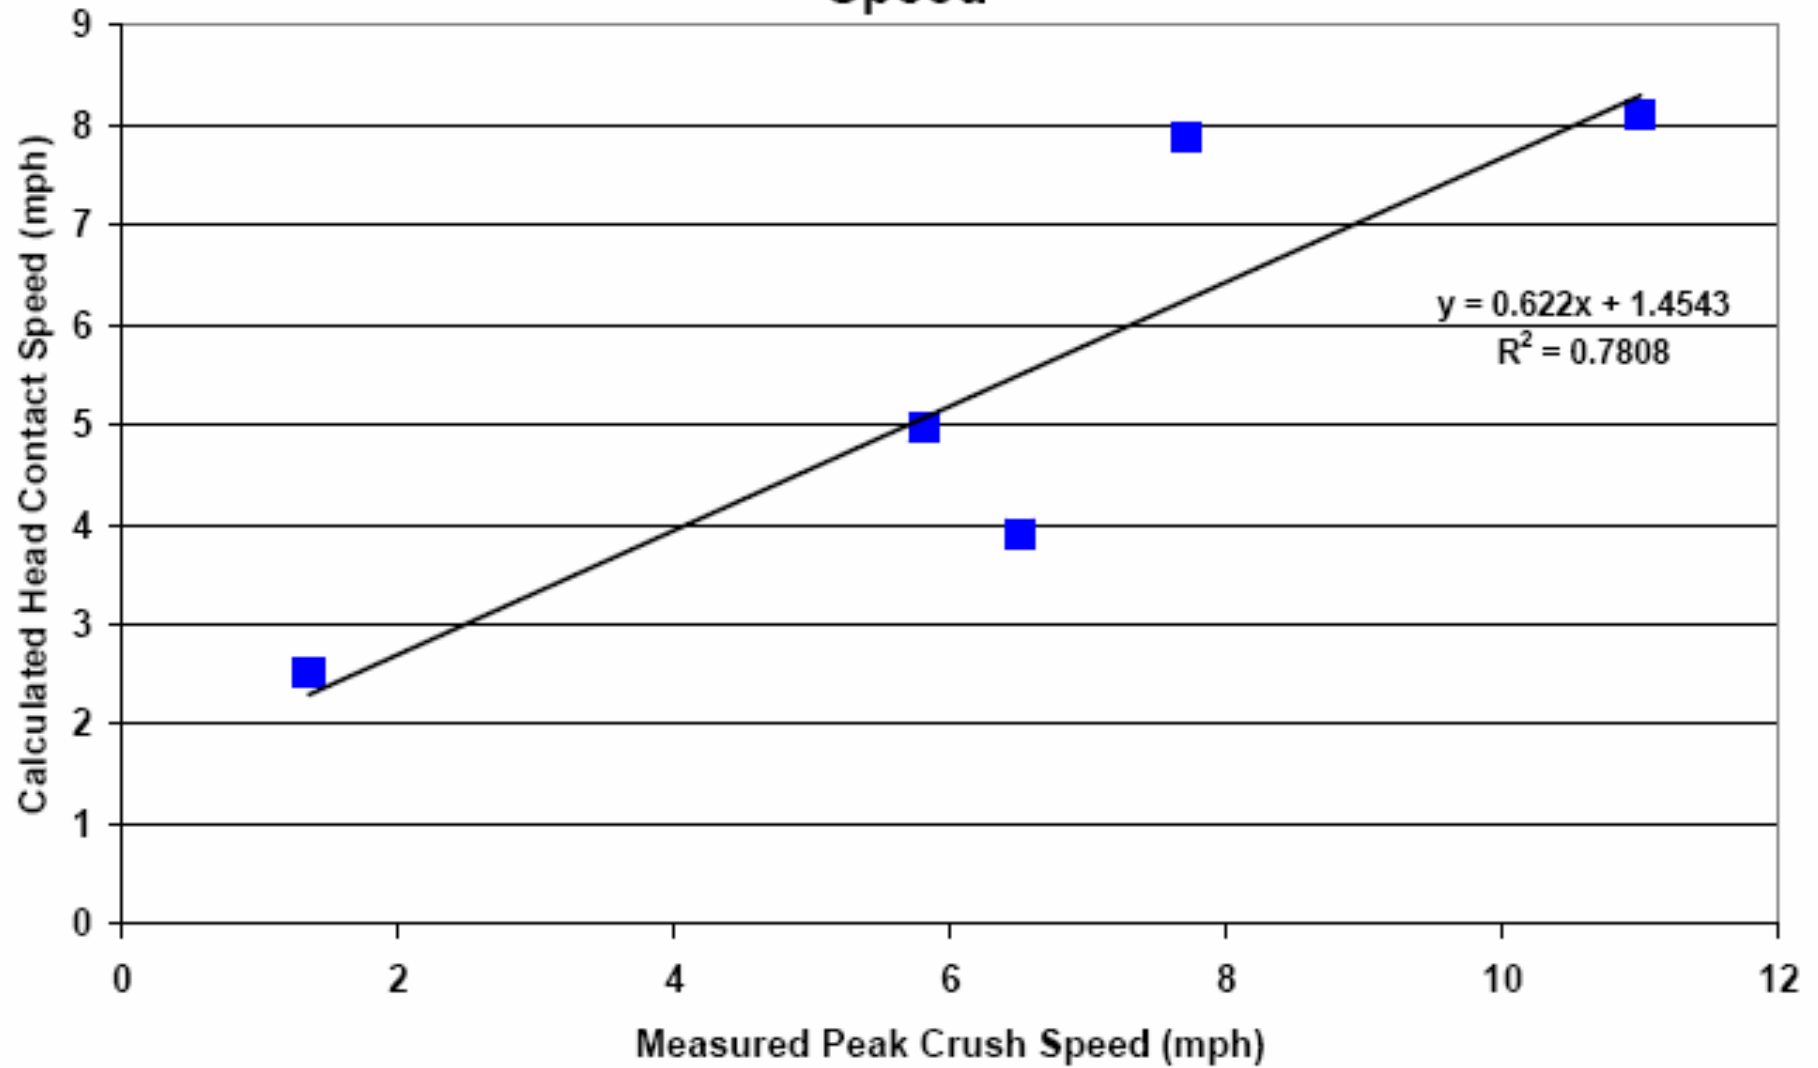
Calculated Head Contact v. Measured Peak Crush Speed

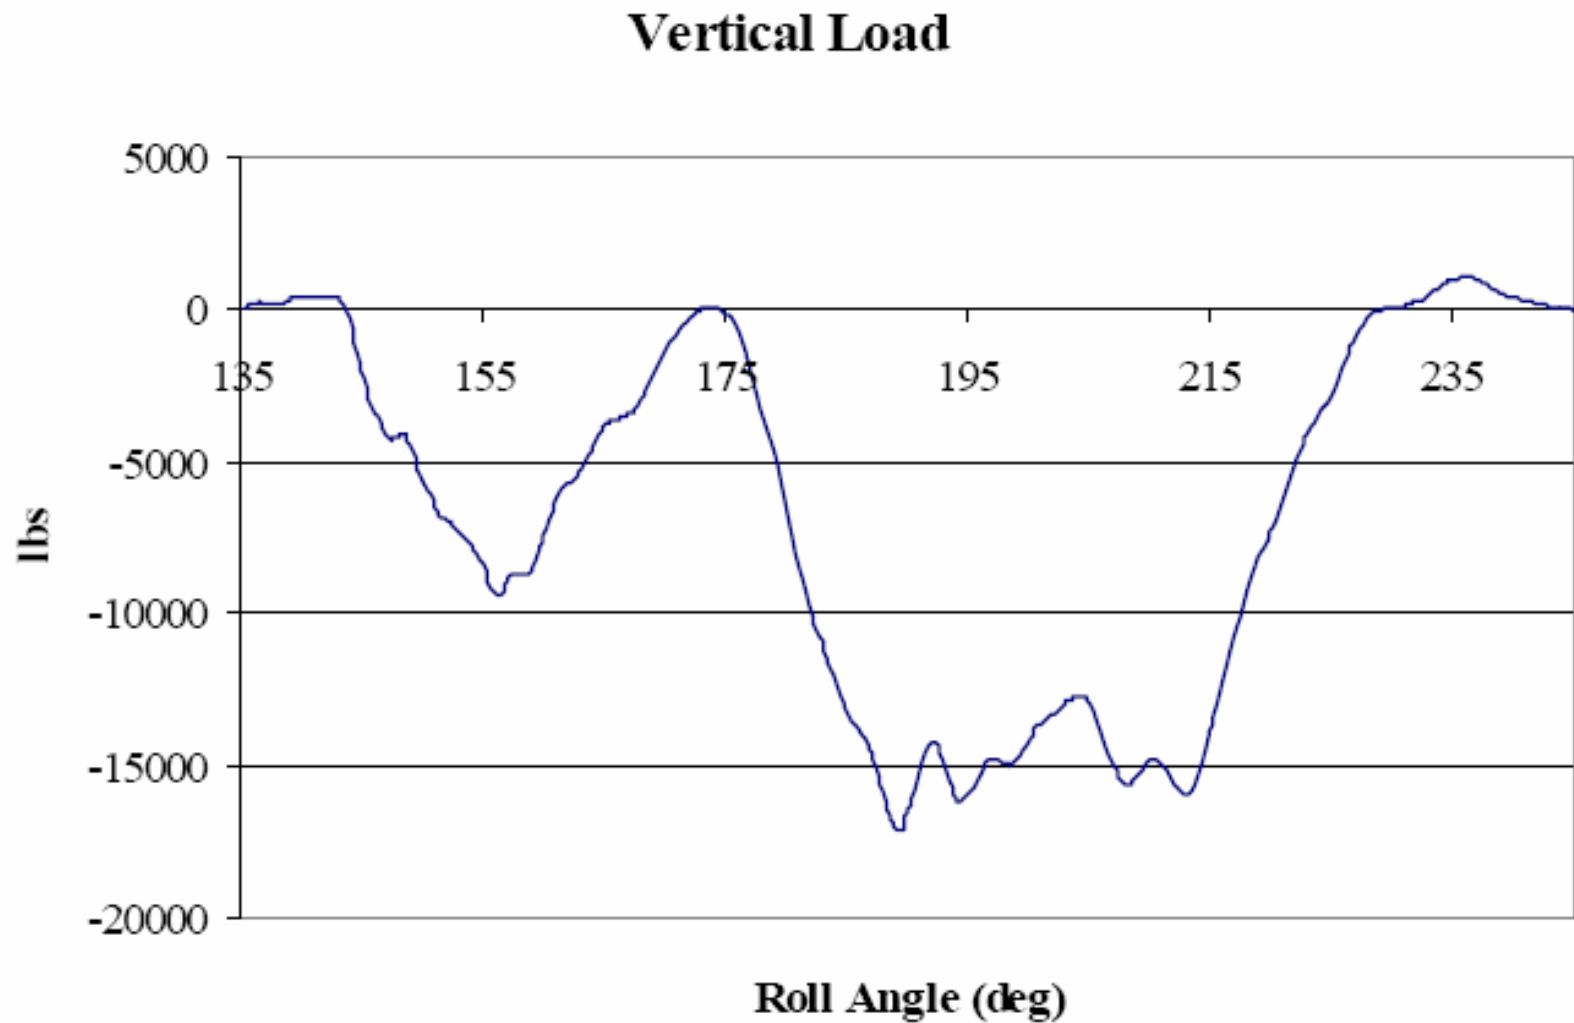
Load as Measured on the Road Bed

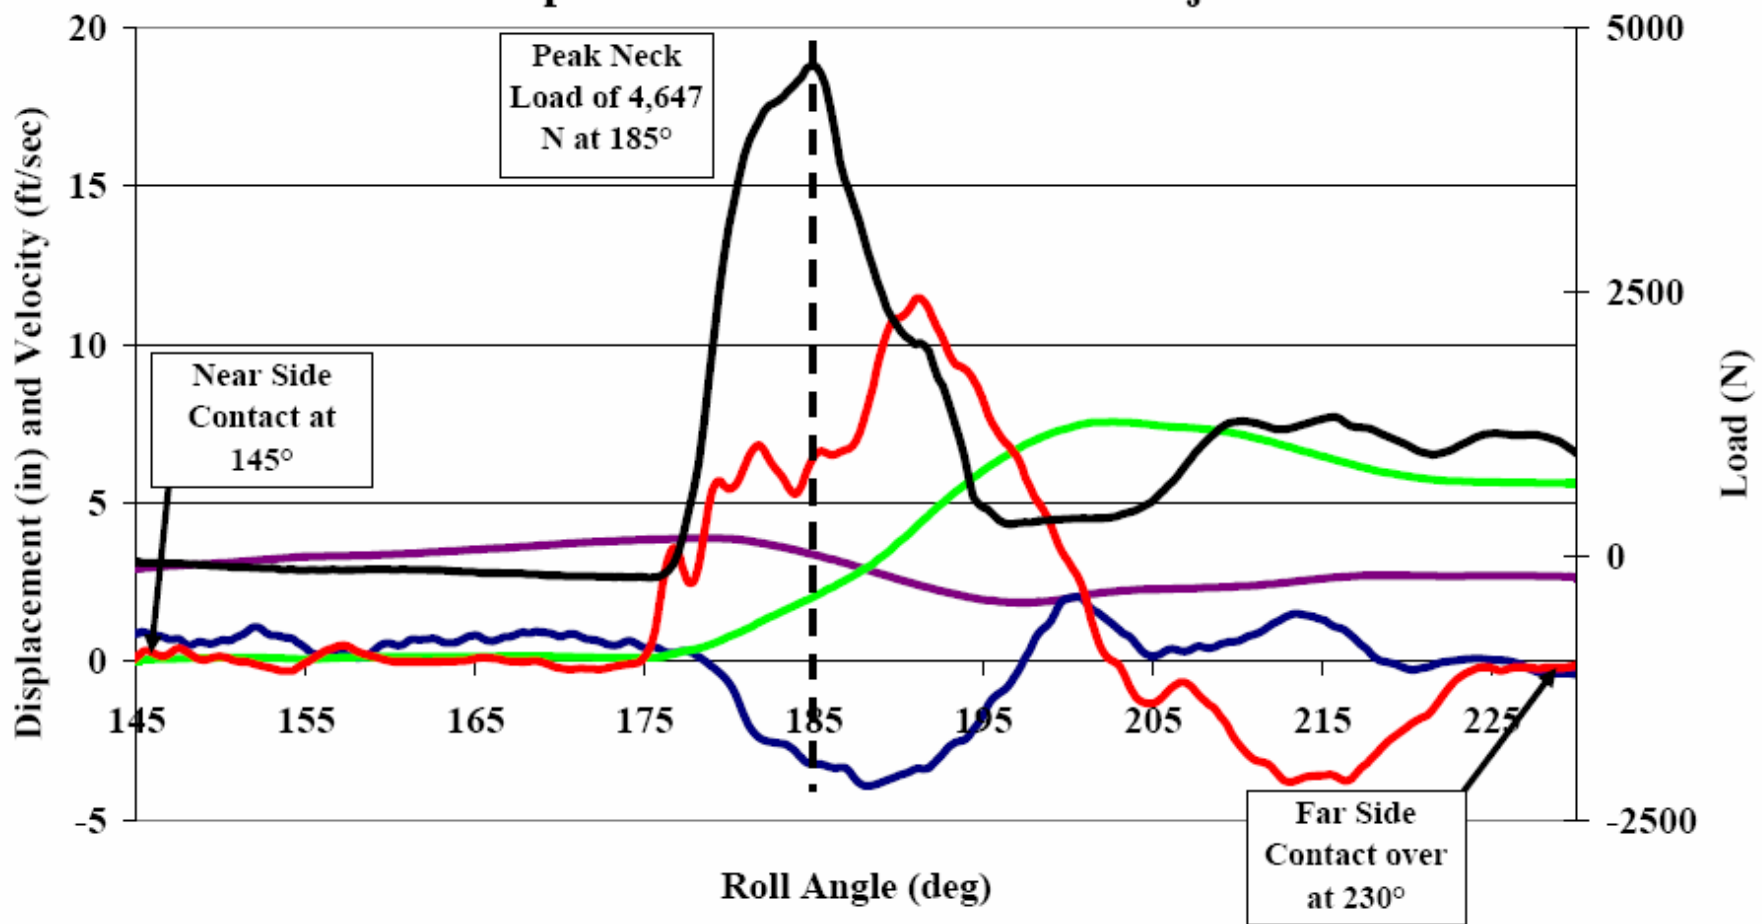
Far Side HIII Dummy Motion as Measured with an Under Seat String Potentiometer Compared with Neck Load and Adjacent Roof Motion

- Under the Seat String Pot: Displacement
- Under the Seat String Pot: Velocity
- Roof Header: Displacement
- Roof Header: Velocity
- Neck Load, Fz
