Jordan Rollover System

Jordan Rollover System (JRS)

The Jordan Rollover System

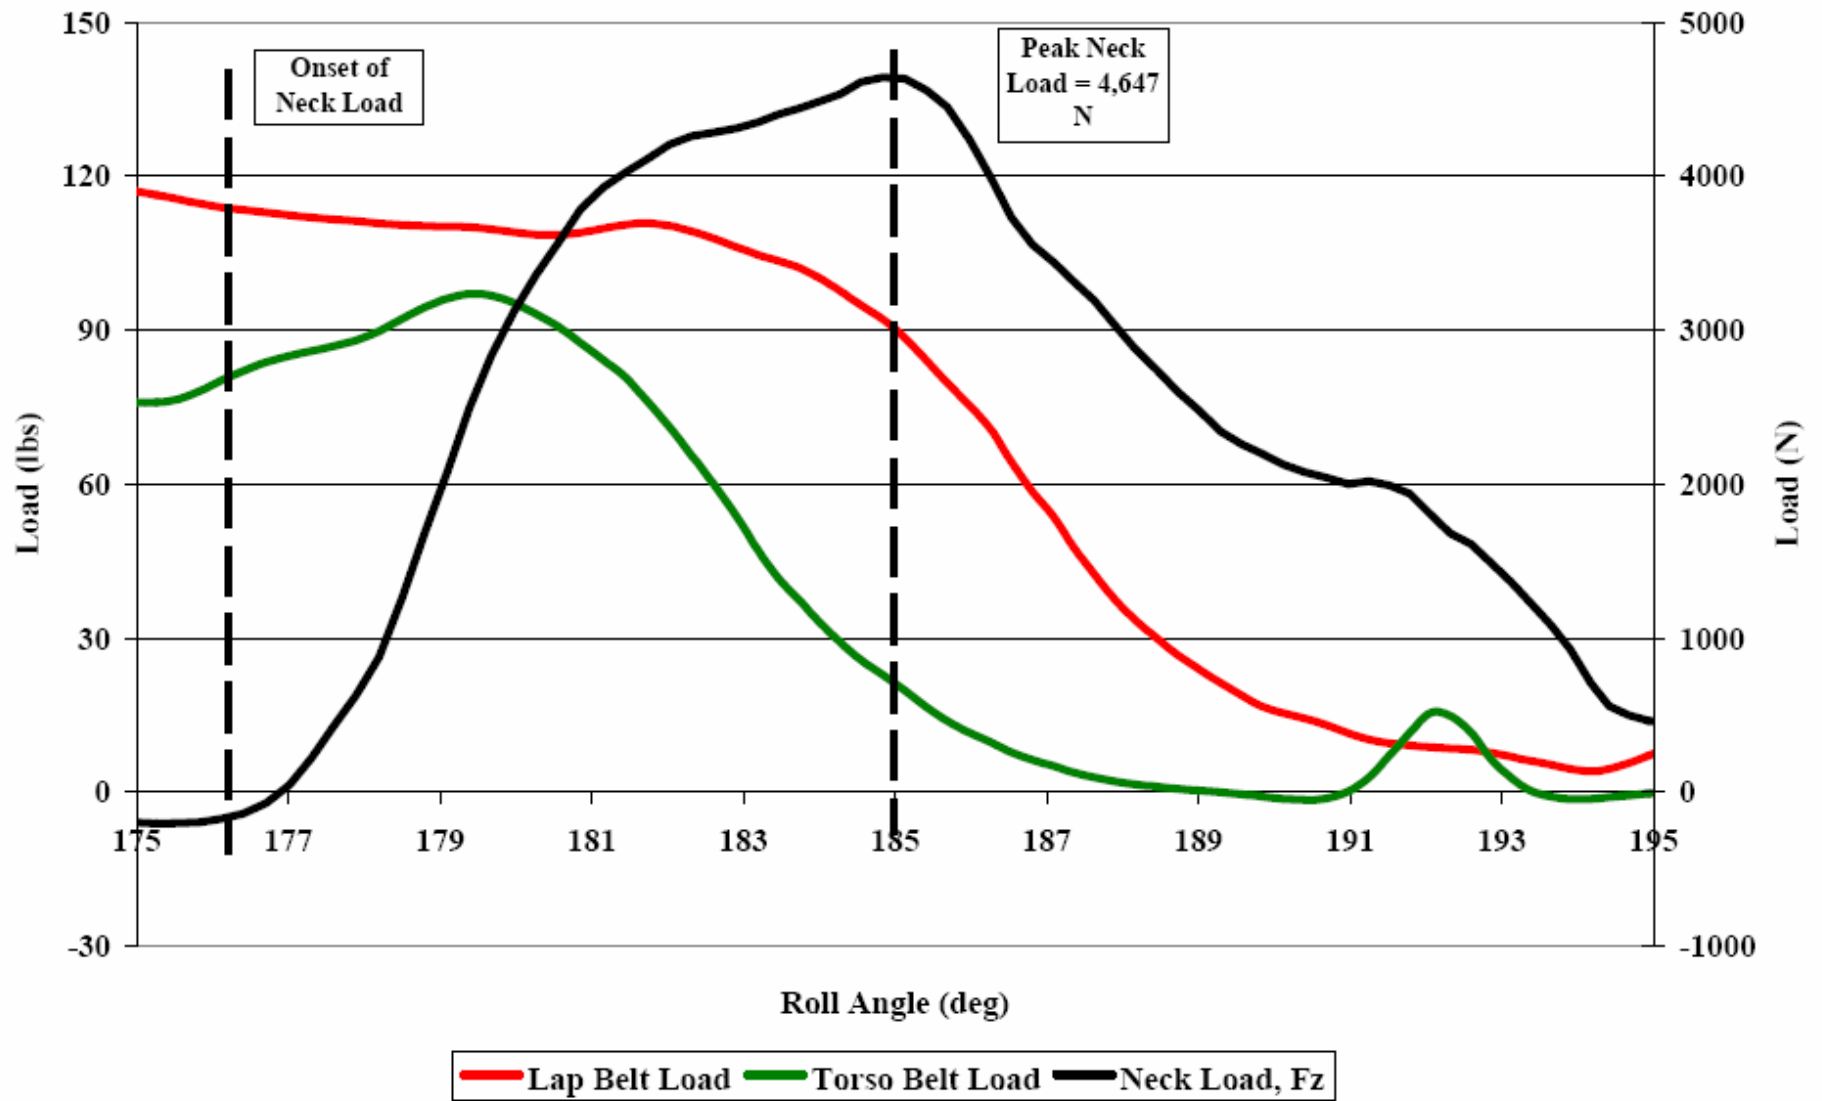
Far Side HIII Dummy Belt and Vertical Neck Loads

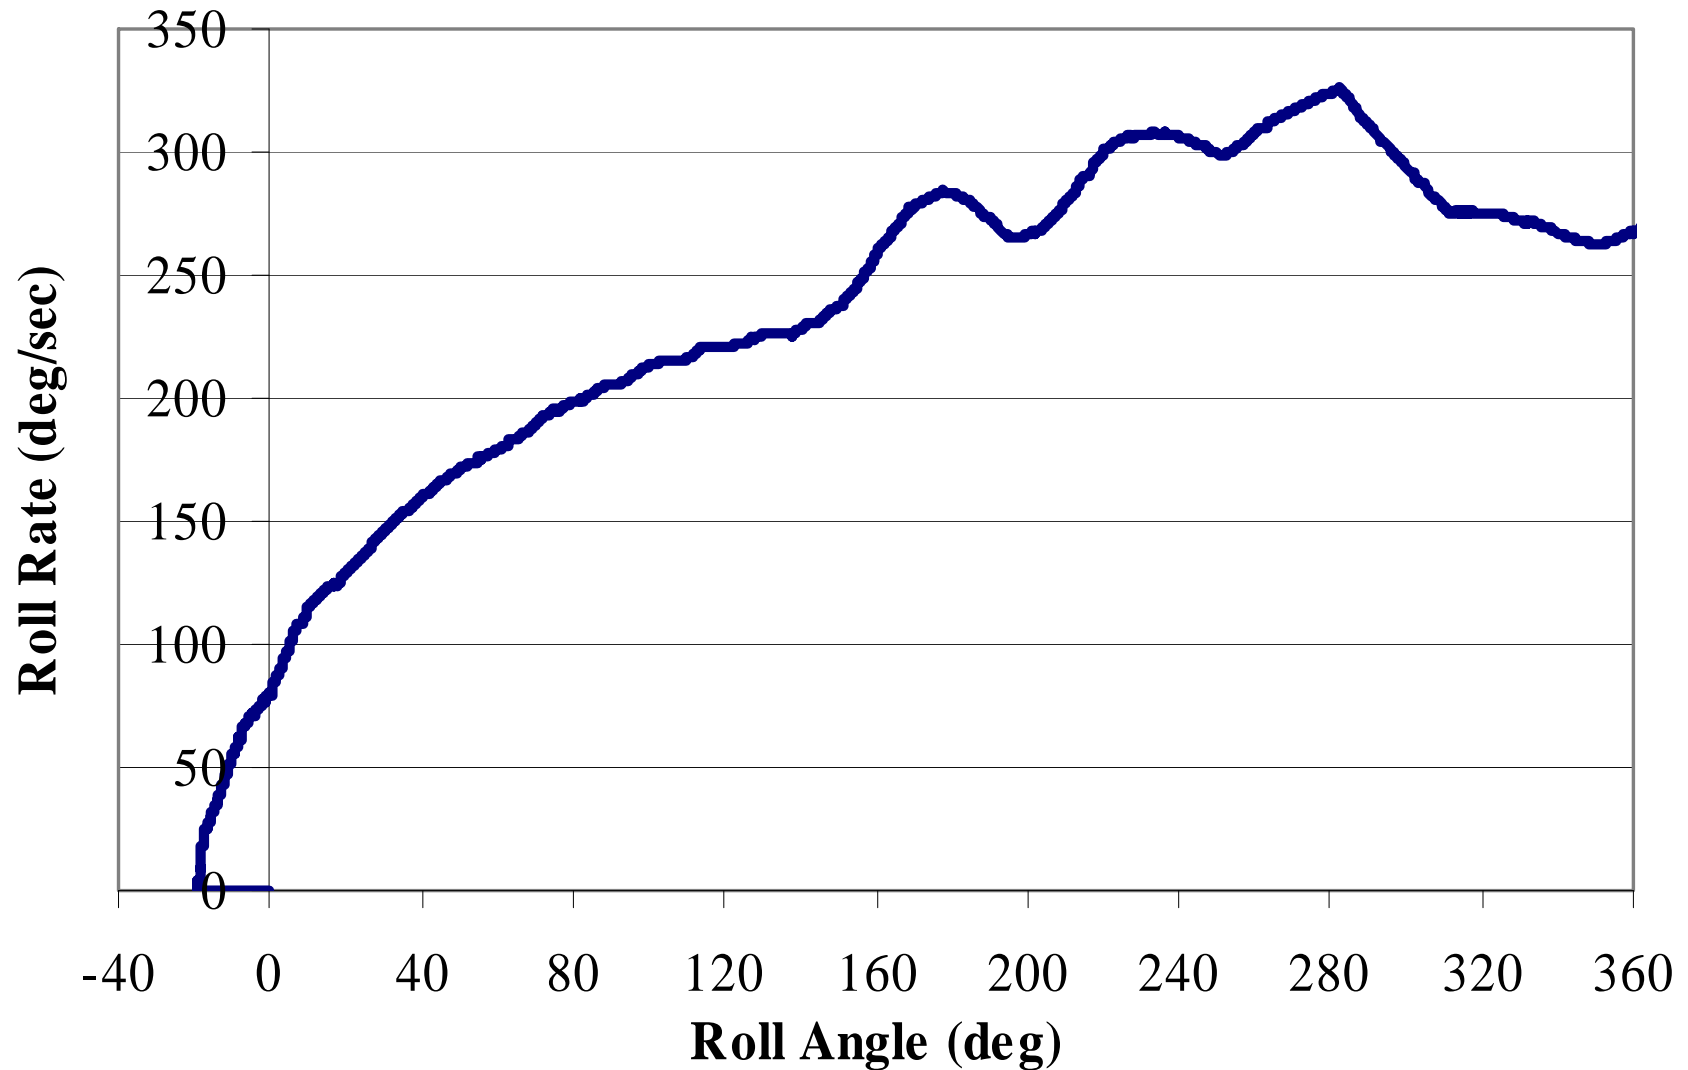
Roll Rate v. Roll Angle

Road Bed Contact at 140° accelerates roll rate

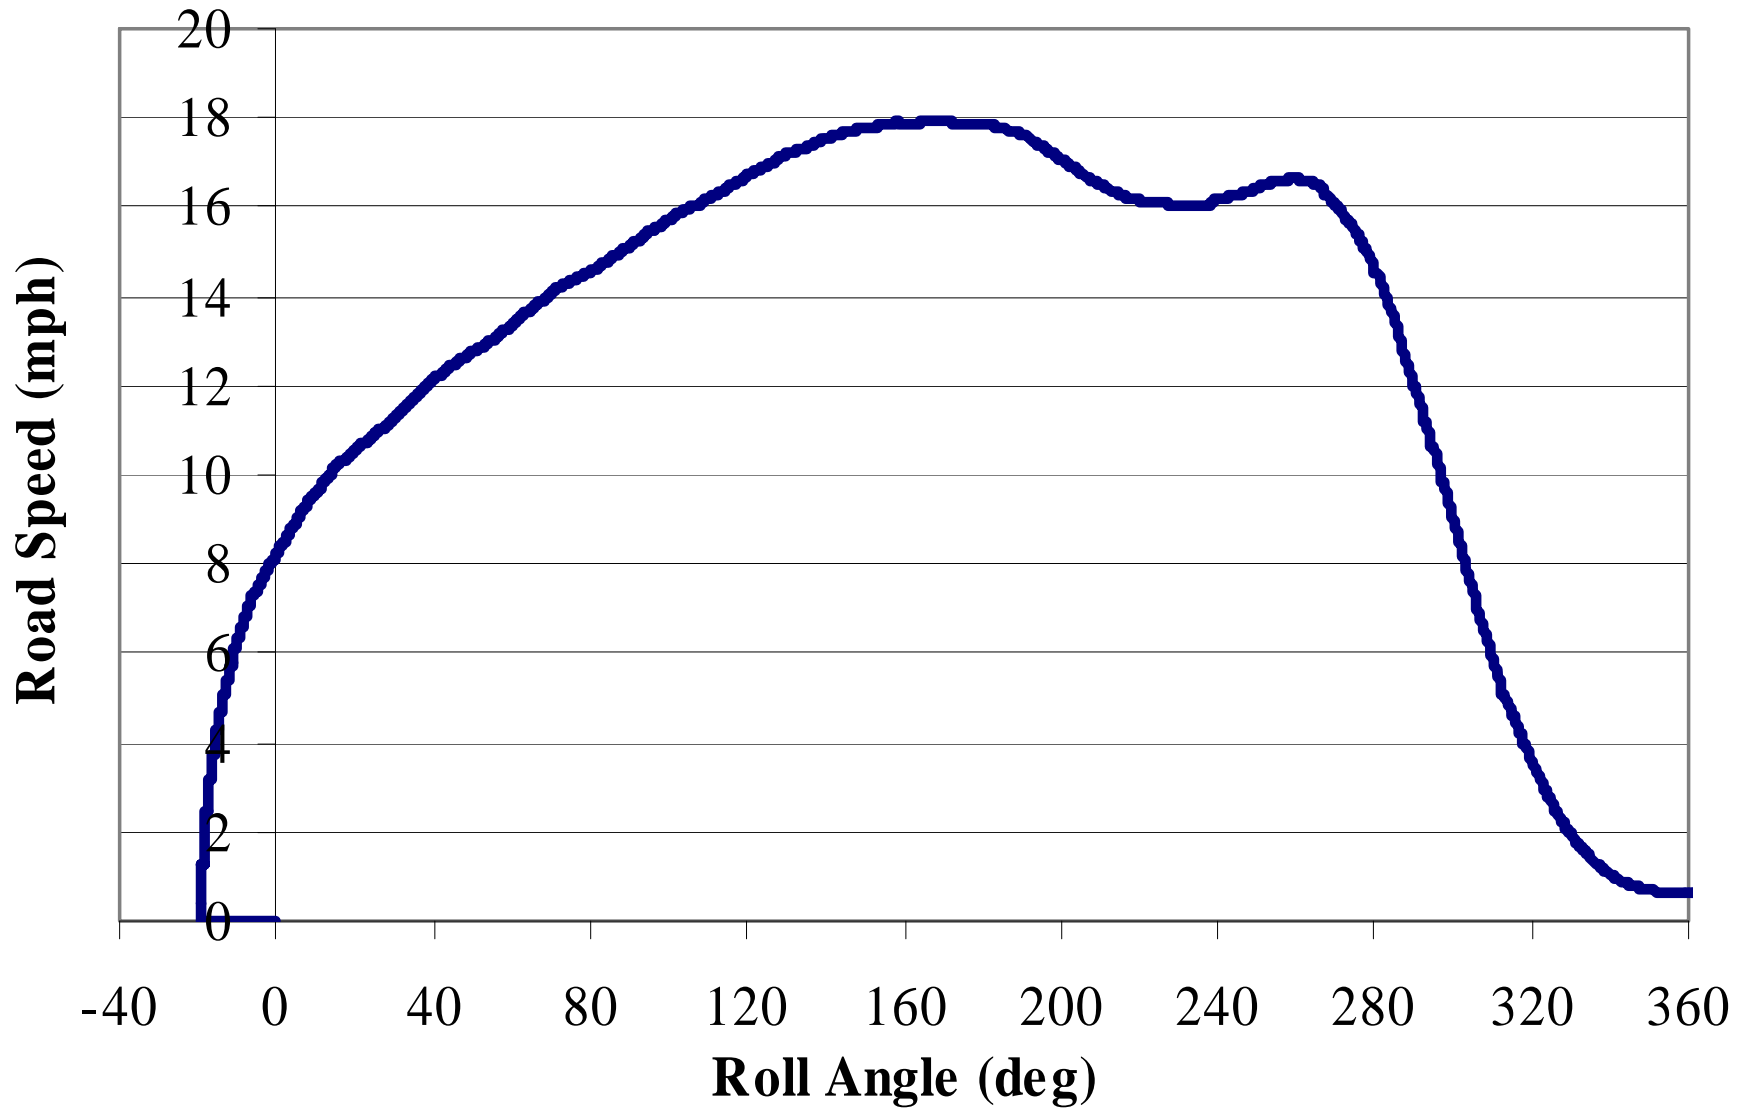
Road Speed v. Roll Angle

Accelerating roll rate reduces road speed after energy transfer

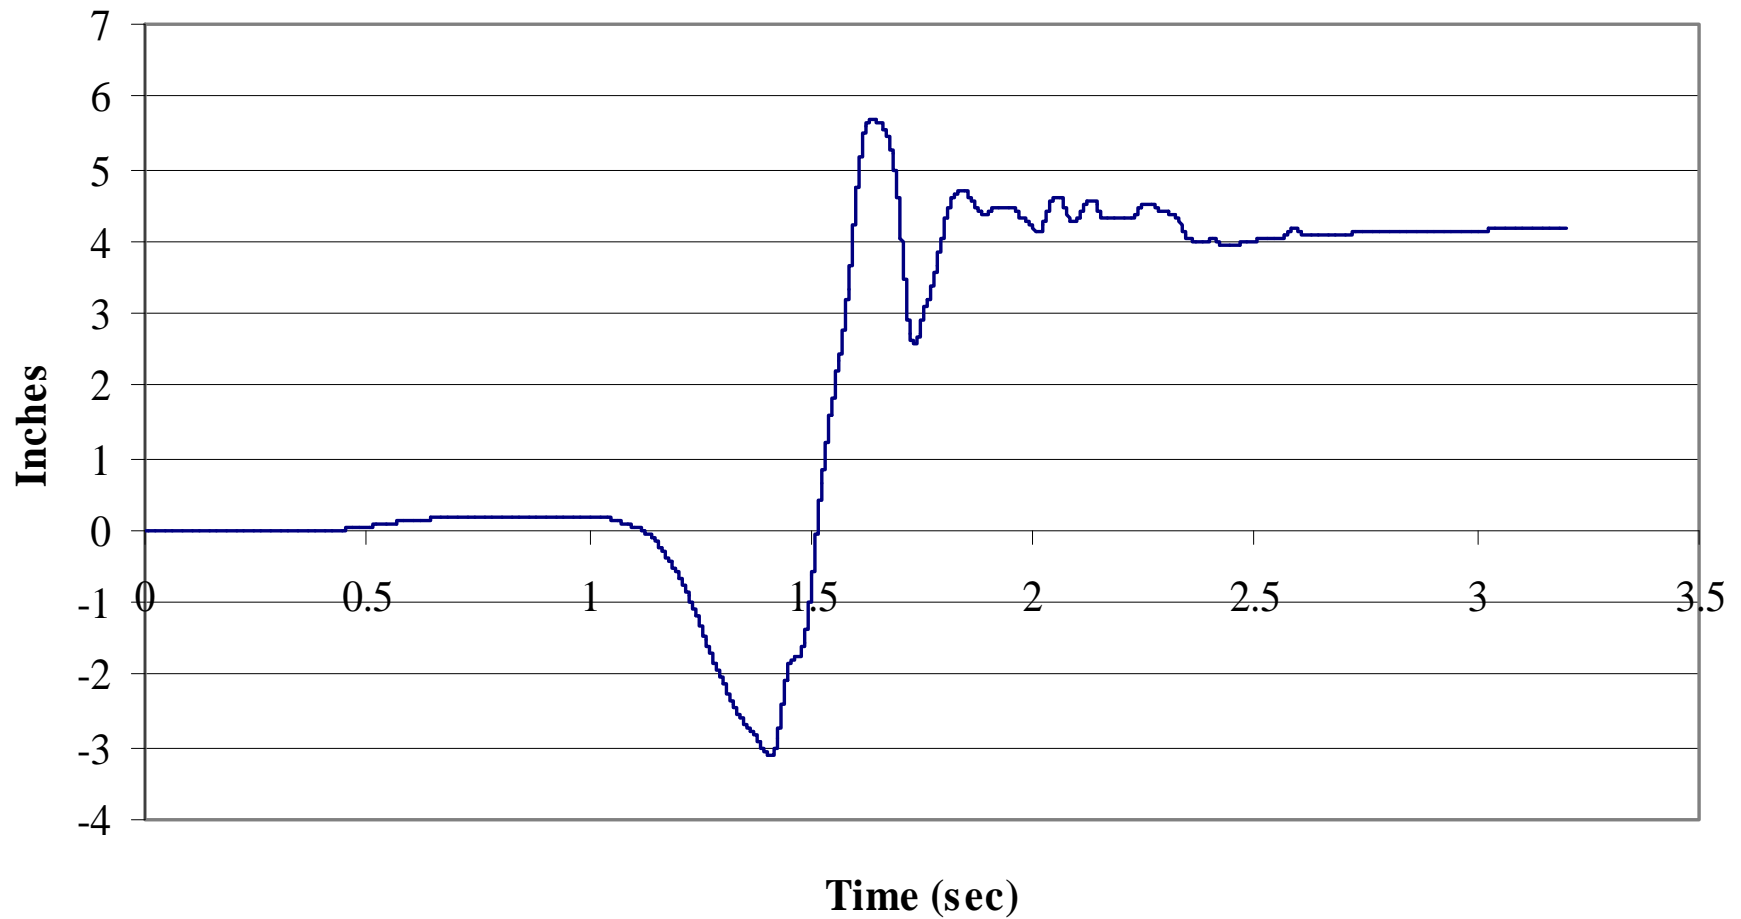
String Potentiometer: Head Lateral Movement

Minus motion of driver dummy towards passenger side

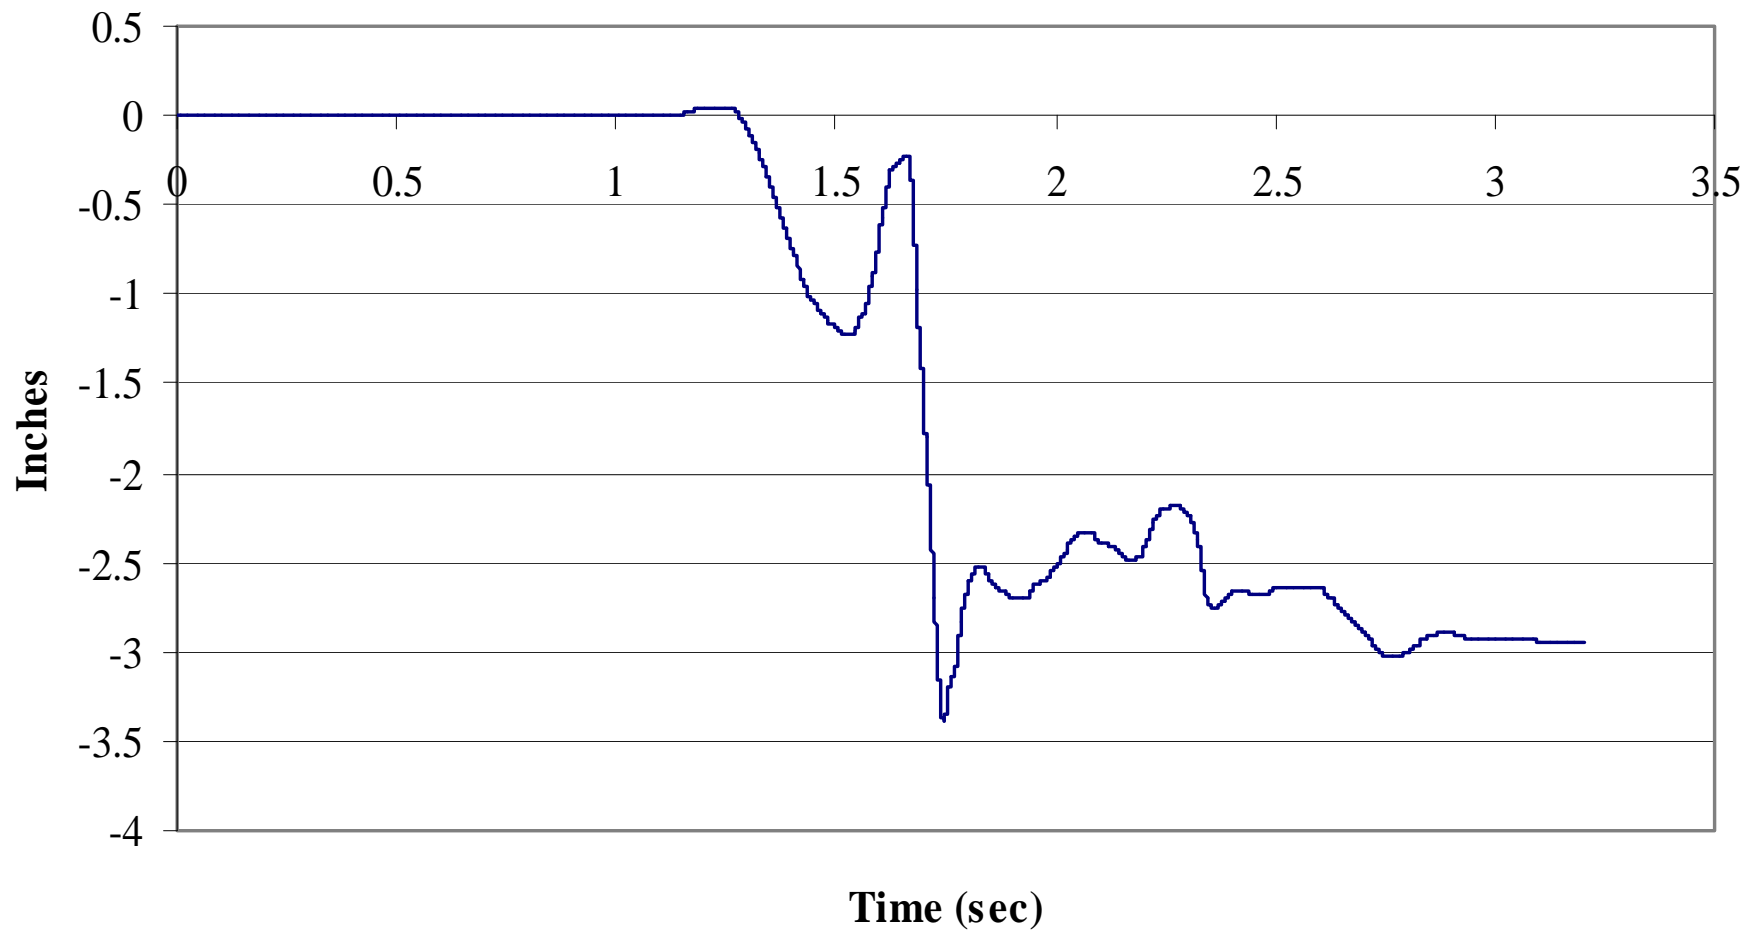
String Potentiometer: Head Longitudinal Movement

Minus driver head motion is in flexion

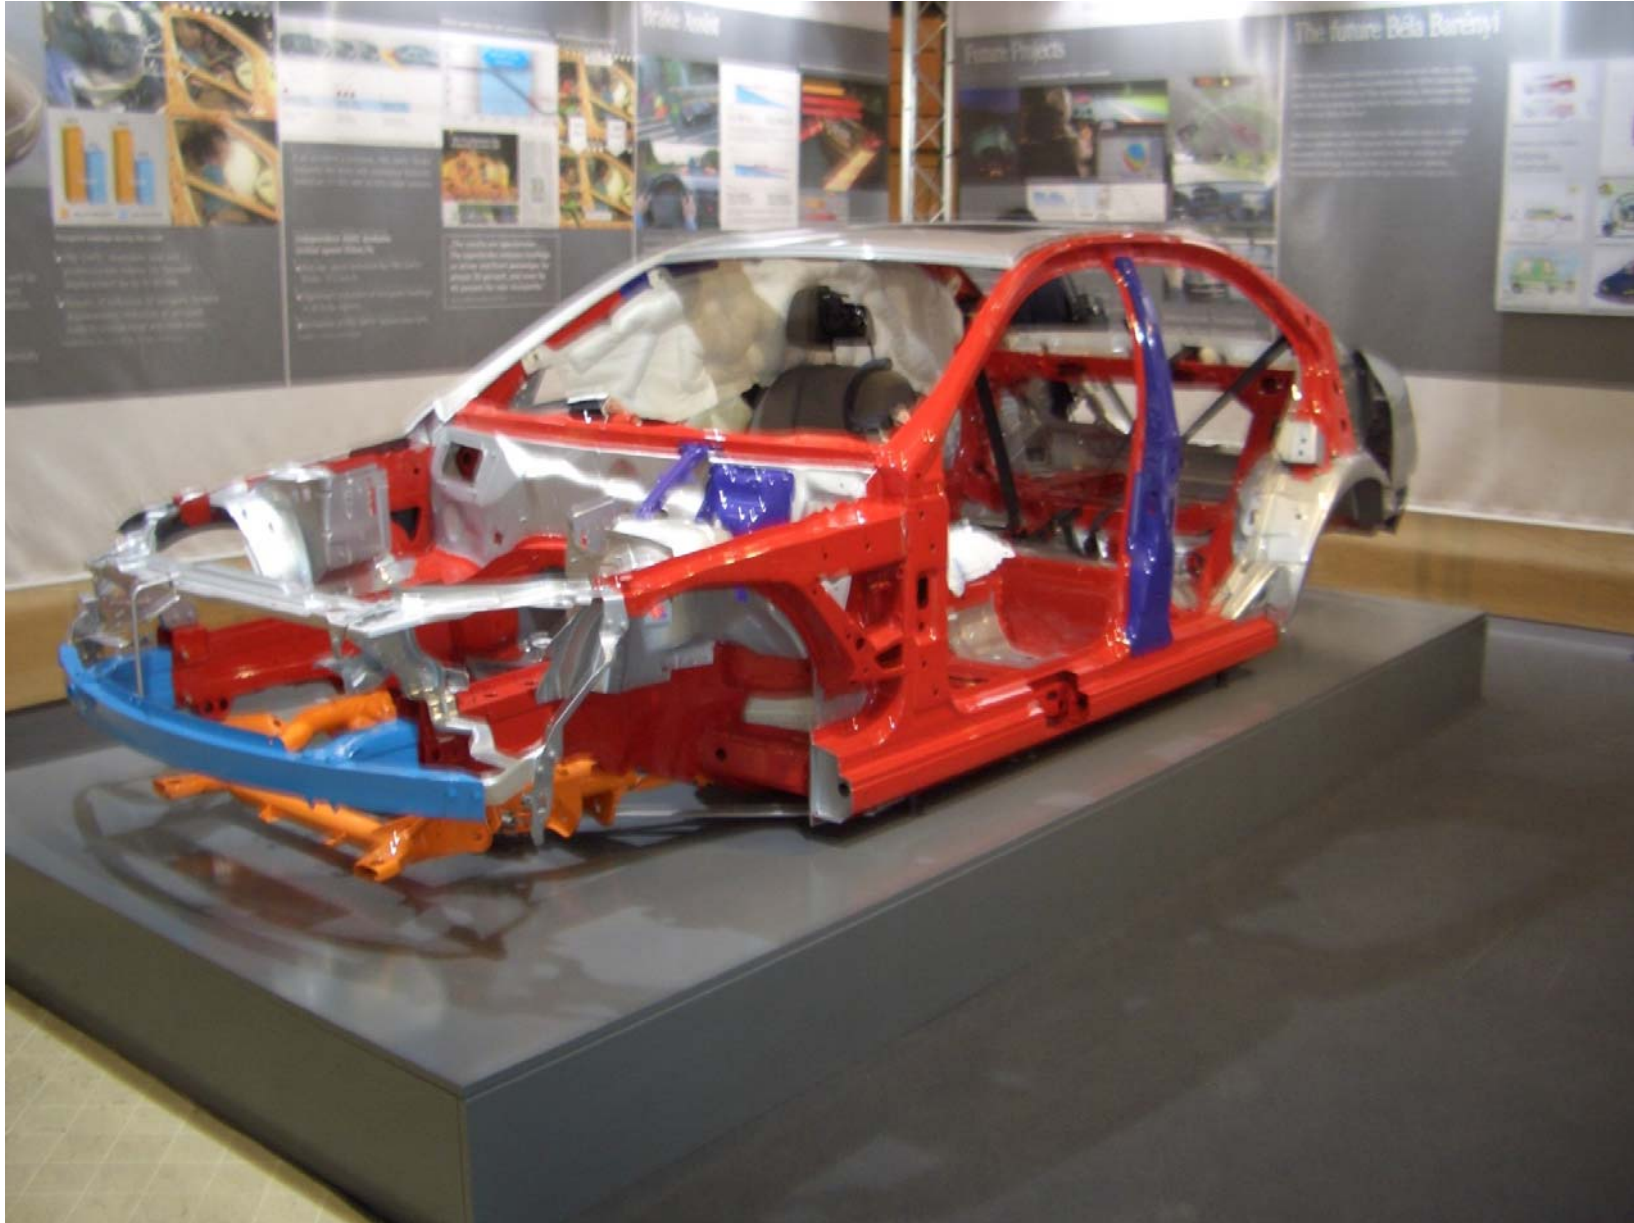
Mercedes 2007 C- Class HSS Structure

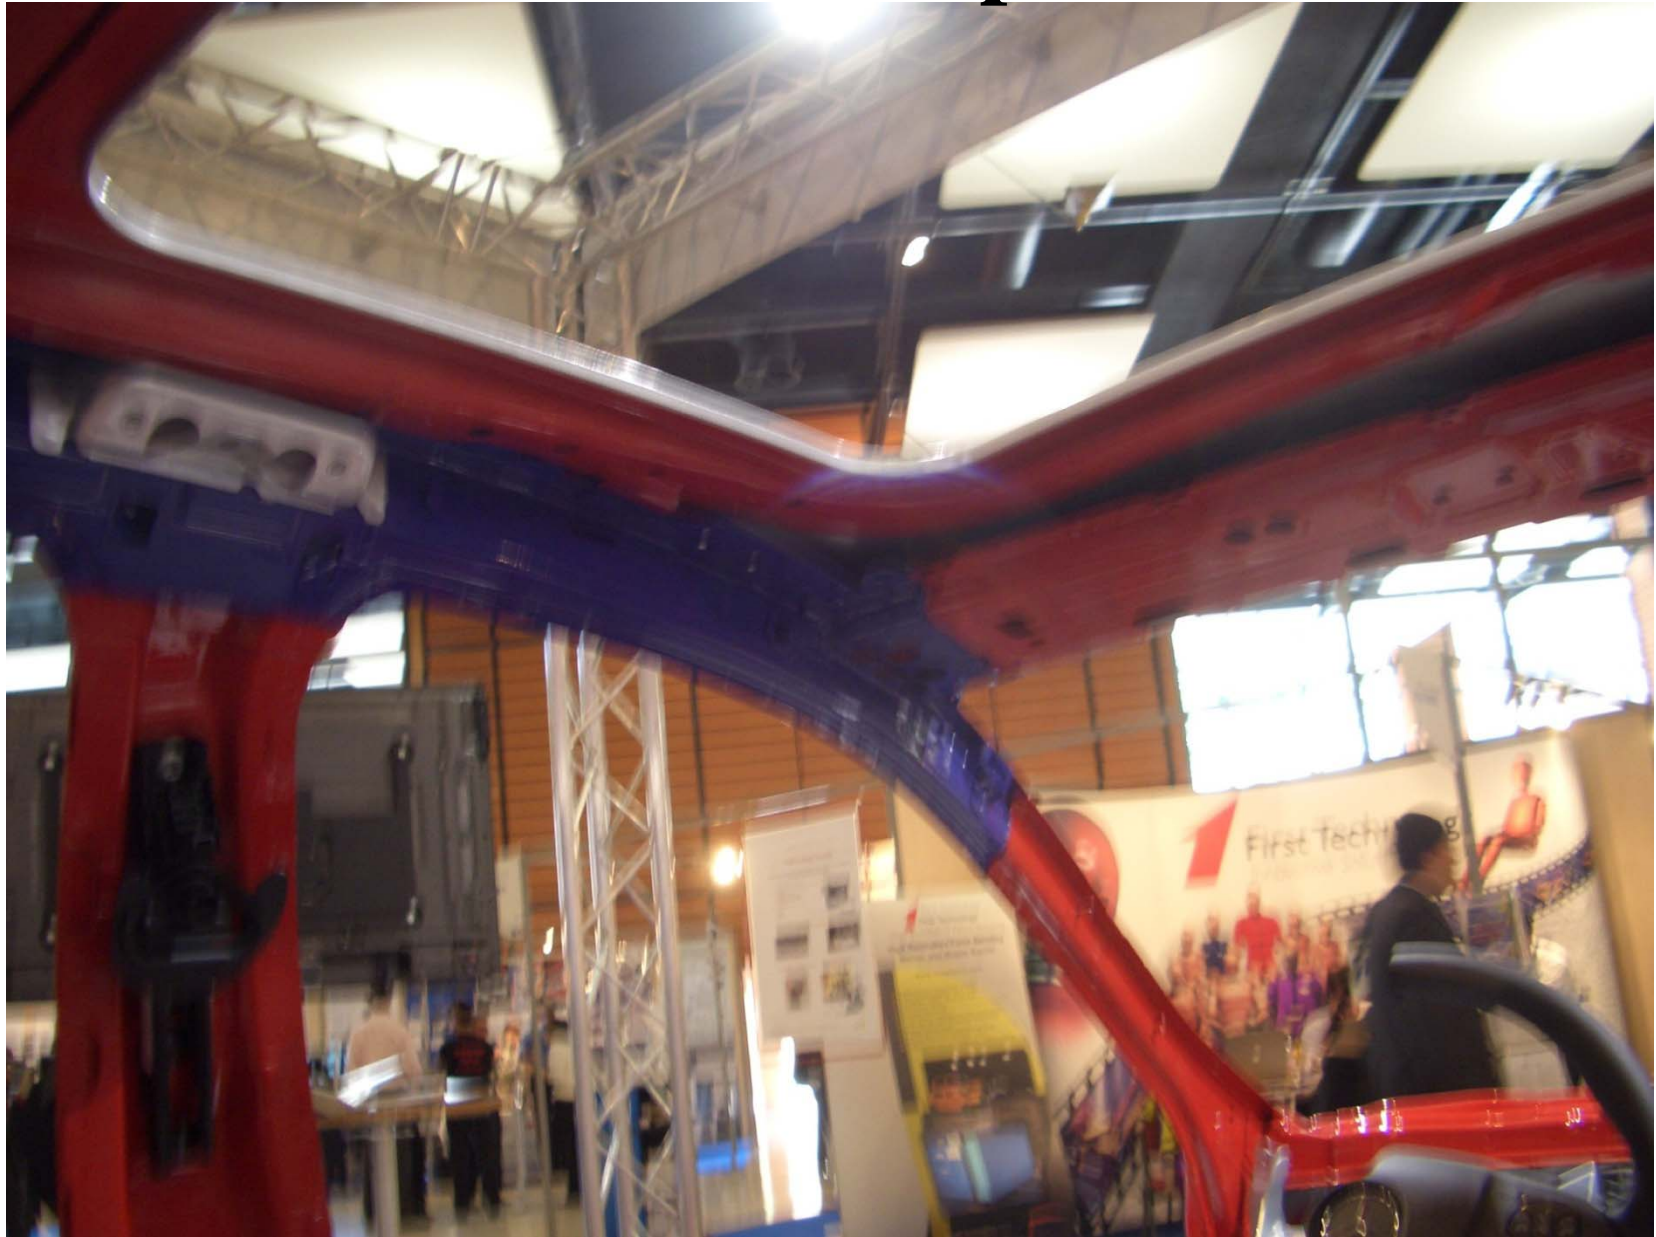
C- Class HSS Roof Rail/A-pillar/Header Joint

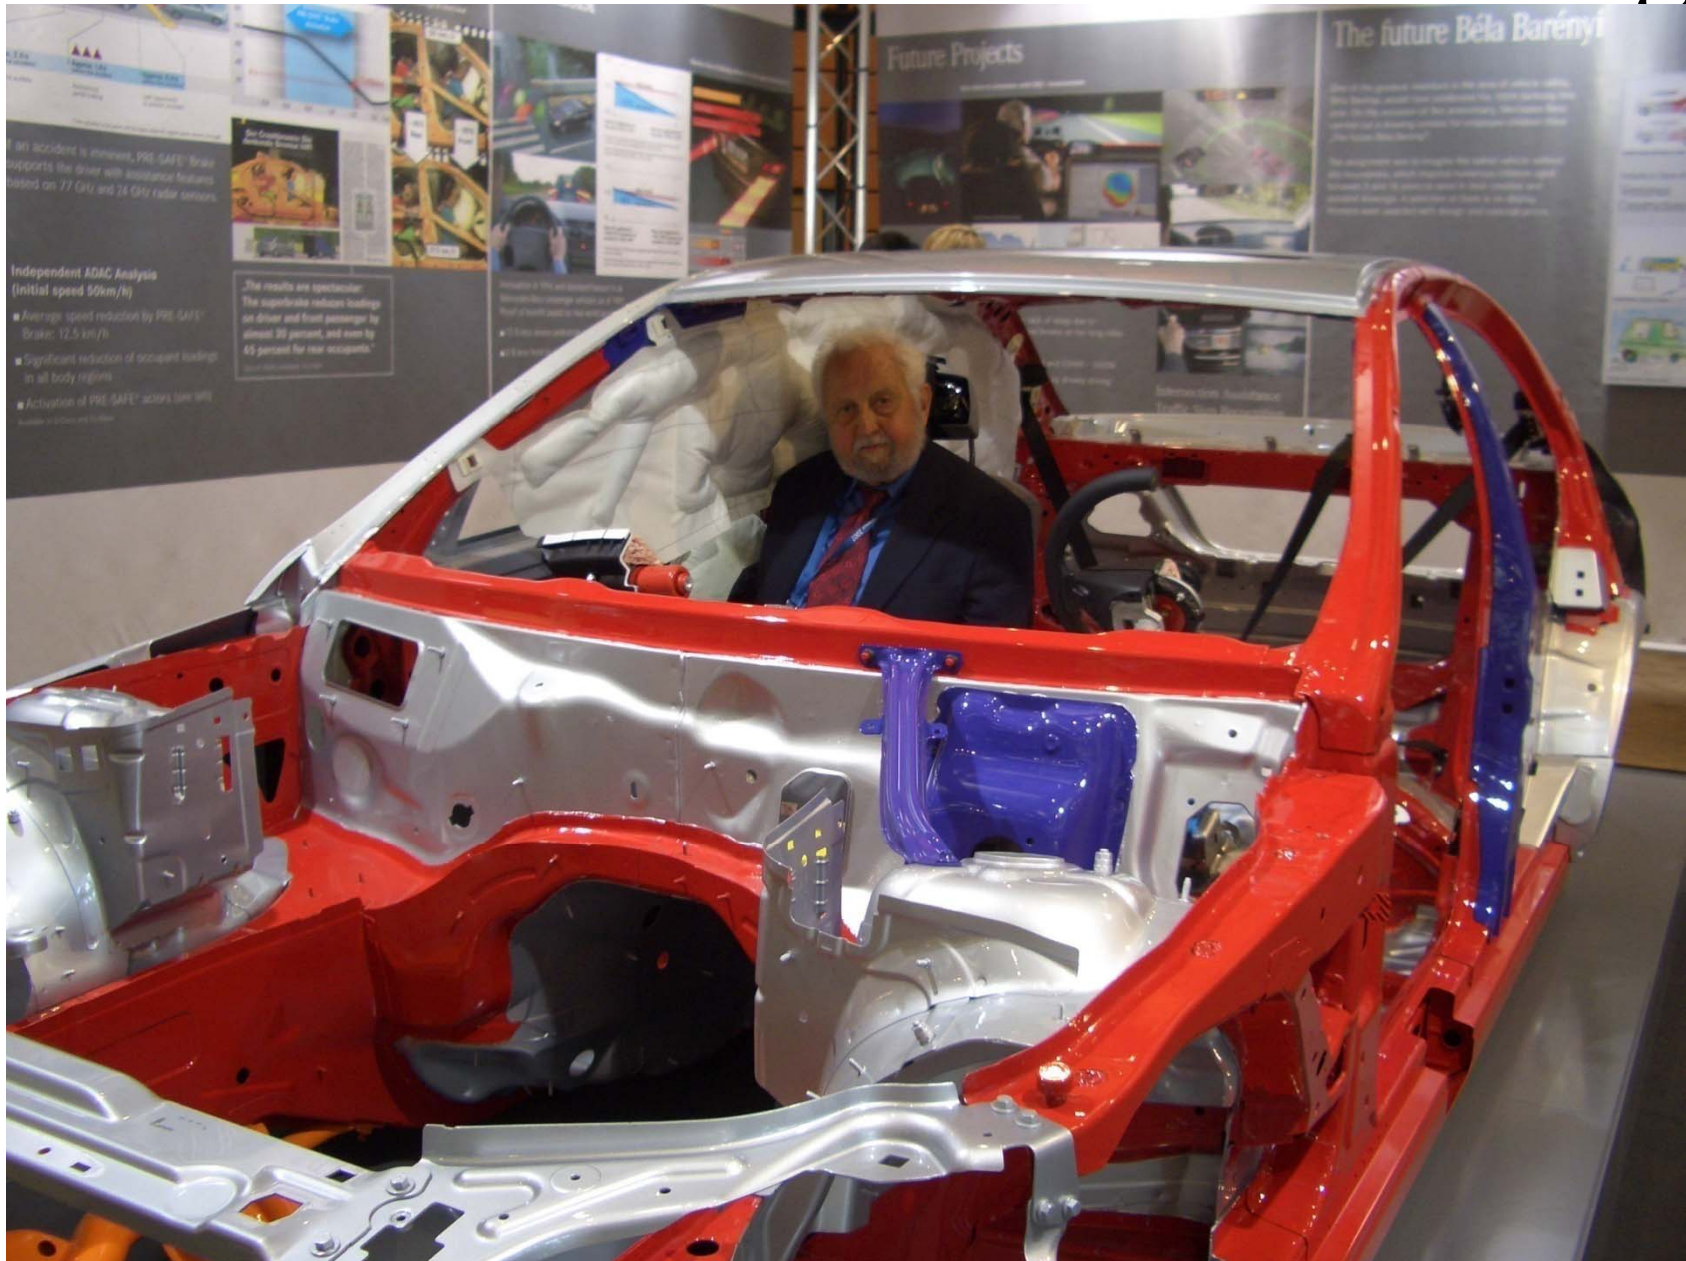
C-Class Window Curtain Air Bag

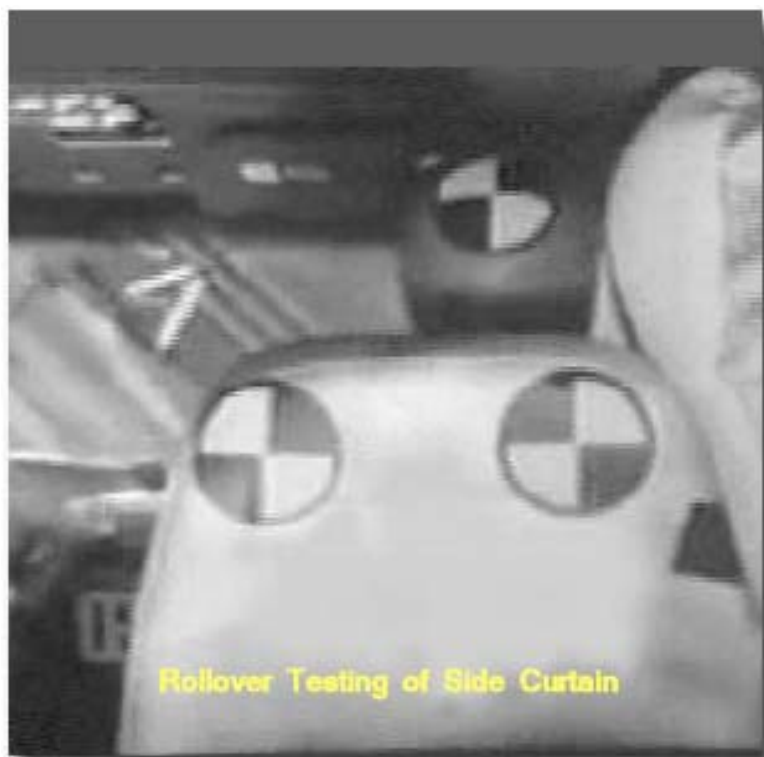
Near side Window Curtain Airbag

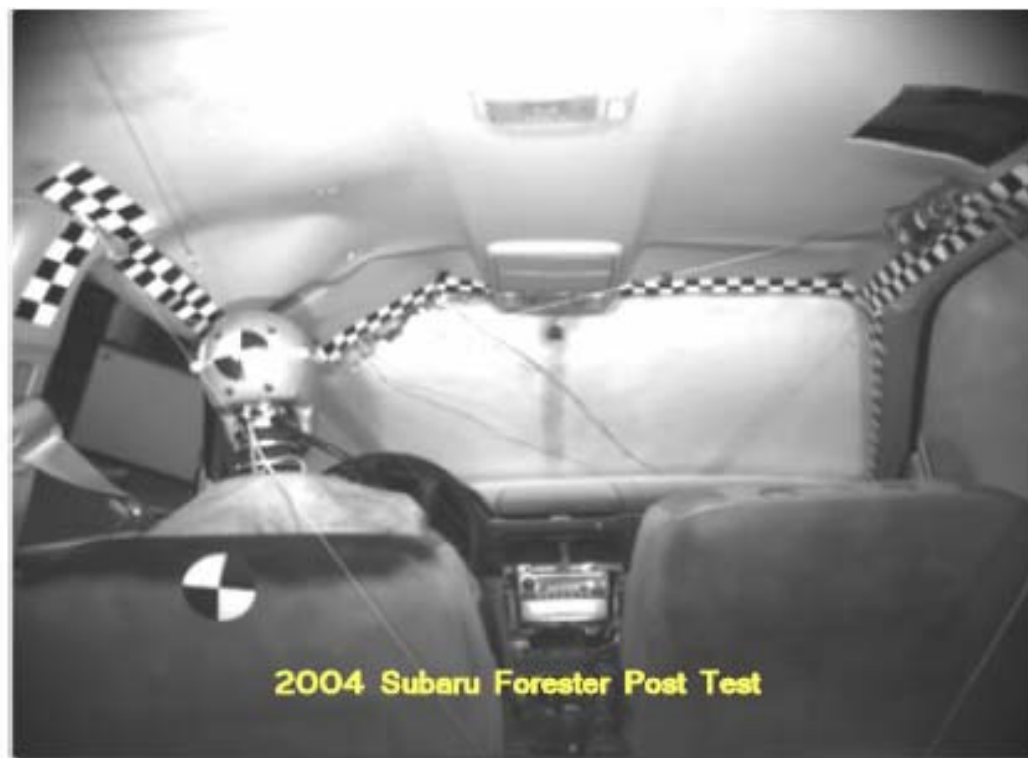
Far side 10° Pitch Intrusion w/ buckled header
