IMECE2010-39032

MATCHED PAIR TESTING OF INJURY POTENTIAL IN REPEATABLE ROLLOVER TESTS WITH THE CRIS AND JRS

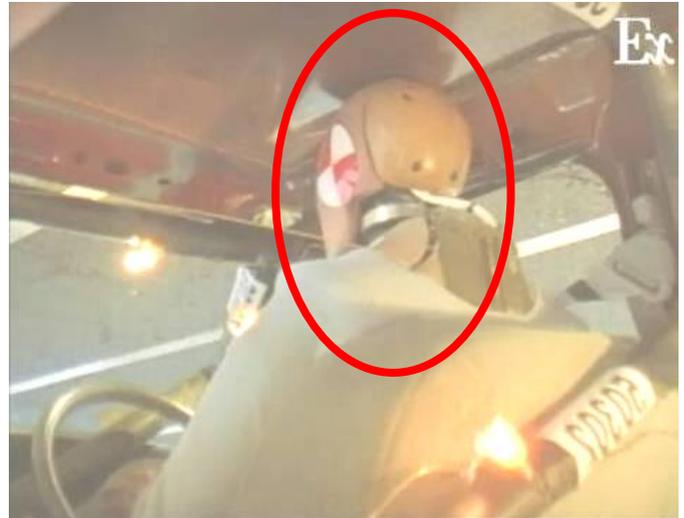
Figure 3. 1998 Crown Victoria (low severity rollcage 50302) max roof crush

Figure 3 shows the orientation of the dummy head and neck at the time of maximum roof crush (estimated at less than 2" (5.1 cm)) for the rollcaged Crown Victoria. The neck of the dummy compressed about 0.5" (1.3 cm) and then bounced off the roof, but the lack of extensive roof crush precluded any bending of the neck. In Figure 4 we can see that the neck of the dummy in the production vehicle bent a significant amount due to the large amount of roof crush. The deformation of the roof trapped the head of the dummy in a position which recorded a residual upper neck moment M_x of 70 Nm. Similar results were obtained in the medium severity CRIS tests of the 1998 Crown Victorias as shown in Figures 5 and 6 and in the low severity CRIS tests of the 1996 Chevrolet Blazers as shown in Figures 7 and 8.

Analysis of the high speed video from the interior of each vehicle showed significant differences in the amount of neck bending after the initial roof to ground contact between the rollcaged and production vehicles. Dummy movement was nearly identical up to the point of peak upper neck axial load. Then the distance between the roof and seat in the production vehicles reduced due to the deforming pillars and roof structure. The deformation of the roof structure and resulting reduction in headroom in the production vehicles forced the head of the dummy laterally and downward causing the neck to bend significantly. The neck of the dummy in the rollcaged vehicles showed no bending at all. Figures 3-6 show the difference in the amount the neck bending at the time of maximum roof crush for four of the 1998 Crown Victoria CRIS tests.

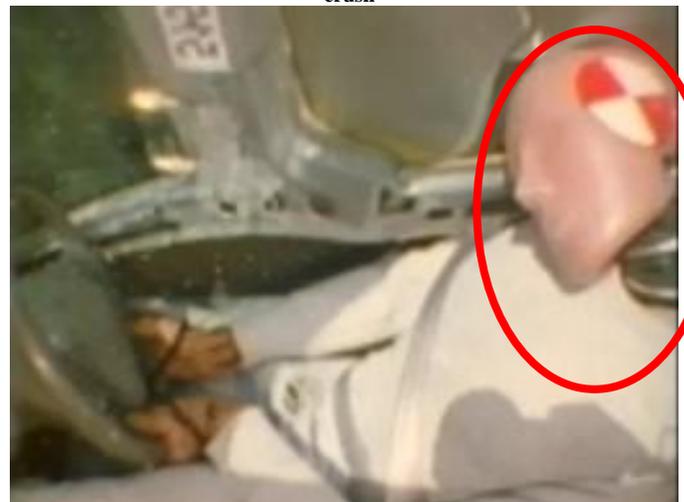
Figure 4. 1998 Crown Victoria (low severity 51502) max roof crush

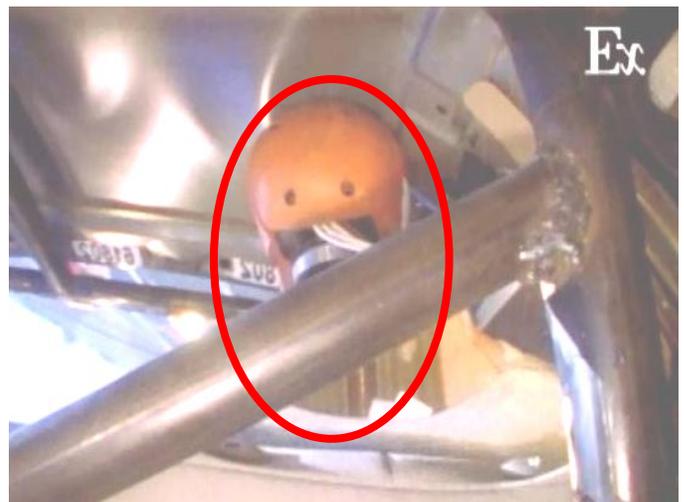
Figure 5. 1998 Crown Victoria (med. severity rollcage 61802) max roof crush

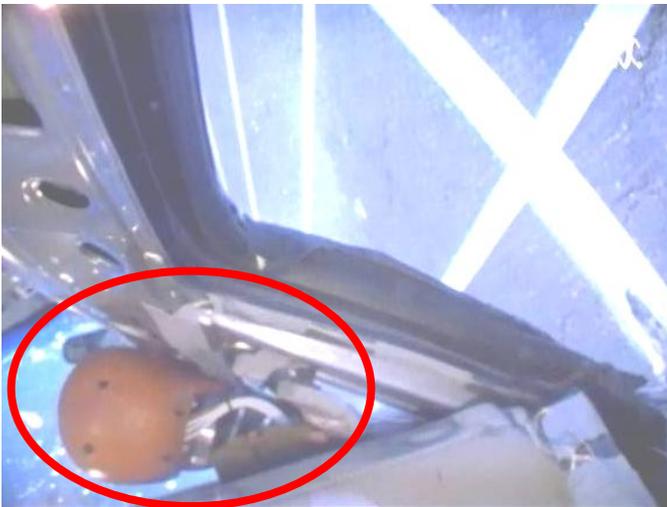
Figure 6. 1998 Crown Victoria (med. severity 62102) max roof crush

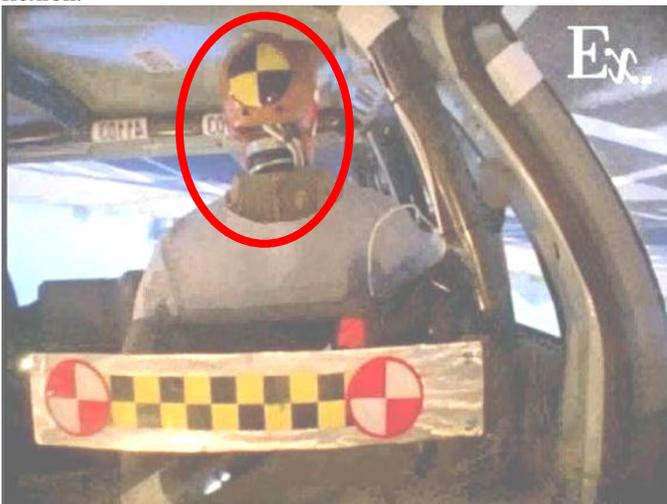
Figure 7. 1996 Chevrolet Blazer (low severity rollcage 41103) max roof crush

The primary direction of neck bending that was observed in the CRIS tests were in the lateral (M_x) direction. The neck has been identified as being only 70% as strong in the lateral direction of lower neck bending as it is in forward flexion.

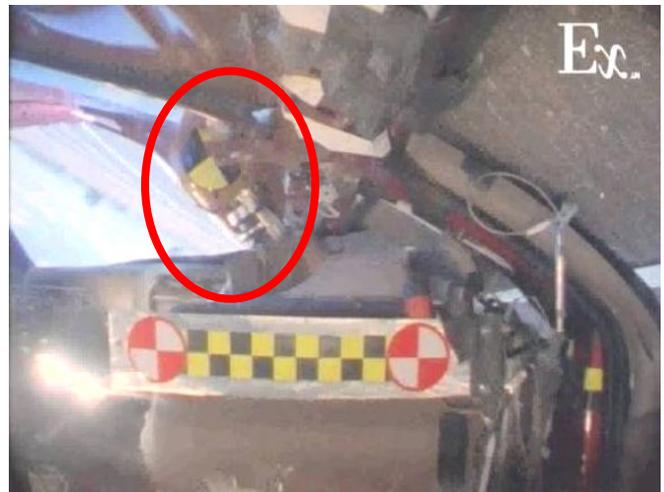
Figure 8. 1996 Chevrolet Blazer (low severity 41703) max roof crush

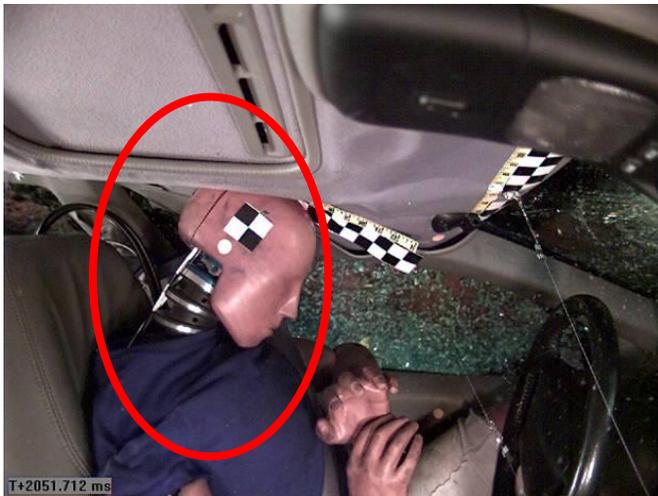
Figures 10-13 are frames from the high speed video that show the neck movement at the time of peak roof crush in each of the JRS tests of the 1998 Ford Explorers.

Figure 10. 1998 Ford Explorer (Production Roll 1) max roof crush

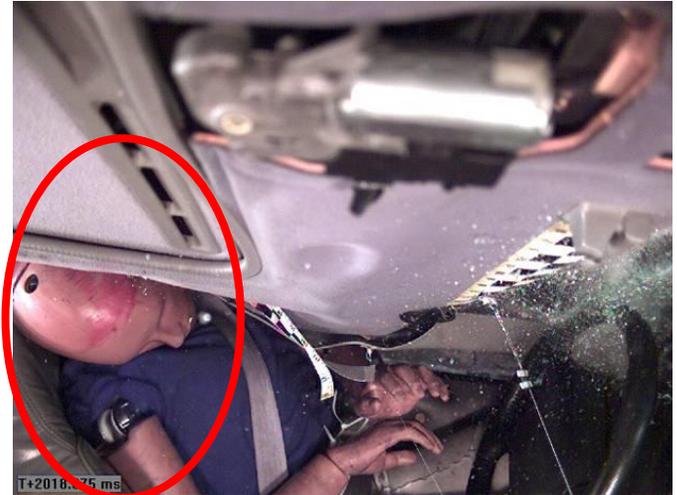
Figure 11. 1998 Ford Explorer (Production Roll 2) max roof crush

In Figure 11 the much reduced headroom has bent the neck of the dummy in a primarily lateral direction. The

deformation of the roof in the second test of the production Ford Explorer was so great that the dummy was pinned in a position that placed a residual moment (M_x) of 55 Nm laterally on the lower neck of the dummy.

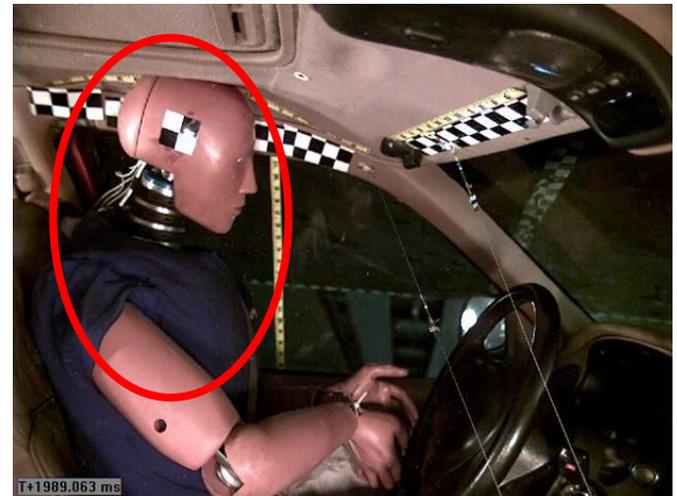
Figure 12. 1998 Ford Explorer (Reinforced Roll 1) max roof crush

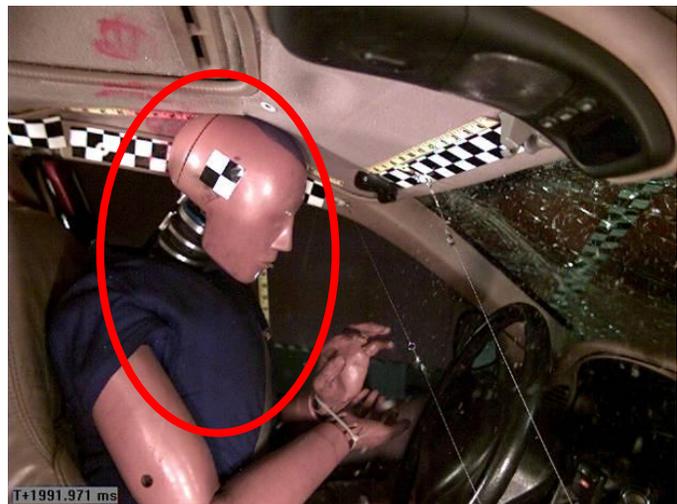
Figure 13. 1998 Ford Explorer (Reinforced Roll 2) max roof crush

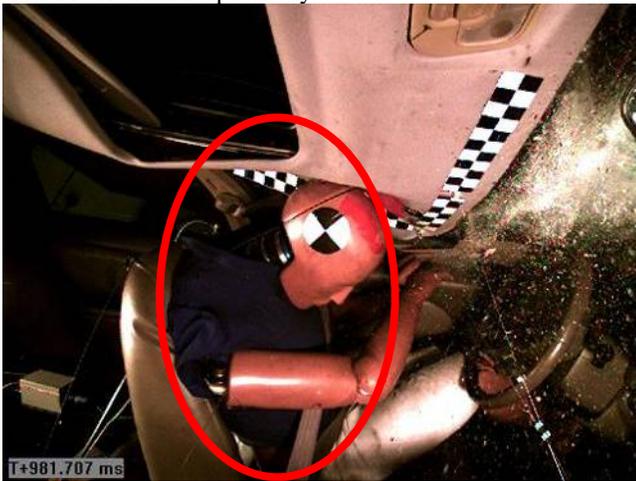
Figure 14. 1999 Hyundai Sonata (Production Roll 1) max roof crush

In the matched pair tests on the JRS the amount and duration of neck bending is related to the amount of headroom lost during the rollover event due to the deformation of the roof. In the JRS test of the reinforced roof Hyundai Sonata, the top of the driver side A-pillar moved 4.5" (11.4 cm) toward the center of the vehicle. Under the same test conditions, the roof of the production Sonata moved 10.9" (27.7 cm) toward the center of the vehicle. The initial headroom in the Sonata for a Hybrid III 50th percentile male dummy is approximately 4.5" (11.4 cm) which equates to a dynamic headroom loss for the reinforced and production vehicles of 0 and 6.4" (16.3 cm) respectively. The results after Roll 1 are shown in Figure 14 and 15. The dynamic intrusion of the roof left the reinforced and production Sonata vehicles with 2.2" (5.6 cm) and 7.3" (18.5 cm) of residual roof crush respectively.

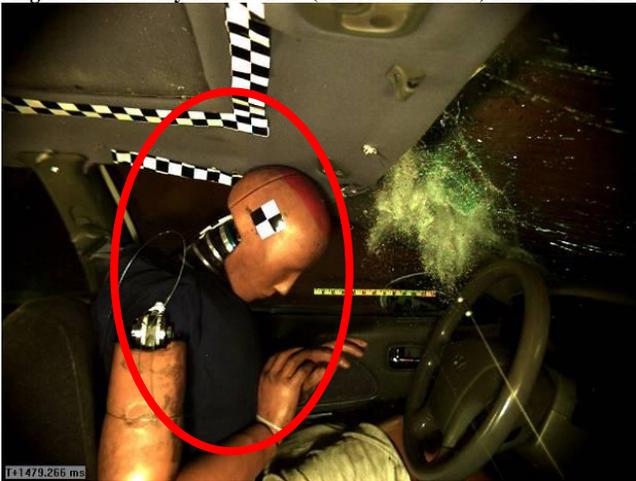
Figure 15. 1999 Hyundai Sonata (Reinforced Roll 1) max roof crush
