Commercial, Police, and Military Vehicle Rollover Protection and Evaluating the Effectiveness of Geometry and Retrofit Rollover Testing

*S Bozzini, *J Jimenez, *G Mattos, **Dr. R Grzebieta, ***Dr. J Paver

Abstract: Rollover crashes cause more than 10,000 fatalities and nearly 30,000 serious injuries per year in the U.S. alone. This is due to the fact that the vast majority of vehicles, including commercial, police, and military, lack the roof strength to preserve occupant survival space and protect their occupants in a rollover. Recent statistical and epidemiological studies have shown a significant relationship between roof crush and injury. This rollover occupant protection problem is well known to industries with large vehicle fleets; until now, this problem has eluded solution. Within these various industries a wide variety of rollover occupant protection systems (ROPS), both internal and external, have been designed, purchased, manufactured, installed, and maintained locally with little expert consultation. A wide variety of designs have emerged with an alarming variance in "assumed" crashworthiness. Couple this alarming trend with the risk of rendering the existing occupant

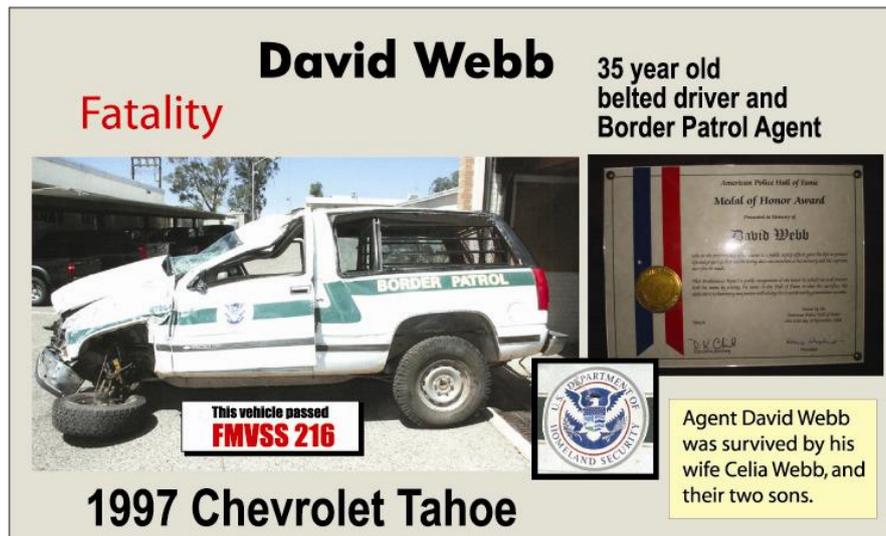
David Webb¹⁵ was a 35 year-old Border Patrol agent out on a routine call when the right rear tire of his 1997 Chevrolet Tahoe blew out. This caused him to lose control and his SUV rolled over. He sustained a fractured skull and never regained consciousness. Figure 1 shows the vehicle with roof deformation at the driver-side A-pillar, after the crash. It is worth noting that the aftermarket roll cage in the rear for detainees was the section of the vehicle that did not crush.

Figure 1. Government vehicle rollover victim (image from www.peoplesafeinrollovers.org)

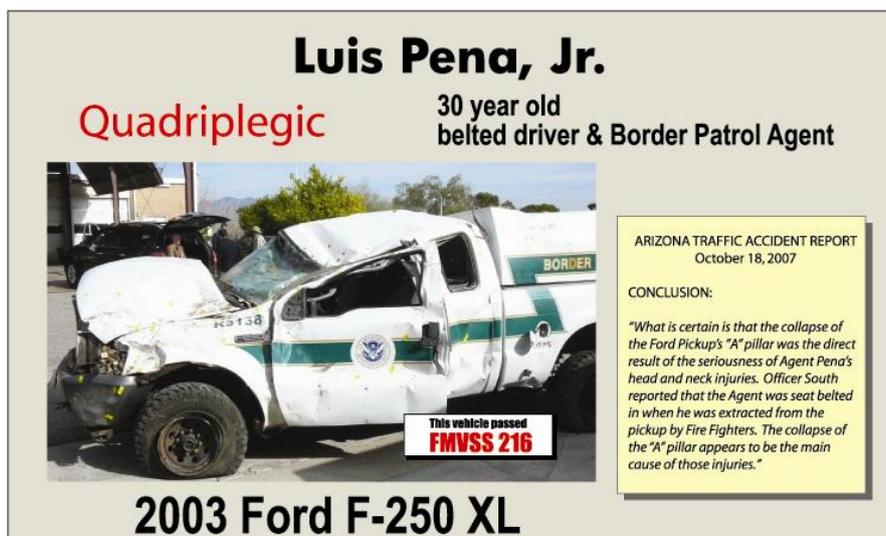
The other victim was 30 year-old Border Patrol agent, Luis Pena, Jr.¹⁶ Mr. Pena was amnesic to the event, but speculates that he may have tried to avoid hitting either a horse or cattle when his 2003 Ford F-250 XL rolled over. His injuries included vertebral dislocation with spinal cord injury, rendering him quadriplegic. Figure 2 shows the roof crush at the driver-side A and B-pillars.

Figure 2. Government vehicle rollover victim (image from www.peoplesafeinrollovers.org)

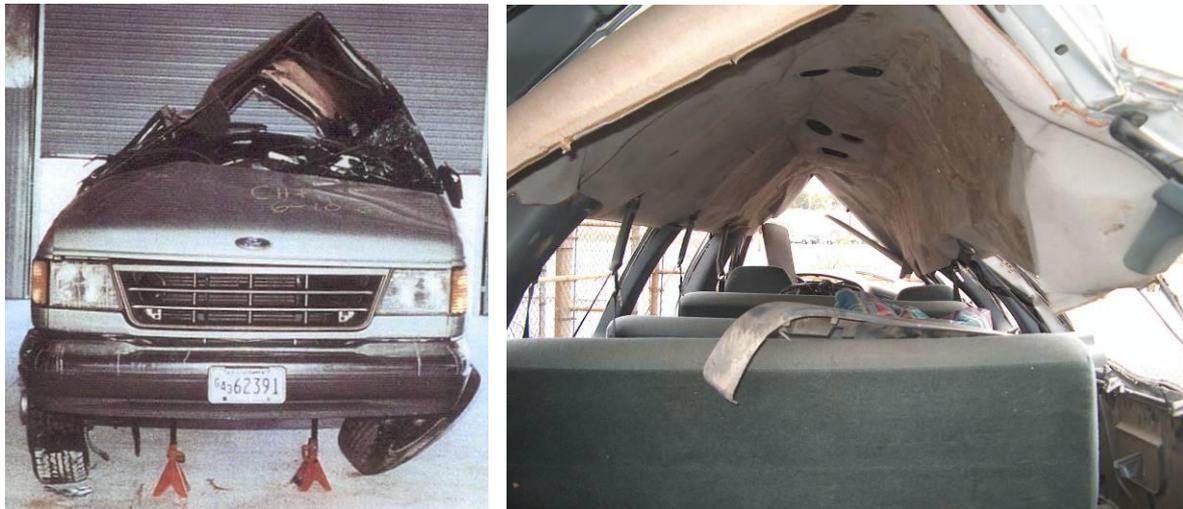
A volunteer driver departed Camp Wilson in route to Laughlin, Nevada, with 15 Marine Corp passengers. The Ford Club Wagon Van had a tire blow out, which caused a loss of control and vehicle rollover. This vehicle sustained multiple impacts to the roof, rear and both sides. There was a significant impact to the right roof and upper right side which caused significant intrusion into the right side of the passenger compartment. This major impact to the roof had a principal direction of force from top to bottom and right to left. Figure 3 shows the marine transport van after the crash; the exterior view is on the left and the interior view from the rear is on the right.

Figure 3. Military vehicle fleet - U.S. Marine transport van case study

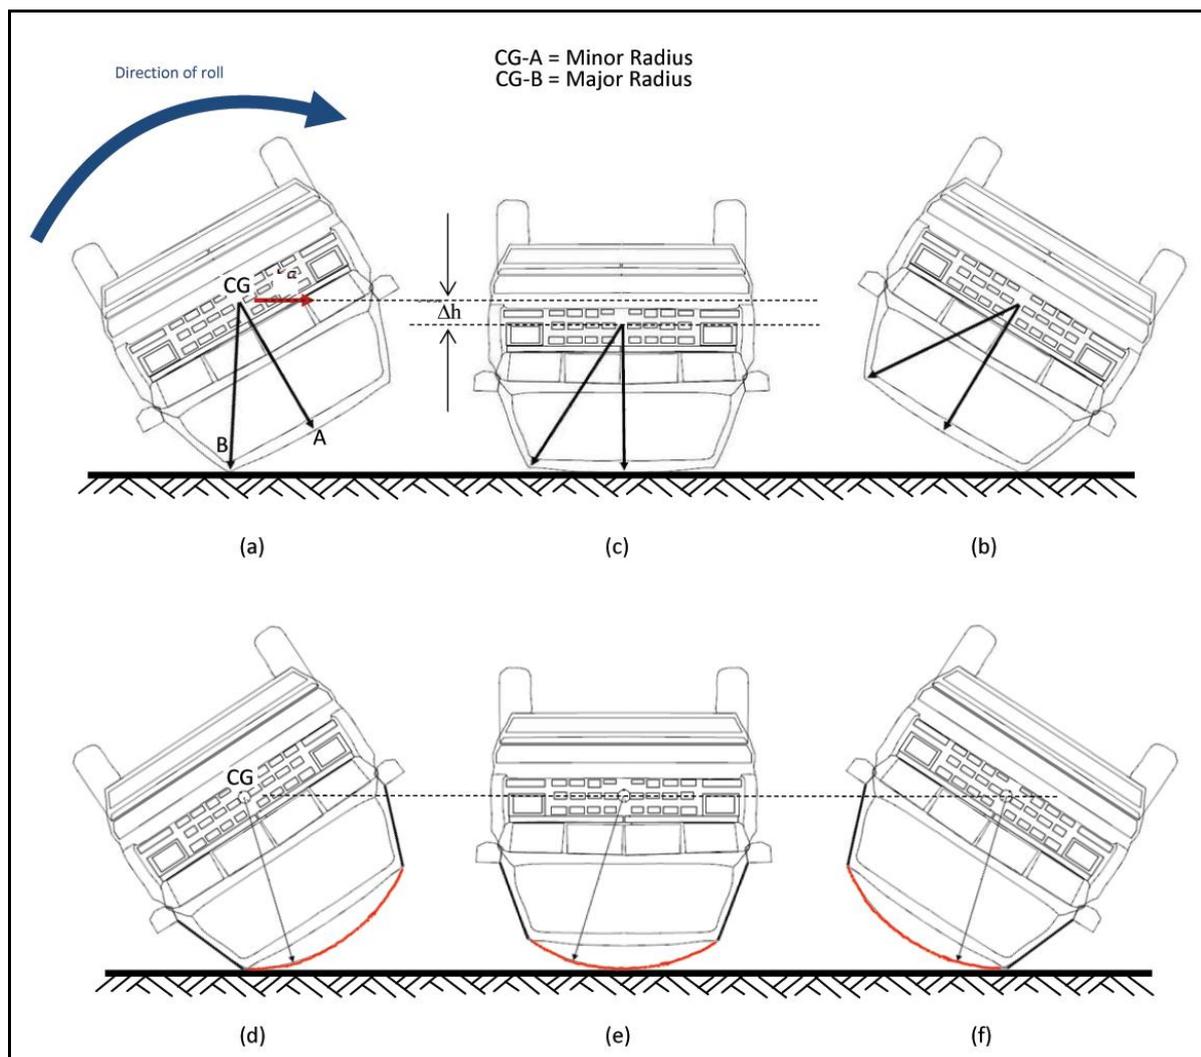
Grzebieta et al (2009)¹² demonstrated a ‘proof of concept’ how roof crush intrusion into the occupant compartment can be prevented using an innovative externally retrofitted rollover load distribution device. It was developed based on an understanding of how vehicles roll and roofs crush during rollover. It incorporates a roll “hoop” placed in line with the major radius of the vehicle changing and improving the vehicle geometry. Figure 4 demonstrates via sketches the concept of this process.

Figure 4. Top row: Vehicle’s CG drops during rollover and then rises again;
Bottom row: Hoop maintains vehicle’s CG at constant height, thus reducing roof load

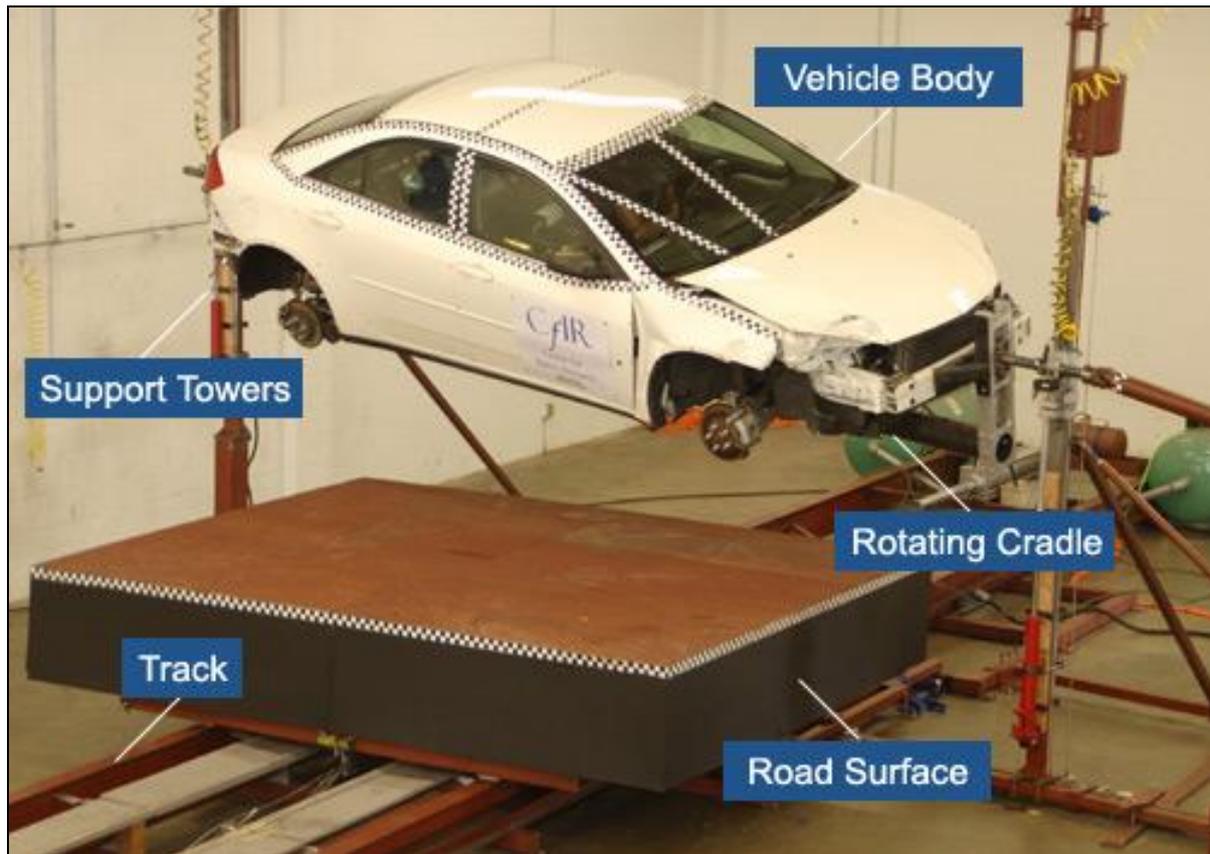
The JRS is shown in Figure 5. The Vehicle Body is mounted on the Rotating Cradle and then fitted into the Support Towers. The Road Surface is moved to the far end (not shown) of the Track. The Support Tower's release mechanism and the Road Surface trigger are synchronized to achieve the prescribed test parameters. The Road Surface moves down the track at the prescribed speed and the Vehicle Body is rotated and released to meet the Road Surface at the prescribed angle and roll rate, and arrested after each roll. Detailed descriptions of capabilities and operation of the JRS are published elsewhere.^{19,20,21}

Figure 5. Photograph of the major components of the JRS

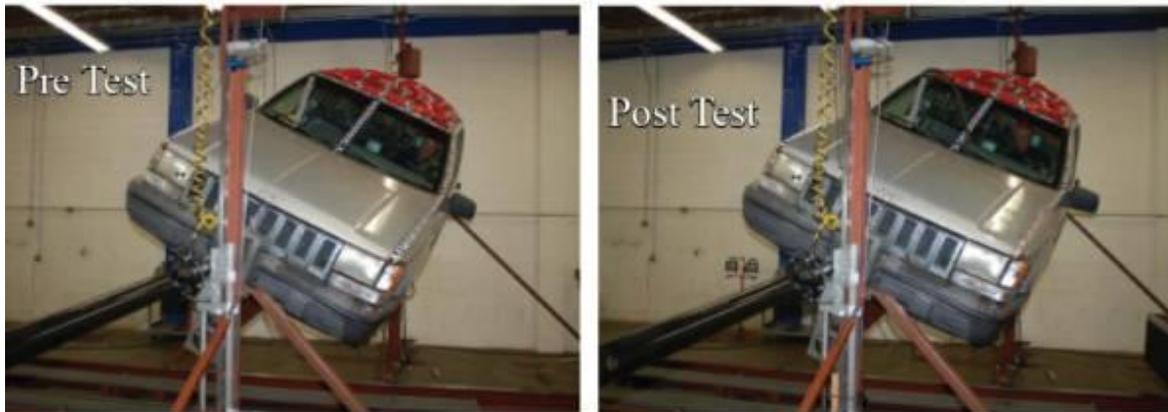
The second prototype of the HALO™ was a much more intricate design with multiple attachment points, a fully integrated interior B-pillar to B-pillar reinforcement and a fully redesigned exterior front. This prototype worked very well in reducing roof crush as shown in Figure 6. The vehicle struck the ground at 147° on the near side and cleanly rolled over the far side with very little apparent damage. The dummy was only lightly loaded during the test. The test results for prototype 2 are shown in Table 1.

Figure 6. HALO™ Prototype 2; No noticeable deformation to the roof structure

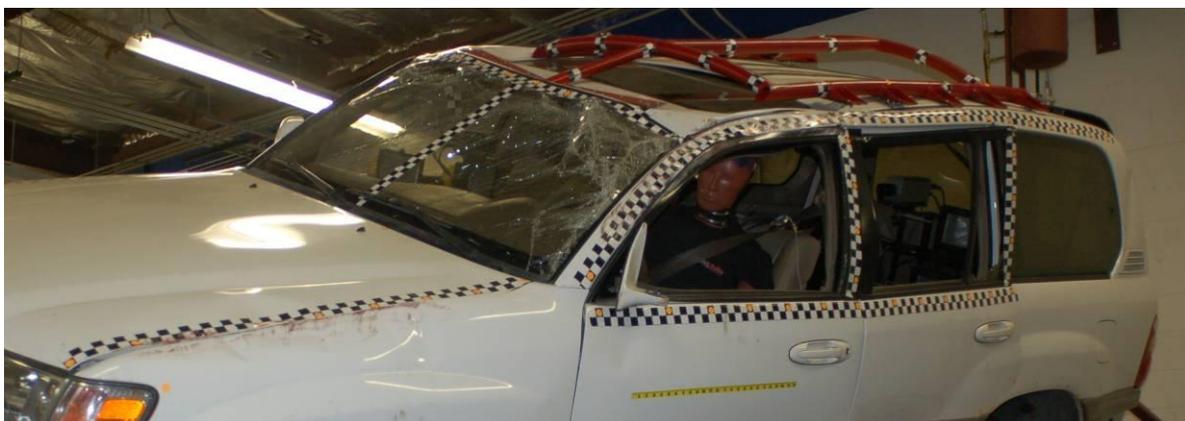
The third prototype of the HALO™ was a more simple design than the previous prototypes with a fully redesigned front. The HALO™ Prototype 3 on a different SUV was tested to check for differences in vehicle type performance and without the internal supports at the B-pillar. This prototype was not as successful in that the B-pillars had some buckling and the flat redesigned exterior front pushed in on the header more than considered acceptable as shown in Figure 8.

Figure 8. HALO™ Prototype 3 post-test photograph

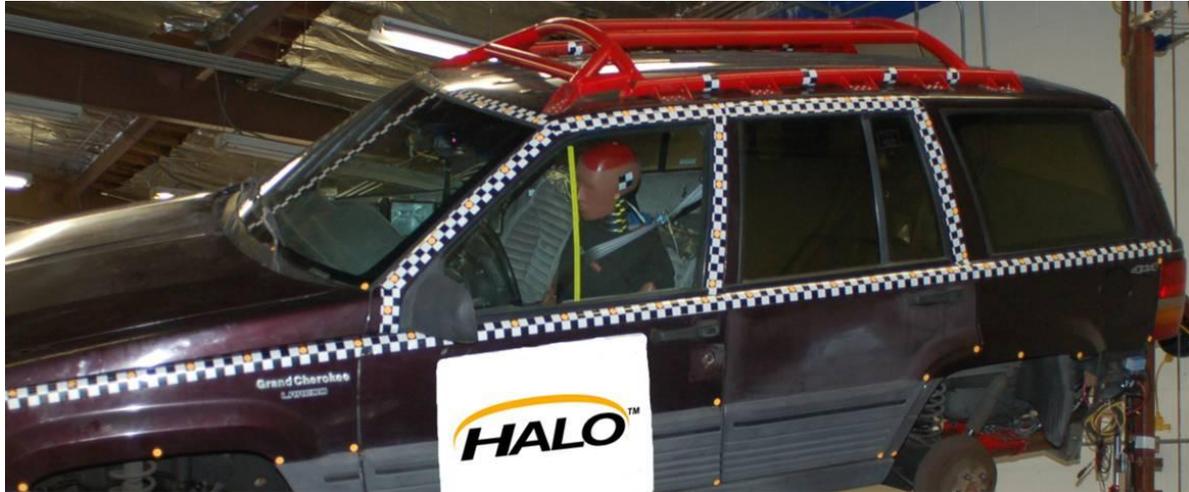
For the fourth prototype test the original SUV type used for prototypes 1 and 2 was used again. The redesign included the B-pillar reinforcement plates, dual longitudinal rails and a redesign of the piece in front of the roll hoop. The same protocol for testing on the JRS was used. Photographs of this design before and after each roll of a 3 roll test series are shown in Figures 9a-d below.

Figure 9a: HALO™ Prototype 4 pre-test photograph

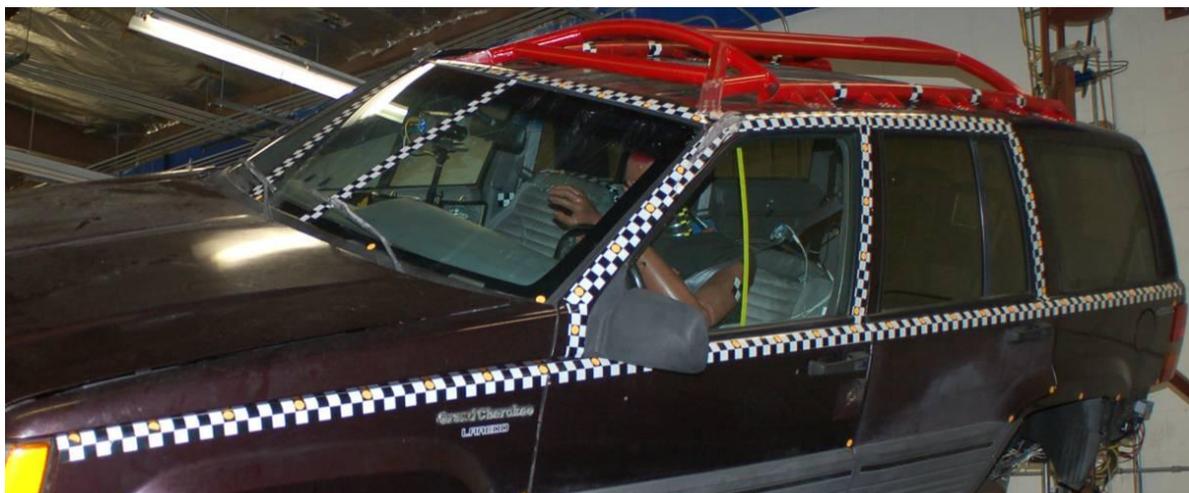
HALO™ prototype 4 performed very well in a three roll series of tests. The first roll was conducted with an 18 mph (30 kph) road speed, 10° of pitch and 145° roll contact angle. The resultant measurements of roof displacement are shown in Table 2. Figure 9b is the post-test photograph.

Figure 9b. HALO™ Prototype 4 Roll 1 post-test photograph

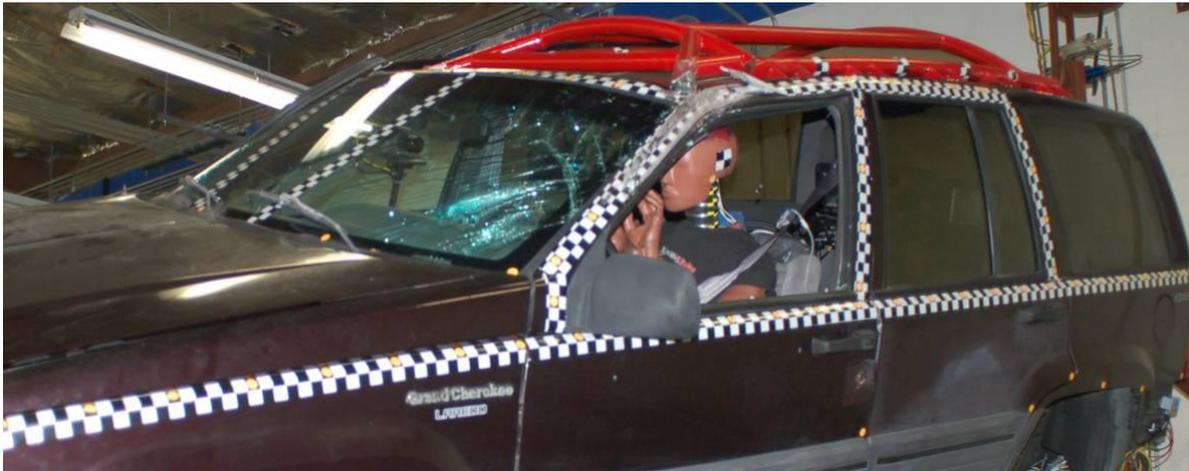
The second roll was conducted with an 18 mph (30 kph) road speed, 10° pitch and 145° roll contact angle. Table 3 lists resultant roof displacement measurements. Figure 9c is the post-test photograph.

Figure 9c. HALO™ Prototype 4 Roll 2 post-test photograph

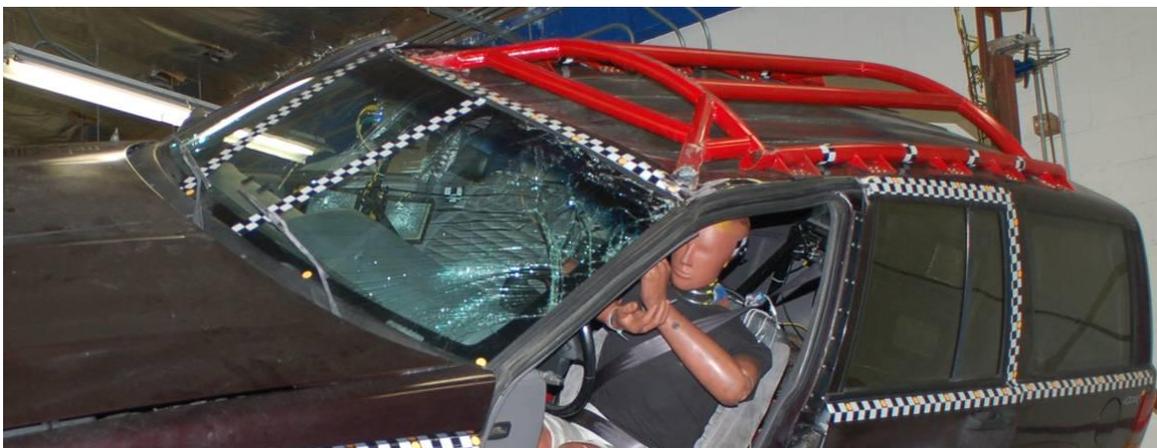
The third roll was conducted at a 15 mph (24 kph) road speed, 5° pitch and 135° roll contact angle. Table 4 lists resultant roof displacement measurements. The post-test photograph is Figure 9d.

Figure 9d. HALO™ Prototype 4 Roll 3 post-test photograph

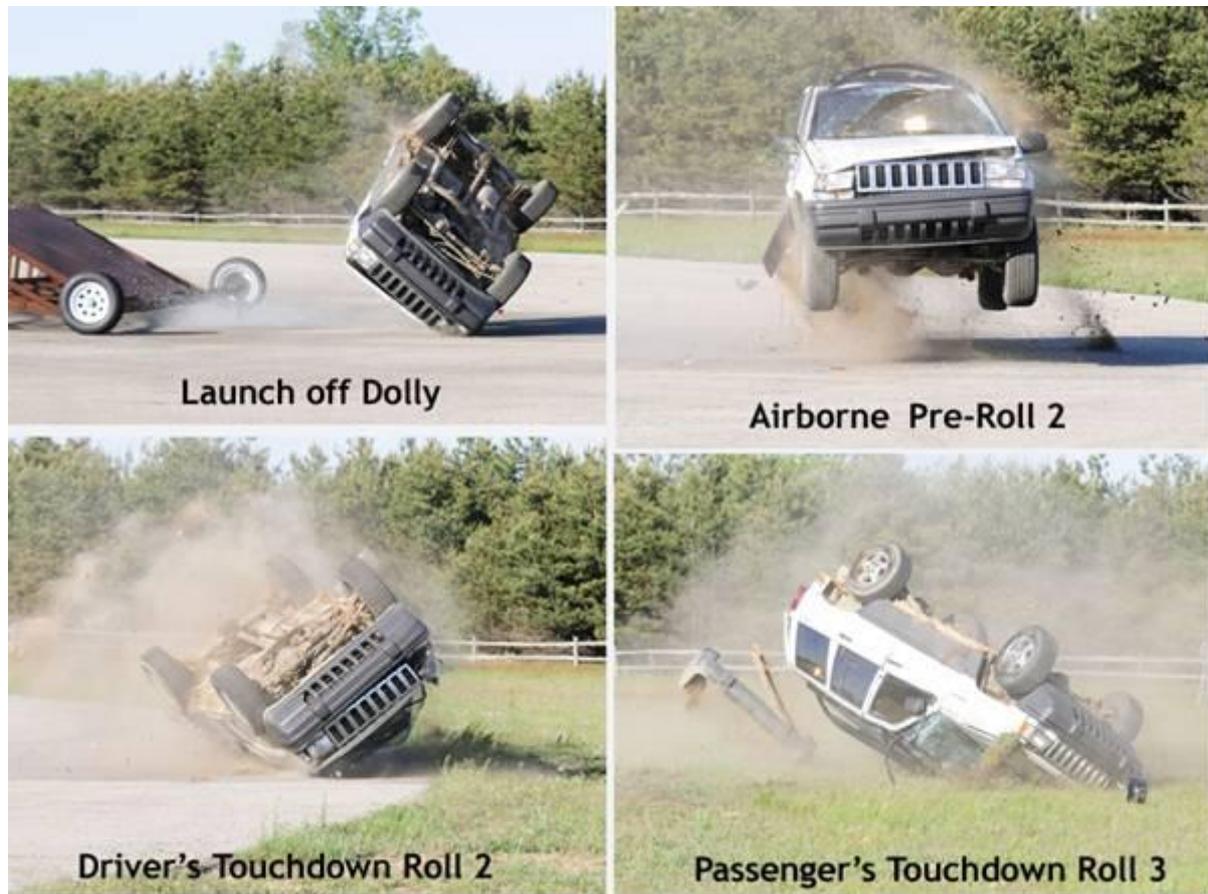
Finally, a dolly rollover test was performed with HALO™ Prototype 4 on a 15 year-old, high-mileage, somewhat-rusted, used vehicle. The test was conducted at 42 mph (68 kph) off the dolly, which was more severe than FMVSS 208. A sequence of photographs from the test is shown in Figure 10.

Figure 10. HALO™ Prototype 4 during a FMVSS 208 dolly rollover test

The various videos were reviewed. From the photo-analysis, the vehicle came off the dolly with a low roll rate, reaching the driver's side at 89 °/sec such that it slid on the driver side before generating the roll momentum to result in the average roll rate in the first roll of 285 °/sec. The average roll rate in the second roll was 335 °/sec. The average roll rate in the last roll was 100 °/sec.

The vehicle kinematics during the rollover were unusually severe involving, on the second roll, substantial lofting and pitch (the vehicle elevated about 2 feet (61 cm) into the air and pitched down about 10°). Interior video and photographs indicate that the roof matchboxed. [Matchboxing is when the roof shifts from side to side rather than collapsing on one side.] This happened because the HALO™ connected the two sides, and when the vehicle rolled, the sides shifted together laterally in the same direction due to the horizontal loading component. It distorted vertically in opposite directions (when the driver side was depressed the passenger side expanded). As a result, there was no significant possibility of loading the passengers that would result in an injury. The only foreseeable circumstance during this three roll event where an injury could occur is if an unbelted driver's head was at the A-pillar on the driver side in the second roll.

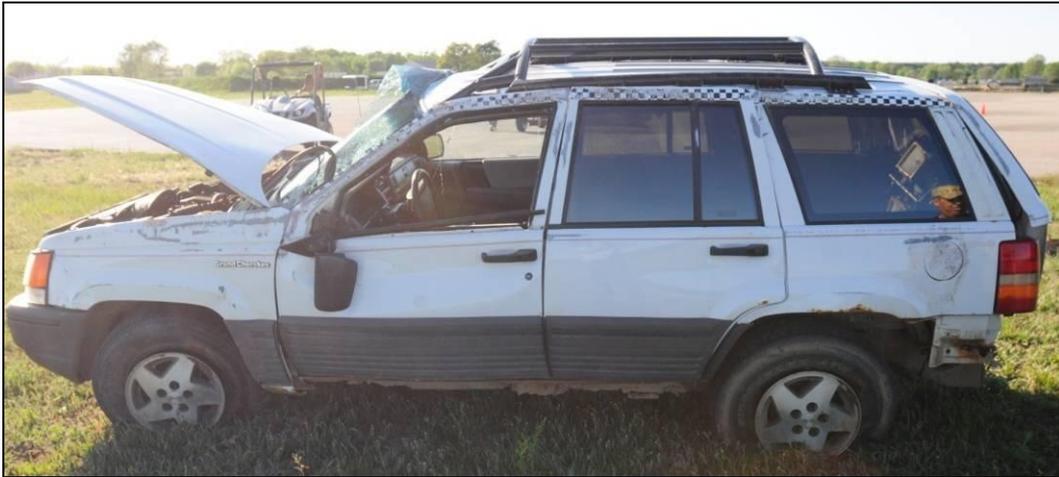
The vertical displacement and velocity on the driver's side at the mid A/B roof rail and B-pillar are unlikely to be injurious. Also, all glass remained intact, except the driver window, limiting ejection possibilities to unbelted occupants. Photographs taken immediately after the vehicle came to rest show a flat roof interior somewhat lower on the driver's side and higher on the passenger side. A photograph of the exterior is shown in Figure 11.

Figure 11. Prototype 4 HALO™ after a 3 roll dolly rollover test

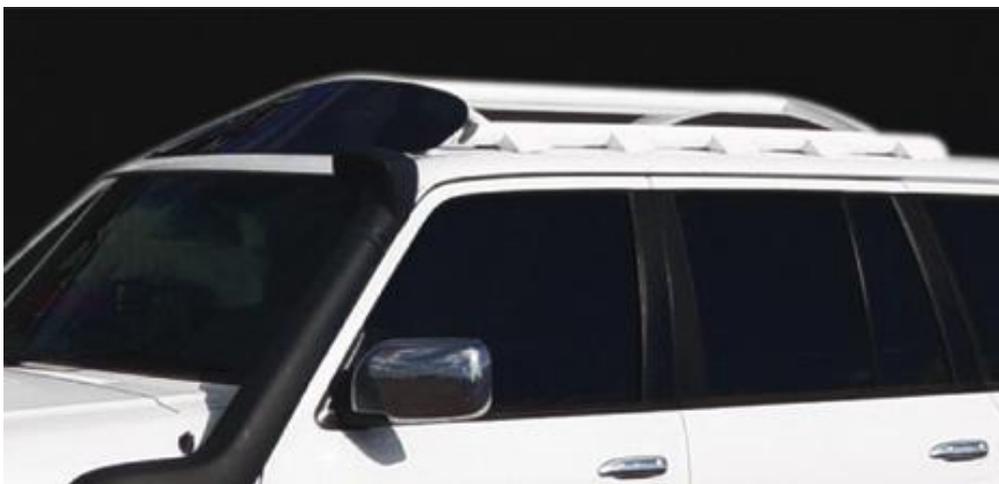
The final prototype was developed into the production HALO™ and was mounted on a 4WD vehicle for use in Australia as shown in Figure 12.

Figure 12. Final HALO™ mounted on 4WD for use in Australia

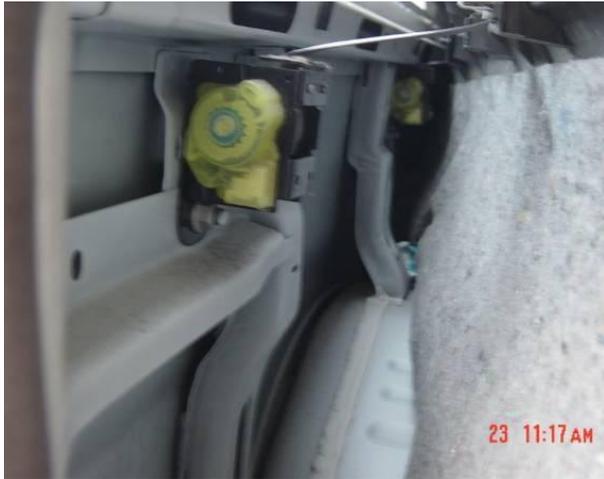
Once the SUV version of the HALO™ was completed, an interior retrofit strengthening system and external HALO™ was designed for a 12 to 15 passenger van, constructed, and installed. First, we performed a thorough examination of the production van structure. Weaknesses were identified. For example, there are no vertical load-bearing pillars between the B-pillars and the D-pillars and the distance between the load-bearing B-pillars and D-pillars is approximately 10 feet and excessive (Figure 13).

Figure 13. Non-structural pillars

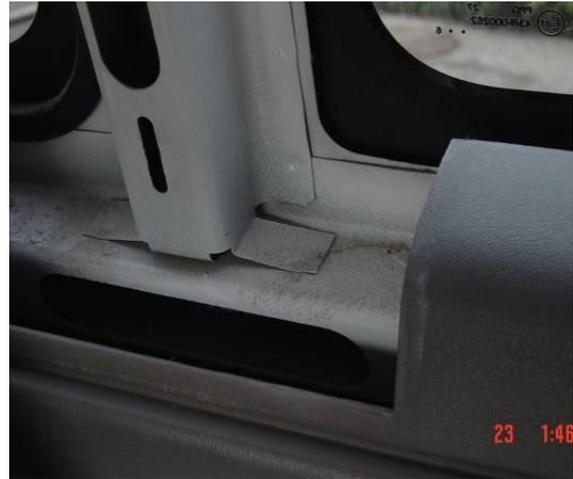
- On the driver's side, the vertical roof C-pillar is essentially a "false" non-structural pillar that provides only the minimum structure necessary to support the window sill (Figure 14).

Figure 14. Driver-side "false" pillars

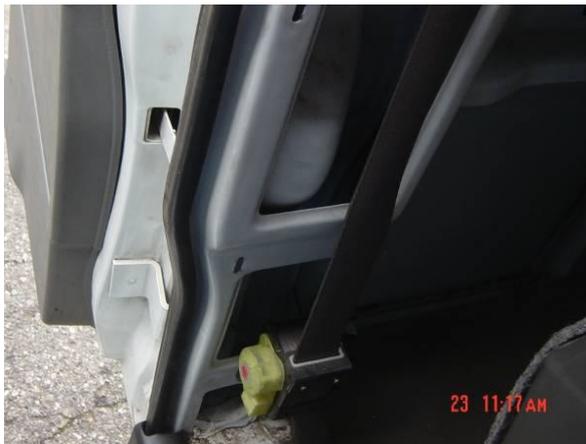
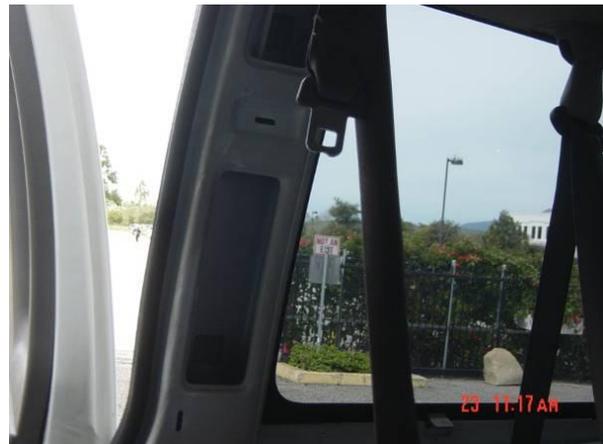
- On the passenger's side, the "C-pillar" has a relatively large overall profile, but is constructed of a single-layer 0.05-inch steel sheet and has open interior sections (Figures 15) that negate its strength, and necks down to a much smaller cross-section on its exterior and likely fails in buckling or local bending when subjected to the high stress concentrations in a rollover.

Figure 15. Passenger-side lower (left) and upper (right) C-pillar open sections

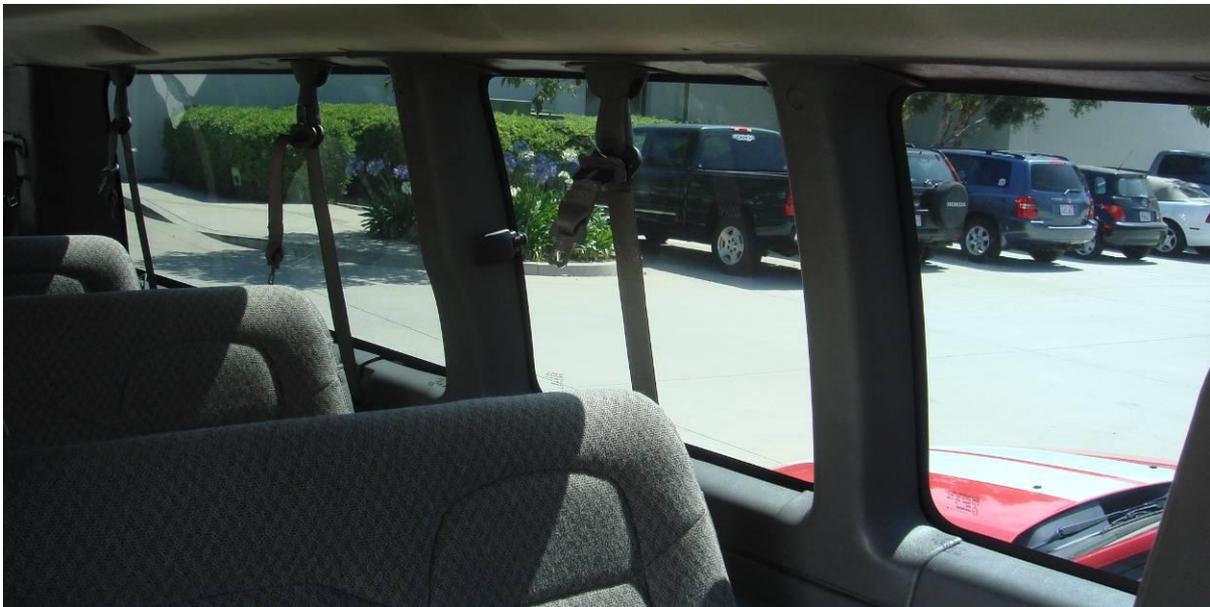
Figure 16 shows the production vehicle. Figure 17 shows the modifications for the proposed internal retrofit strengthening system.

Figure 16. Production passenger van

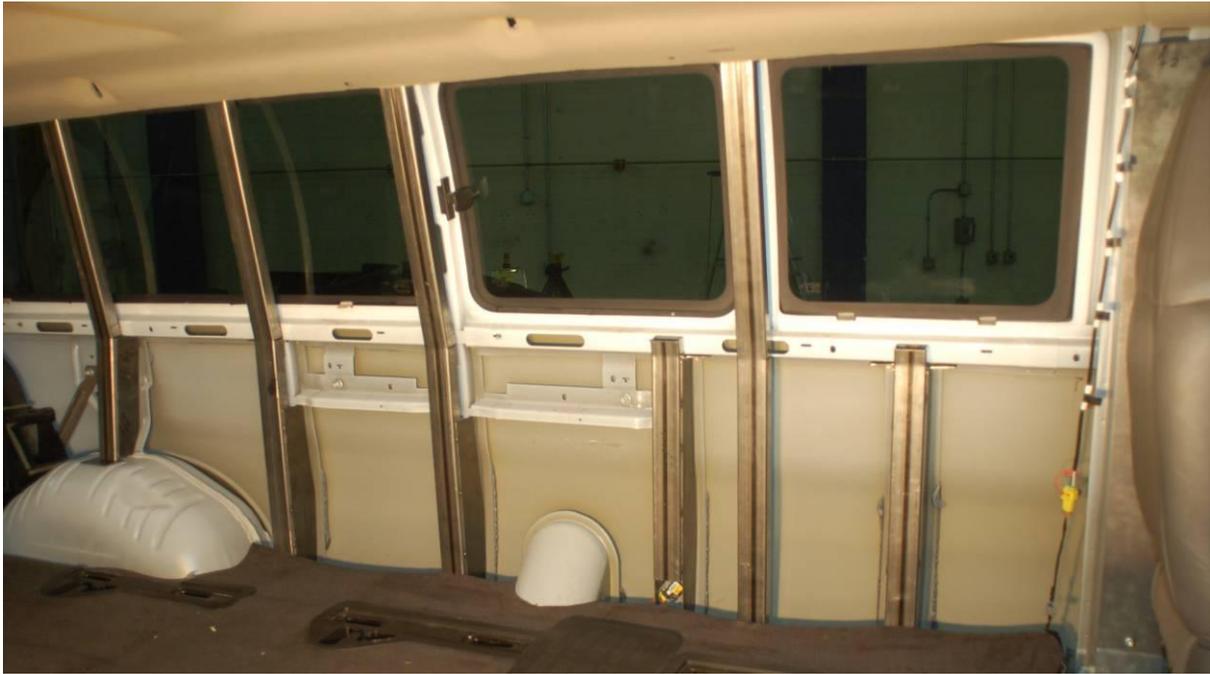
Figure 17. Passenger van internal retrofit strengthening system

- Driver-Side B-Pillar Reinforcement within the interior plastic
- Four additional Driver-Side Structural Pillars were
 - attached to the floor, roof rail, window sill, and
 - gloved over the existing “false” pillars and then riveted to the pillar with plates added to the floor in the region of each newly added pillar
- Two additional short pillars were added to the Driver-Side stemming from the floor to window sill in order to provide better lateral support to the region.

- Passenger-Side B-Pillar reinforcement within the interior plastic.
- Passenger-Side C-Pillar reinforcement within the interior plastic.
- Two additional Passenger-Side Structural Pillars were
 - attached to the floor, roof rail, window sill, and
 - gloved over the existing “false” pillars and then riveted to the pillar with plates added to the floor in the region of each newly added pillar

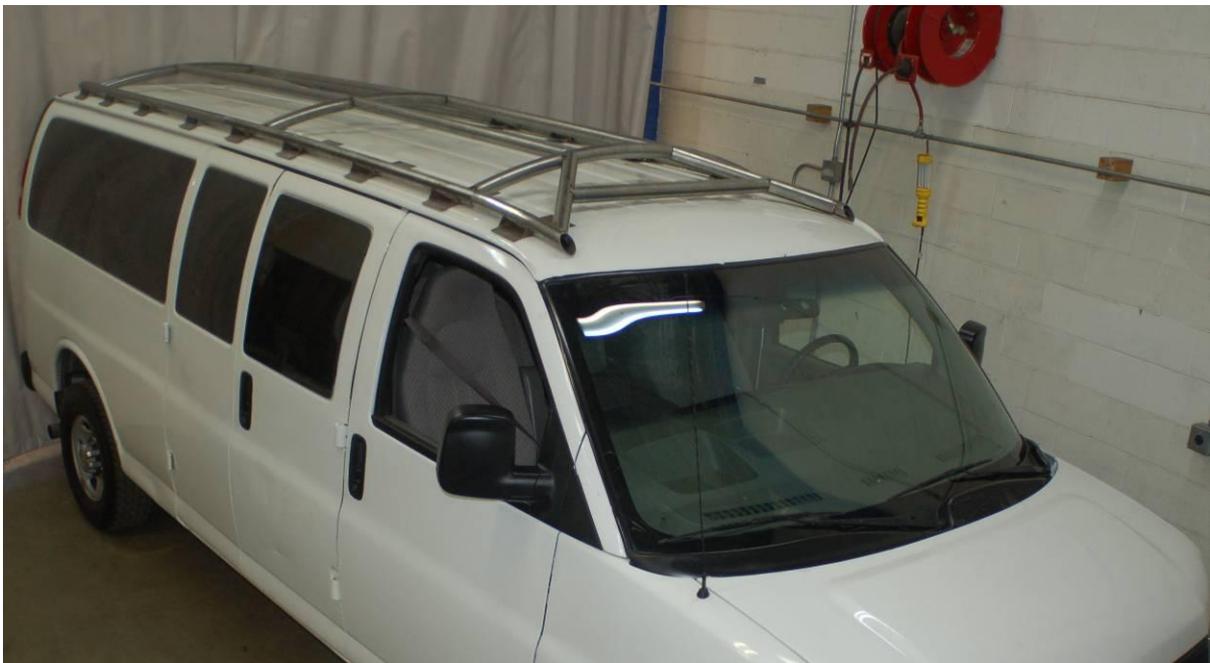
After finalizing the internal requirements for the retrofit, an external HALO™ was designed for the roof. Due to the length of this vehicle, the triple-hoop design shown in Figure 18 was developed for the van. With the proposed retrofit strengthening system, it is expected that the vehicle could withstand typical rollover roof loads.

Figure 18. 12 to 15 Passenger van with HALO™ rollover load distribution device.
