REDUCING ROLLOVER OCCUPANT INJURIES: HOW AND HOW SOON

Donald Friedman and Carl E. Nash, Ph.D.

Center for Injury Research

Paper No. 05-0417

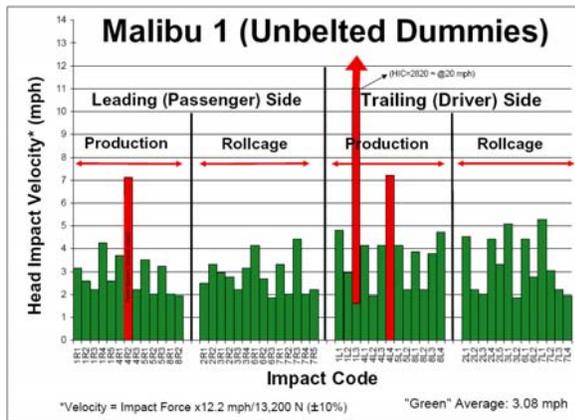
Figure 1. Malibu I neck compression velocities.

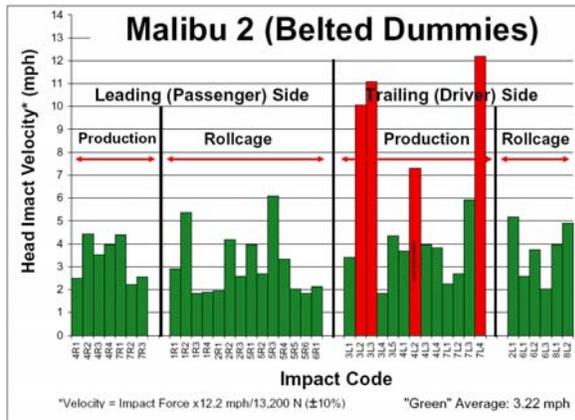
Figure 2. Malibu II neck compression velocities.

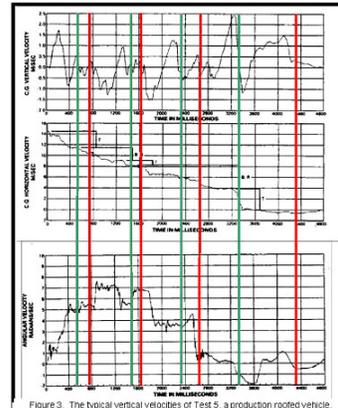
Figure 3. Contact Velocities in a Production Malibu.

GM Malibu I
Test 5
(All data from GM Discovery)
Near Side Contacts:
(Green Lines)
550 ms = 0.6 mph
1500 ms = 0.3 mph
2350 ms = 1.2 mph
3350 ms = 1.2 mph
Far Side Contacts:
(Red Lines)
790 ms = 0.6 mph
1677 ms = 0.4 mph
2662 ms = 1.2 mph
4330 ms = 0.7 mph

rollover impacts were similar and about 1 mph in production and about 3 mph in roll caged vehicles as shown in Figures 3 and 4 [4].

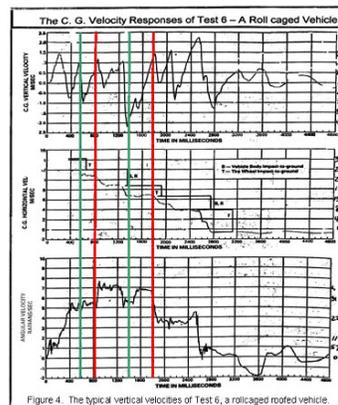
Figure 4. Contact Velocities in a Rollcaged Malibu.

GM Malibu I
Test 6
(All data from GM Discovery)
Near Side Contacts:
(Green Lines)
575 ms = 2.2 mph
1500 ms = 2.5 mph
Far Side Contacts:
(Red Lines)
836 ms = 2.7 mph
1802 ms = 3.1 mph

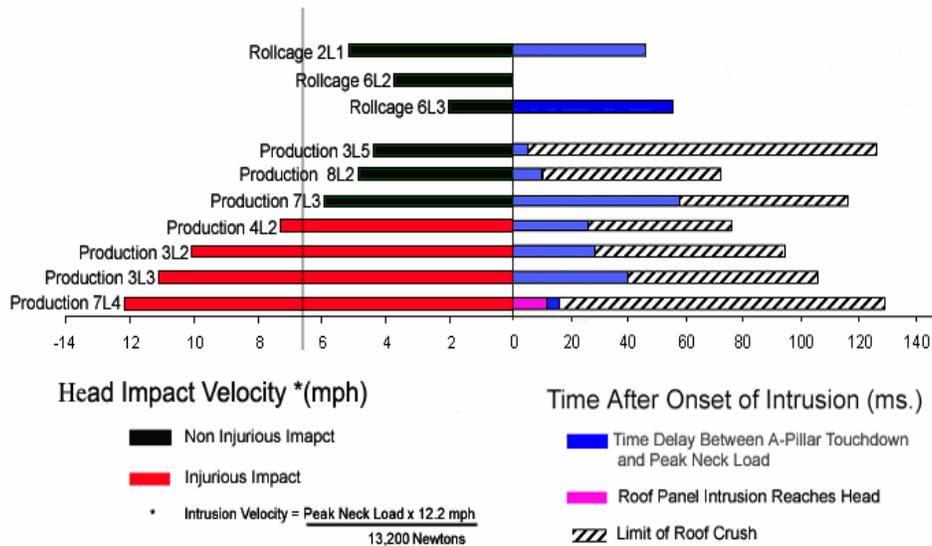
Malibu 2, GM Analysis of “Potentially Injurious Impacts”

Figure 5. Head impact velocity and timing of GM selected impacts.

analyzed by GM (See Figures 5 and 14) they include 3L3 v 6L1 and 7L4 v 2L1. GM deliberately chose a pair that had the same low neck load to suggest that there is no added protection from a strong roof vehicle.

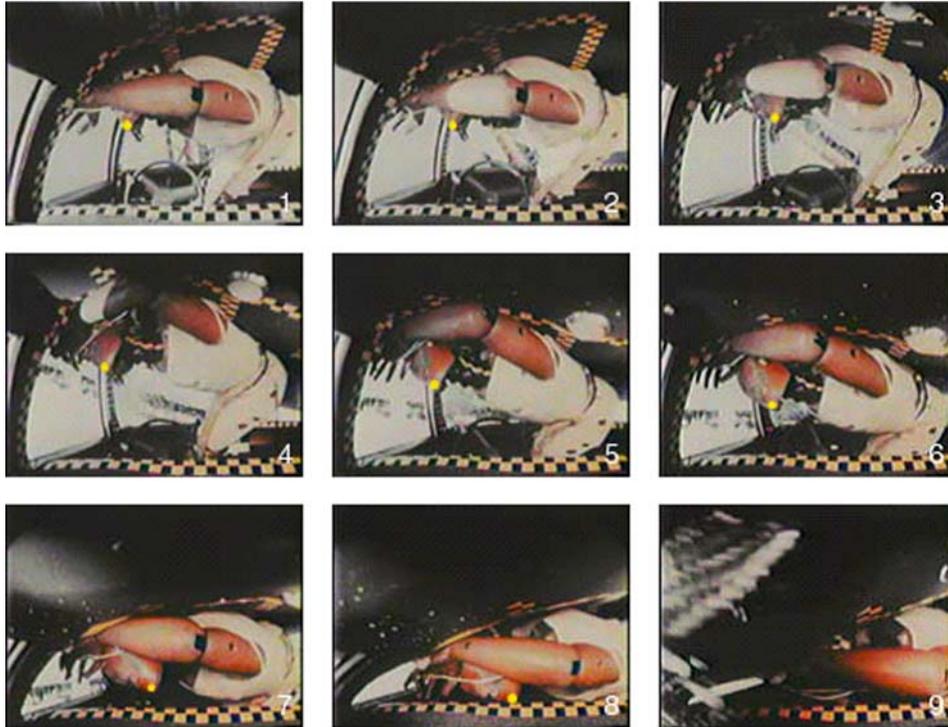
Figure 6. A sequence of frames from Malibu I, Impact 1L3.

Figures 6 and 7 show a sequence of frames from the photographic documentation of 1L3 and 4L4 that demonstrate that the injury mechanism was, in fact, the roof displacement..

Figure 6 shows Malibu I Impact 1L3 in a sequence of interior views (at 4 ms timing per frame) of the driver dummy during roof intrusion of 12 inches at 20 mph velocity taking place over 32 ms. This roof intrusion produced a HIC of 2,820 to the dummy that is against the roof (from centrifugal force) and driven inward and towards the seat cushion. Notice the checkered seat back reference is stationary so that the path of the head can be followed by the sequence of yellow dots which locate the dummy's chin.

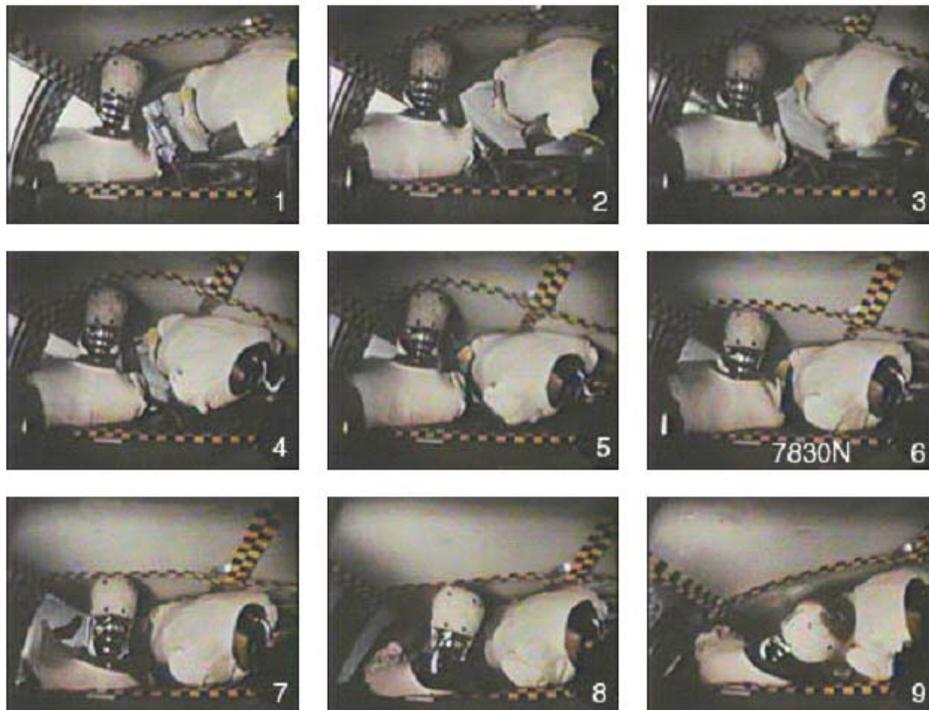
Figure 7. A sequence of frames from Malibu I Impact 4L4.

Figure 7 shows the Malibu I Impact 4L4 sequence of interior 4 ms frames of the driver being struck by a traveling buckle in the roof panel moving from the passenger side towards the driver side. The loading occurs in frame 6 when the neck is seen compressed and the dummy is subsequently driven towards the seat.

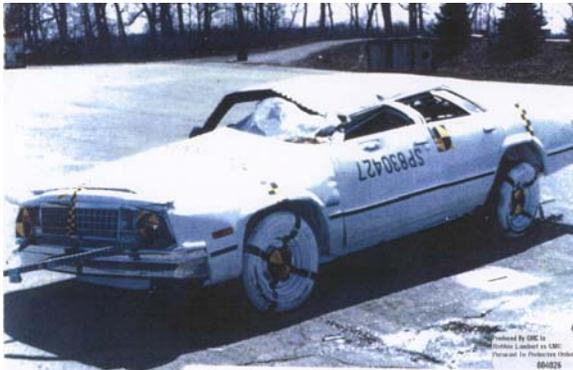
Figure 8. Malibu I Test 1 vehicle at rest with residual driver side intrusion.

Shown below in Figures 8 and 9 are the vehicles at rest showing the extent of lateral roof crush to the vehicles in these tests.

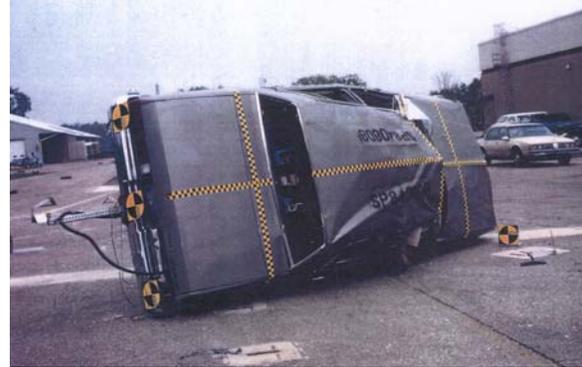
Figure 9. Malibu I Test 4 vehicle at rest with residual front seat intrusion and tenting.

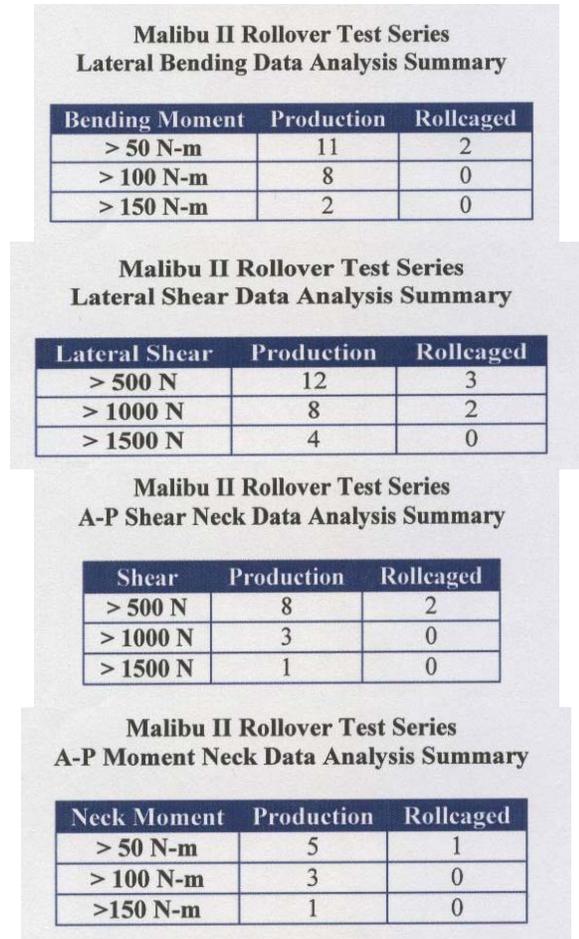
Figure 11. The numbers of impacts in which neck shear and bending moments exceed various limits in the Malibu II tests. (Reproduced from GM documents from the Malibu tests.)

The potential for injury comes not only from axial compression. When considering the trailing side occupant (the driver in the Malibu tests), the tables of Figure 11, show the substantially higher risk of injury from lateral bending moments, lateral shear forces, A-P Shear forces and A-P Moments in production as compared to rollcaged vehicles.

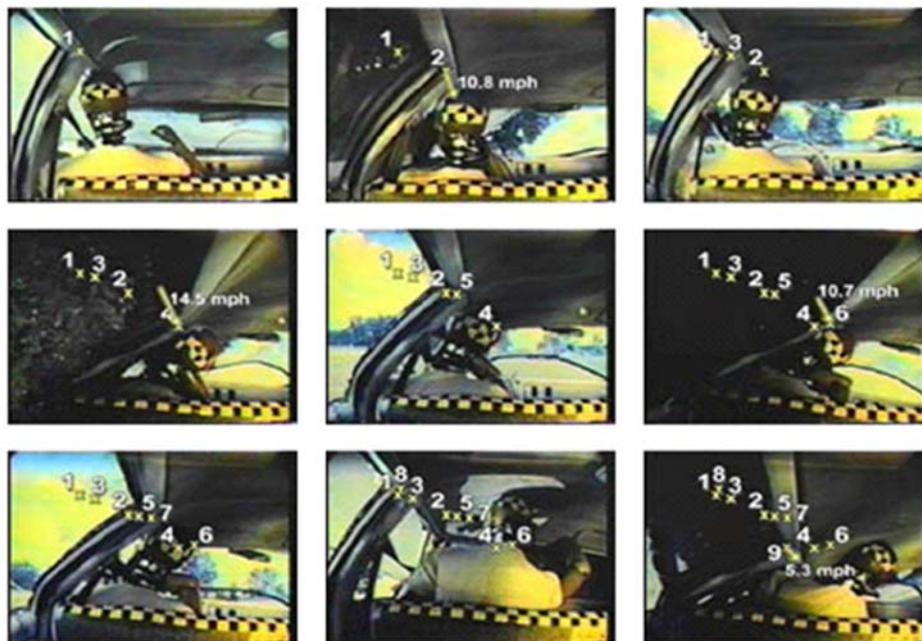
Figure 12. Malibu II Test 3 sequence of the intrusion position of the trailing side roof.

Figure 12 is a sequence of frames of the Malibu II Test 3 video showing the trailing side structure and driver dummy’s head and shoulders. It has been annotated with the sequential location of the intersection of the roof rail and B-pillar. The numbers 1, 3, 5, 7 and 8 show the roof after near side impacts while 2, 4, 6, and 9 show the roof after far side impacts. In this 3½ roll event, the trailing B-pillar rebounds elastically as well as from restoring forces from near side impacts. At position 8, just before the vehicle came to rest on its roof, the roof has virtually been restored to its original position. This behavior shows that residual roof crush, as used in statistical studies (without a detailed investigation of individual cases), can be misleading.

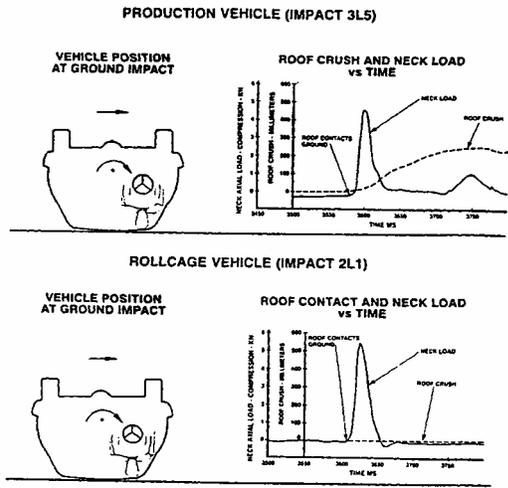
Figure 13. (Figure 12 in the Malibu II paper.) Roof Crush and Neck Loads versus Time from a GM Comparison between 3L5 (production) and 2L1 (roll caged).

“The roof crush which is seen in the films is actually the vehicle body moving closer to the roof, which occurred after the peak force on the neck; consequently, this deformation had no effect on the severity of the head-to-roof impact. Figure 12 from Malibu paper (here shown as Figure 13) illustrates that the dummy neck loads occurred prior to vehicle roof crush.” (SAE 902314, p. 106)

Photo analysis of these impacts reveals that the production vehicle neck load measured by the dummy occurred approximately 26 ms after the roof hit the ground and the dummy head was on the inside of the roof panel. The first four inches of high speed roof crush intrusion, which is seen in the films, occurs before the peak force on the neck. The maximum (or residual) deformation had no effect on the severity of the head-to-roof impact. Figure 16 illustrates that the high dummy neck loads occurred after the initial four inches of high speed intrusion but before the maximum roof crush.

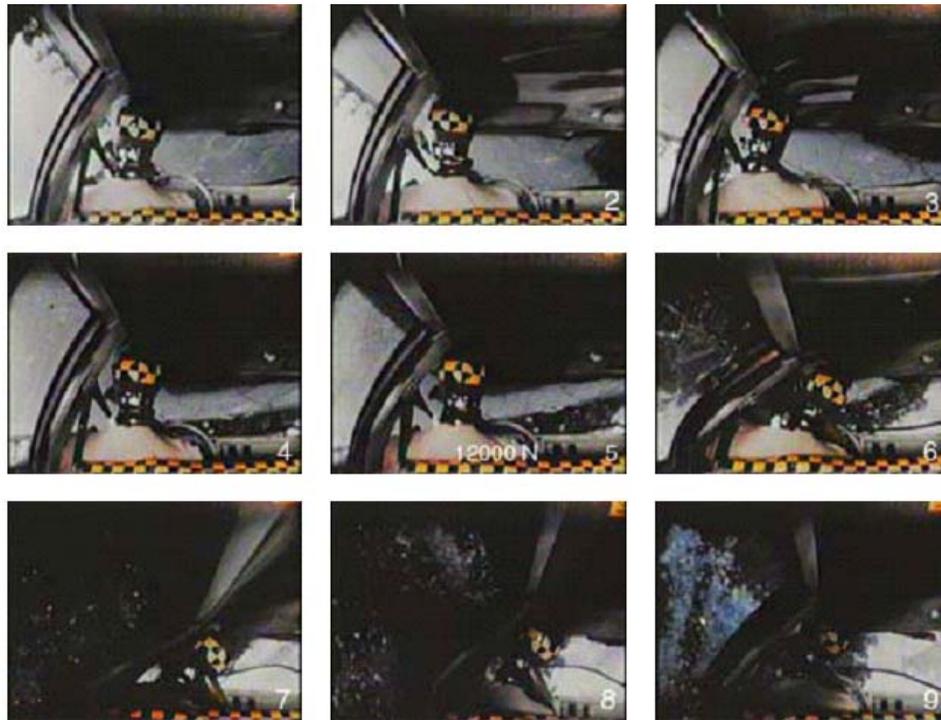
Figure 16. A sequence of frames from Malibu II Impact 3L3.

Impact	3L3	6L1
Roll Angle	217°	225°
B-Pillar Displacement	16.7 in	0 in
Peak Neck Load	12,000 N	2,800 N
Vehicle Rotation Rate	407°/sec	500°/sec
B-Pillar Velocity	10.7 mph	0 mph

The second roll of test 3 (3L3) and test 6 (6L1) showed very similar roof-to-ground impacts, but the production car suffered substantial roof crush from that roof impact. In the roll caged vehicle, which had no roof deformation, the driver dummy had an axial neck load of 2,800 N. In the production roof vehicle, which had 225 mm of roof crush, the driver dummy

had an axial neck load of 12,000 N. In both instances the dummies were in very similar positions, the roof-to-ground impacts were of similar severity. The neck loads however were vastly different because of the difference in roof intrusion velocity which was 6.3 m/sec (14 mph as determined from the initial slope of the roof crush versus time graph) for test 3 but only 2.2 m/sec for test 2; and roof crush which was 23 cm (9 inches) for test 3 but less than 3 cm for test 6 (see Figure 16, 17, and 18).

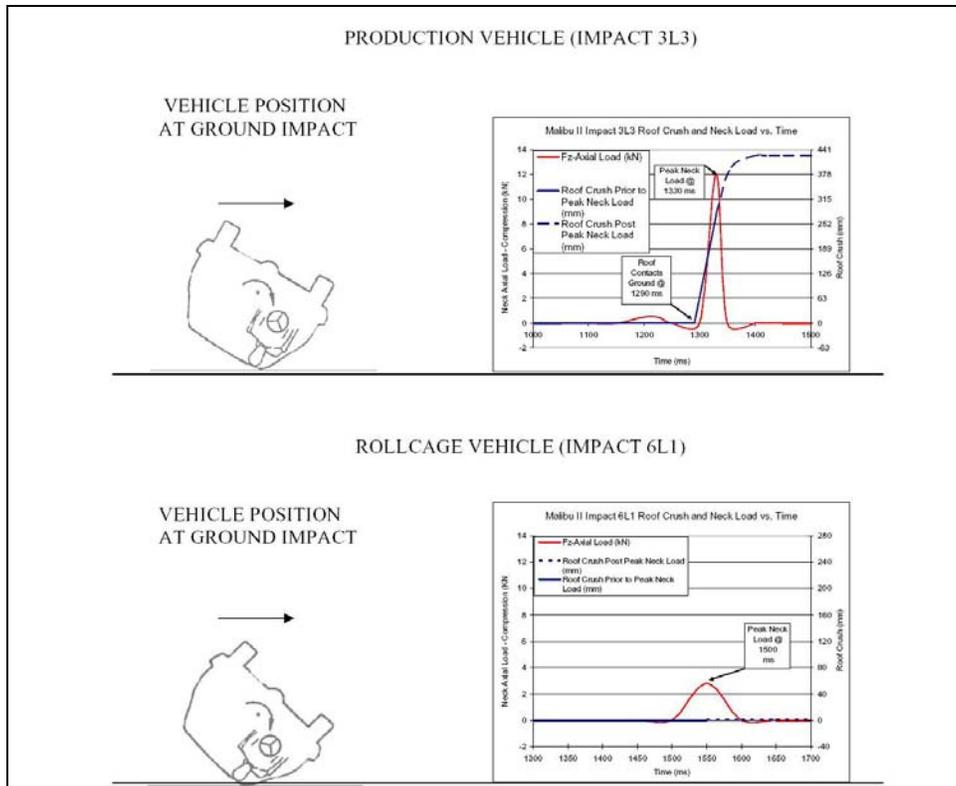
Figure 18. Roof Crush and Neck Loads v. Time for Impacts 3L3 (prod.) and 6L1 (roll caged).

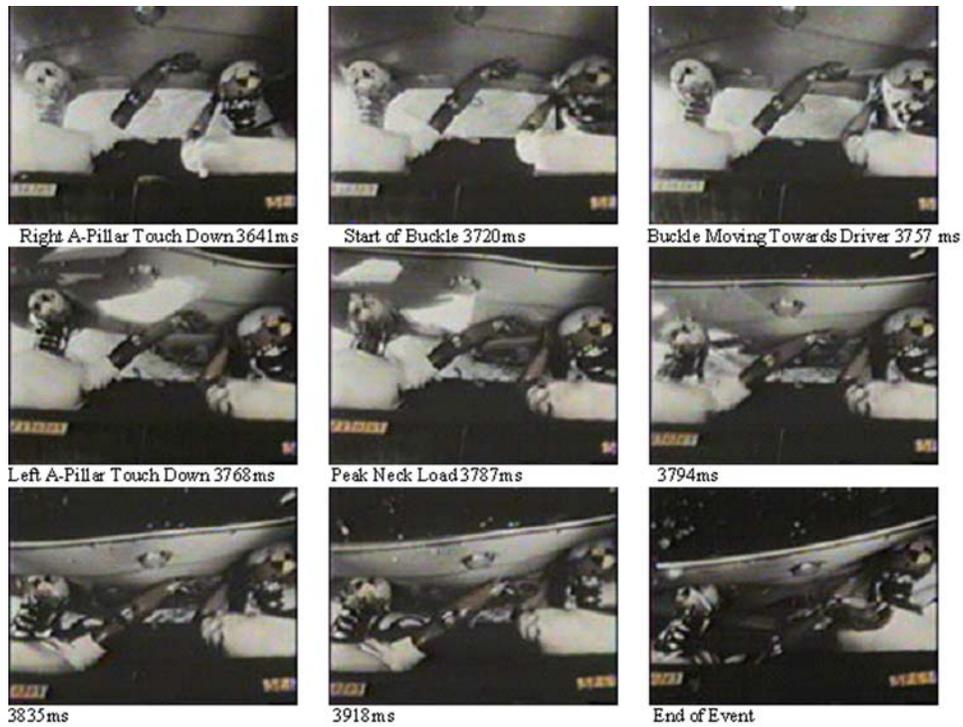
Figure 19. Nine frames from impact 7L4 with timing referenced.

Impact	7L4	2L1
Roll Angles	176°	184°
B-Pillar Displacement	9.8 in	0 in
Peak Neck Load	13,200 N	5,600 N
Vehicle Rotation Rate	172°/sec	184°/sec
Vehicle Horizontal Velocity	6.7 mph	6.5 mph

Photo analysis of these impacts reveals that the production vehicle neck load measured by the dummy occurred approximately 200 ms after the near side roof hit the ground and a roof panel buckling wave (what GM called a contact patch in Malibu I, but did not mention in Malibu II) struck the dummy's head which was pressed against the inside of the roof panel. The first four inches of high speed roof crush intrusion, which is seen in the films, occurs before the peak force on the neck; although the maximum (or residual) deformation had no effect on the severity of the head-to-roof impact. Figures 19, 20 and 21 illustrate that the high dummy neck loads

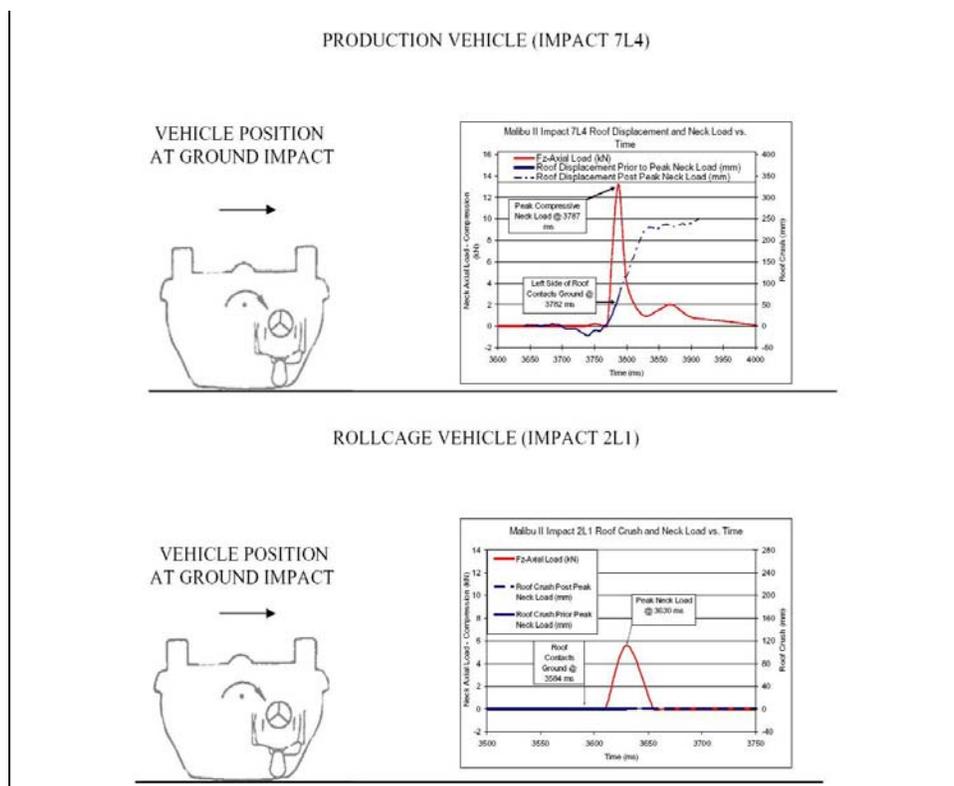
Figure 21. Roof Crush and Neck Loads v. Time for Impacts 7L4 (prod.) and 2L1 (roll caged). The roof displacement in 7L4 is measured over the driver dummy’s head.

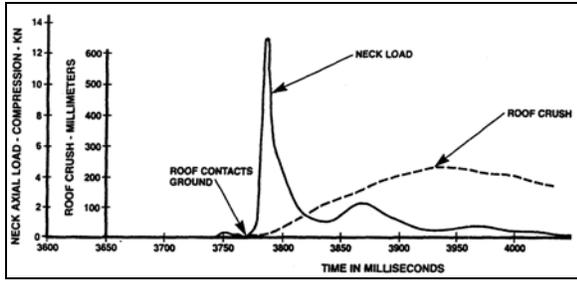
Figure 22. Figure 13 of the Malibu II paper.

“Figure 13. [Impact 7L4, shown as figure 22 here] ... First the load on the dummy neck is the result of the dummy head stopping against the roof when

the roof is against the ground. When the dummy head stops, the dummy torso continues to move toward the head, causing high axial forces in the neck. The neck measurements indicate that the peak of the force pulse occurred approximately 10 ms after the adjacent roof panel struck the ground, which was before any significant roof crush occurred.” (SAE 902314, p. 106)

4L4, that the GM authors called a “contact patch” as we explained earlier. Figure 24 depicts the sequence of sample frames shown in Figure 22, starting at the near side contact, then the three frames during which the buckle compresses the neck at an intrusion speed of 12.2 mph and the merging of the buckle with the far side roof crush driving the dummy towards the seat.

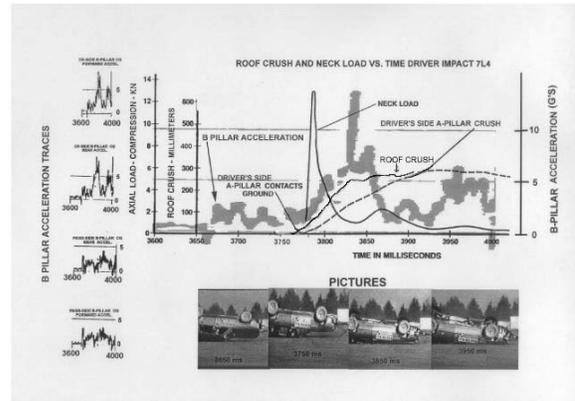
Figure 23. 7L4 redrawn to reflect the correct timing perspective and the timing of the B-pillar accelerometer traces.

We have redrawn their Figure 13 from the Malibu II paper as Figure 23 here to reflect detailed measurements of right and left B-pillar acceleration, the interior intrusion and intrusion velocity. With the

original film there is sufficient resolution to track the motion of the roof directly above the dummy’s head.

The load on the dummy neck is the result of the dummy head being contacted by the deformation of the roof panel from the near side ground contact and intrusion. That contact also forms a traveling buckle in the roof panel starting on the near side and traveling across the vehicle roof to merge with the trailing side contact and intrusion. The traveling buckle has an amplitude of about 4 inches and is off the ground and intrudes on the dummy head at 12 mph, causing the peak neck load over about 12 ms.

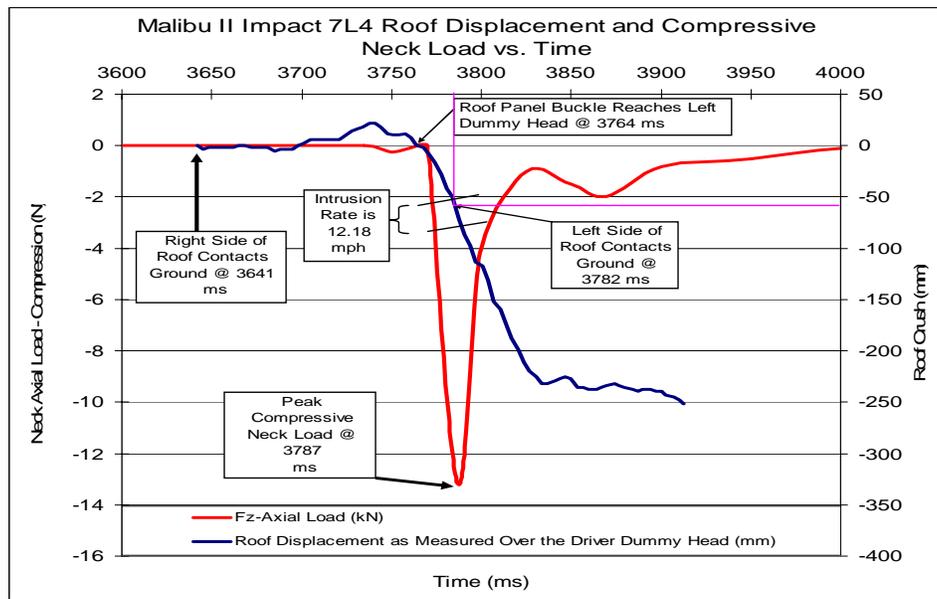
Figure 24. The motion of the roof above the driver dummy's head relative to a reference line.

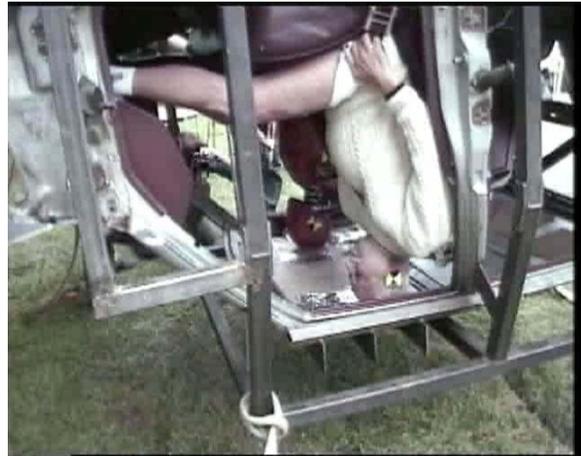
Figure 26. One of the authors (Friedman) and a Dummy in a 5.4 mph Malibu Drop Test in which roof crush was precluded.

Production Belted Standing Pelvis Dummy	Production Belted Seated Pelvis Dummy	Production Belted Iliac Crest Pelvis Human
Lap Loop Load	2,136 N	5,106 N	8,432 N
Head Force Z	6,915 N	4,255 N	(not measured –lightly struck roof)
Total Force	9,051 N	9,361 N	> 8,432 N

Although not stated in the paper, the dummies used in these tests were standing, not seated pelvis dummies (with the probable exception of the belted driver in the production vehicle drop test). A subsequent test conducted by one of the authors with the same vehicle, with a production belted human and a seated pelvis dummy in a rigid roll caged vehicle showed a major difference in neck loading, Figures 26 and 27.

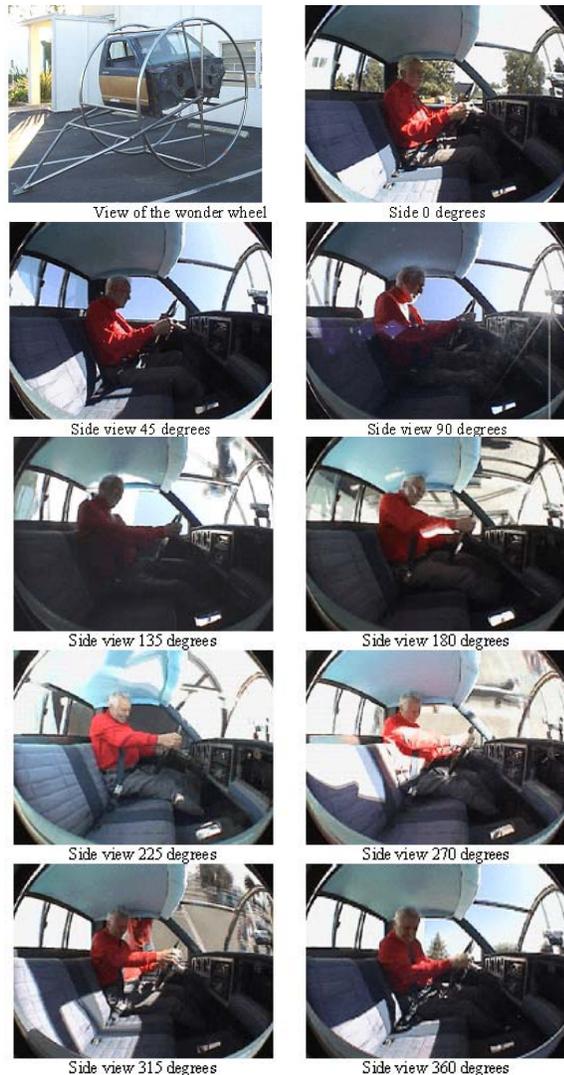
Figure 28. A human volunteer wearing a seat belt in the “Wonder Wheel”[6] that is rolling through 360 degrees. The occupant of this rotating fixture does not experience diving into the roof because his motion is essentially circular so that when the occupant’s head is nearest to the ground, it is traveling parallel to the ground.

We have illustrated this point with the “Wonder Wheel,” a device that simulates the motion of a rolling vehicle cab but with no roof crush or intrusion velocity. A human volunteer test subject is shown in Figure 28. His head moves to about the middle of the roof rail (even without vehicle pitch) and rises and
